Pre-purchase Manufactured Home Inspection Report

Sample of a 10 year old 2754 square foot Manufactured home with detached garage/office & shed.

Steve Garcia Inspections

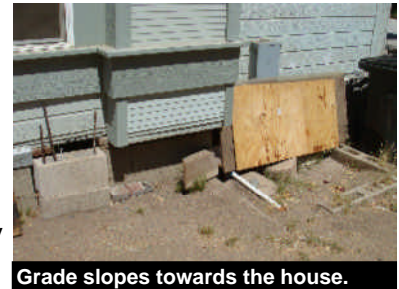
[CR] The grading at areas around the house, storage building, garage and office is not adequately sloped away from the perimeter foundation. It is important that surface grade be sloped away from the perimeter foundation to prevent moisture accumulation next to the buildings, which may infiltrate below the building effecting the structural integrity of the buildings support systems.

There are no rain gutters to control roof water runoff. I recommend installing rain gutters and downspouts. The downspouts should be extended away from the house and buildings.

[FE] I recommend the site be evaluated during heavy rains to determine the grading corrections /drainage plan needed.

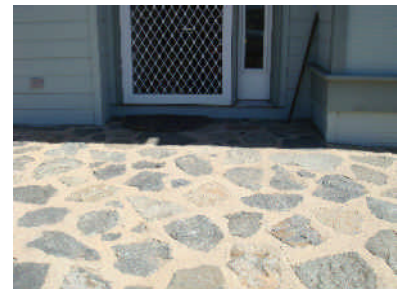
[FE] The entry/porch surface is above the building siding improperly. This condition is conducive to moisture intrusion and deterioration of the wall.

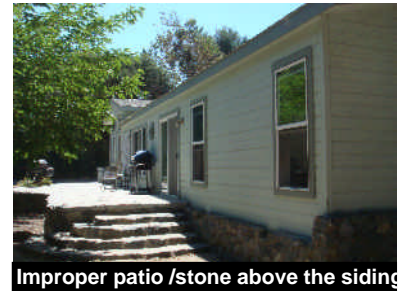
205 PATIO(S) **Description:** Concrete.

[CR] The patio surface is above the building siding. This condition is conducive to moisture intrusion and deterioration of the wall.

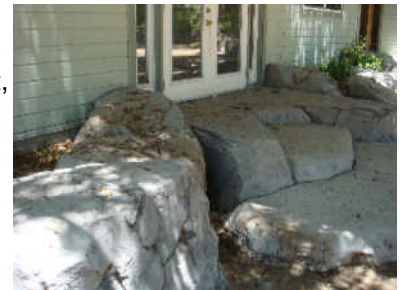
208 STEPS & STAIRS

[SC] There is improper rise on steps/stairs at the front, left and rear of the house. This condition is a trip hazard.

[CR] The office and garage stairs /steps are irregular and the step outside of the garage side door is improper.

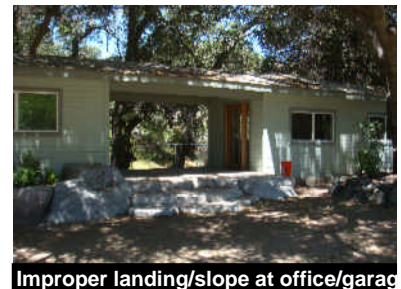
[CR] The irregular and improper stairs /steps into the buildings have improperly sloped landings that are too high onto the house and up to the door thresholds.

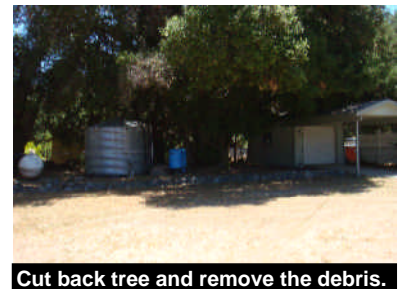
[CR] Maintenance, trimming or removal of vegetation is needed at the shed to prevent overgrowth and encroachment onto the building /roof.

[FE] The cosmetic stone planter at the garage has been placed up onto the garage siding improperly.

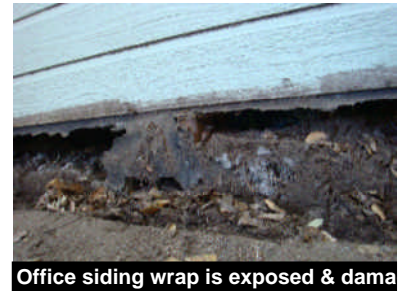
[CR] The office siding around the bottom is covered improperly with blocks and siding material. This condition is causing moisture damage to the siding materials.

Office siding wrap is exposed & dama

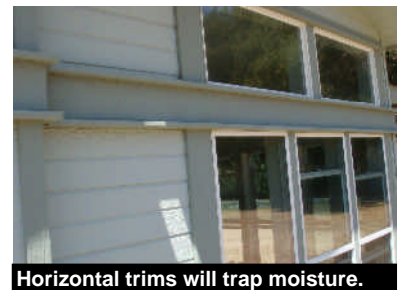
[CR] There are no visible metal flashings installed at the top of the door/window trims. This condition is conducive to moisture intrusion/deterioration.

[FE] There are overdriven fasteners noted. These condition(s) are conducive to moisture intrusion and deterioration.

Horizontal trims will trap moisture.

I recommend recaulking and painting the buildings.

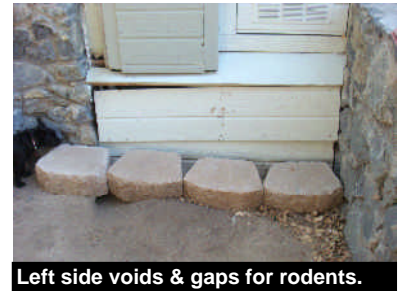
319 VENEER

[CR] The improperly installed veneer is lacking head flashings, is loose and separated from the wall at the front. This condition can allow moisture to become trapped between the veneer and wall siding.

[CR] The veneer is incomplete at the left and right sides of the house. The perimeter block suspected foundation mud sill and metal hold down plates are exposed at the right side.

[CR] The underside of the house is improperly open to rodents at the left and right sides. The areas are lacking perimeter blocks, siding and access opening covers.

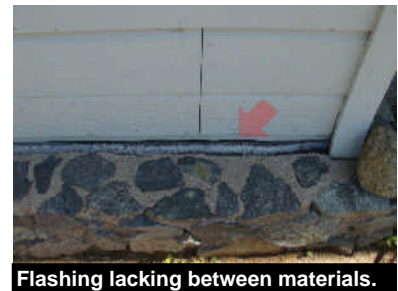
320 FLASHING(S)

[CR] The stone veneer should have flashing installed below the siding and over the top of the stone.

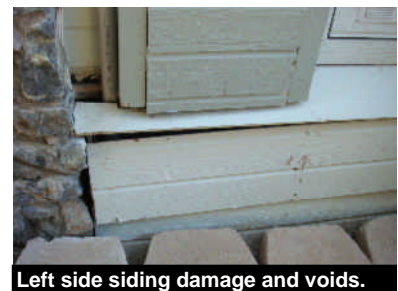
[CR] The siding at the left side of the house below the main electric panel is loose and damaged. This condition allows rodents into and below the building.

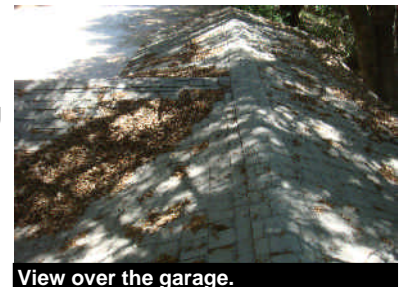
Inspector Notes: The garage, office and shed roofing materials do not have any visible defects other than the office skylight is lacking step flashings.

[FE] The debris should be removed from the roofs, and the roofs be inspected before the rainy season.

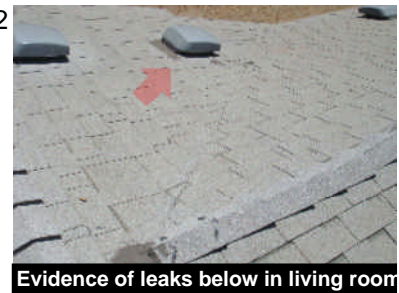
[CR] The roof installation is substandard with over exposed courses. The roof shingle head lap (overlap of the shingle above to the shingle below) is less than the manufacturers installation guidelines.

Evidence of leaks below in living room

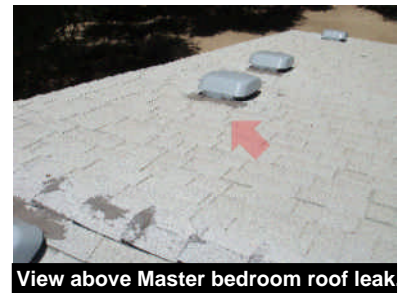
516 COMMENTS [CR] The ridge caps are cracked and patched. The heads of the vent flashings are patched.

The house appears to have been recently painted, re-painting may masked other leaks.

View above Master bedroom roof leak

I recommend replacing this roofing system before the rainy season.

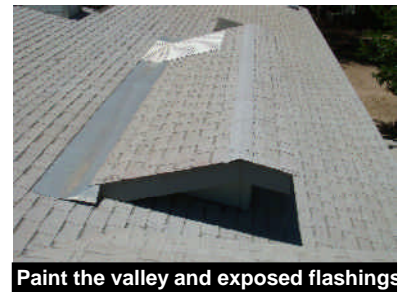
Paint the valley and exposed flashings

I recommend painting all metal flashings.

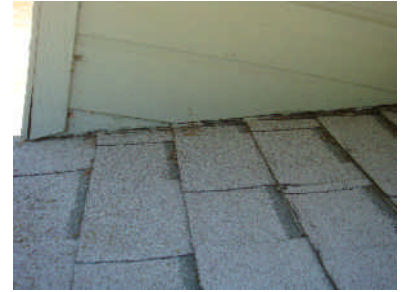
518 FLASHINGS [FE] The roof to wall /siding step flashings are not visible /present.

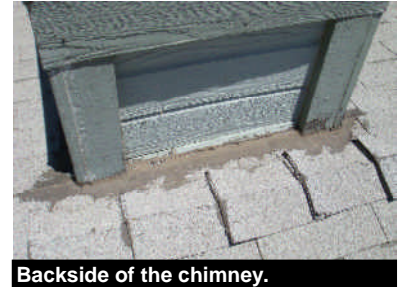
519 INSPECTOR RECOMMENDS [CR] The chimney is lacking a flashing at the back side, and the siding trim prevents water runoff.

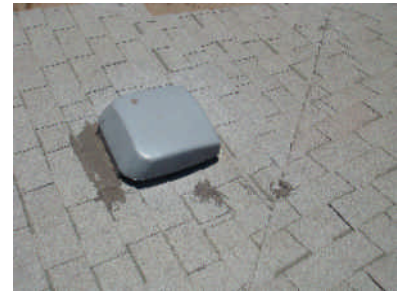
Mastic patching is evident at the heads of the flashings.

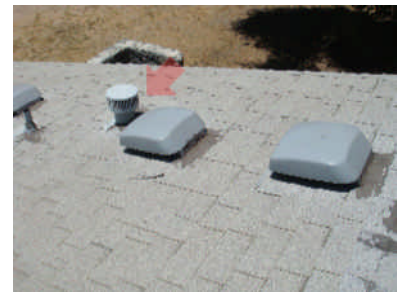
[CR] The water heater flue /vent pipe is improperly terminated (too short).

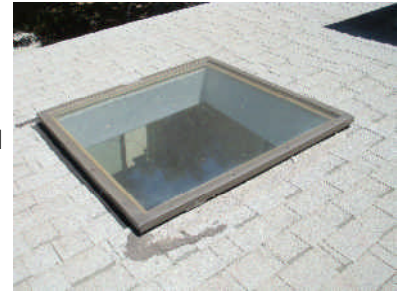
[CR] The large skylight is lacking a cricket /diverter in the roof behind the skylight to divert roof runoff around the skylight.

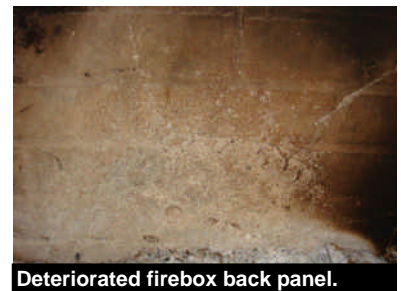
[CR] The firebox back wall panel is deteriorated and damaged.

Deteriorated firebox back panel.

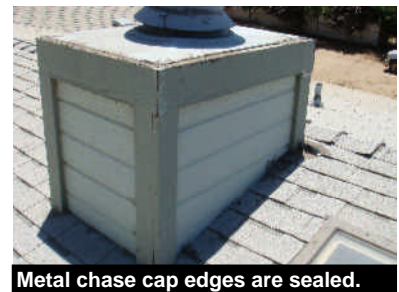
Metal chase cap edges are sealed.

The manufactures installations instructions should be reviewed for the installation of the chase cap.

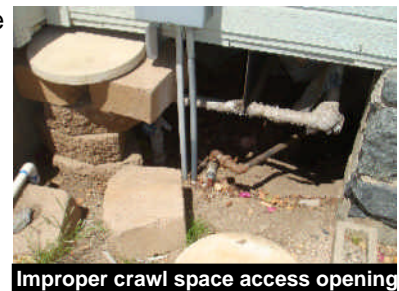
800 VENTILATION [RU] The crawl space ventilation is minimal due to the rear patio placed above the building siding, and the location of the vent openings.

Improper crawl space access opening

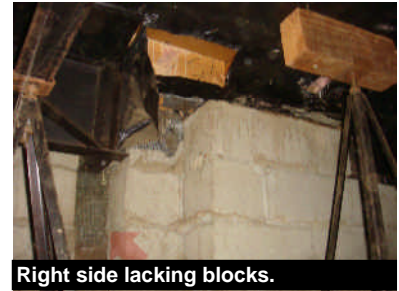
Right side lacking blocks.

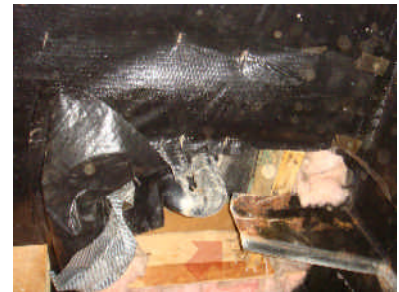
[FE] Below the hall bathroom shower a section of the metal frame appears to have been cut off for the installation of the shower drain trap.

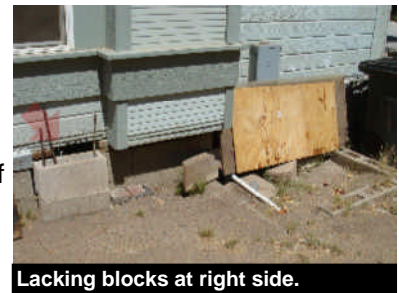
Lacking blocks at right side.

I recommend a crawl space access be made at the two areas for inspection and repairs to the underside of the building.

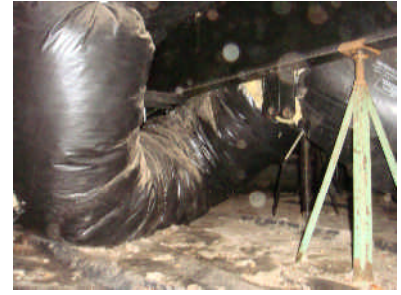
[FE] A couple of the stands are rusting and should be evaluated, and/or painted.

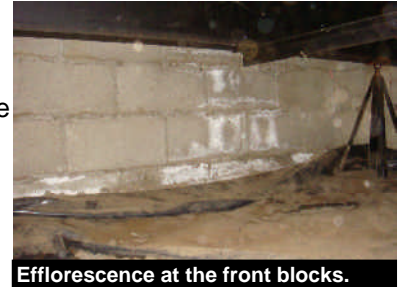
[CR] There is a condition known as efflorescence visible at the front area of the blocks. This is mineral deposits left when moisture in the concrete blocks evaporates. This condition indicates that the blocks are experiencing wet and dry cycles. I recommend the exterior grading and drainage be improved to divert moisture away from the building.

Efflorescence at the front blocks.

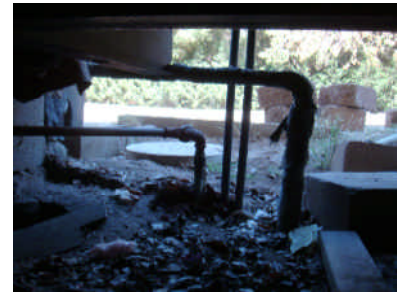
[CR] Access to the crawl is below grade with no curb. This condition is conducive to moisture intrusion into the crawl space.

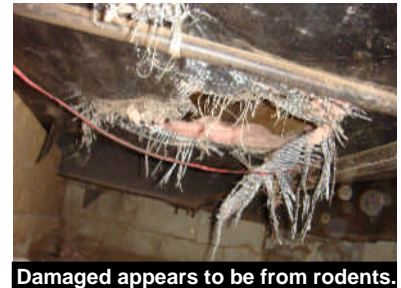
[CR] Insulation is damaged, open and missing at areas. It appears rodents have caused some of the insulation damage.

Damaged appears to be from rodents.

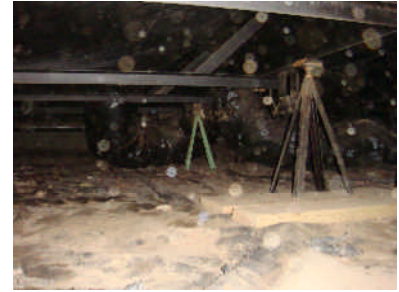
821 COMMENTS The plastic ground /soil cover is soiled from the rodents. I recommend the crawl space be cleaned out and the plastic replaced after cleaning.

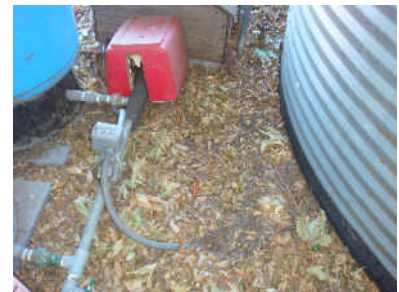
[FE] The water supply piping and control at the well should be evaluated by a specialist.

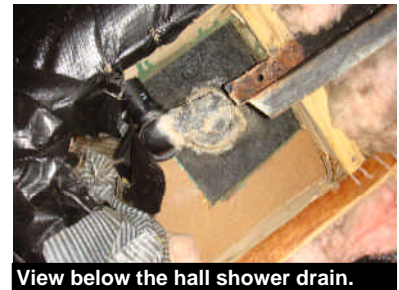
[FE] The hall bathroom shower appears to have leaked.

View below the hall shower drain.

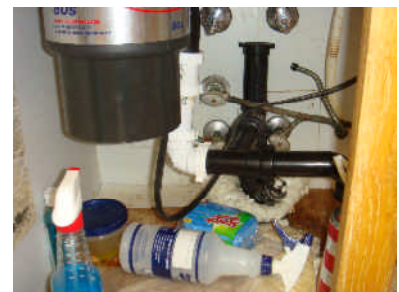
[CR] The kitchen sink drain is leaking, and the air admittance valve is missing.

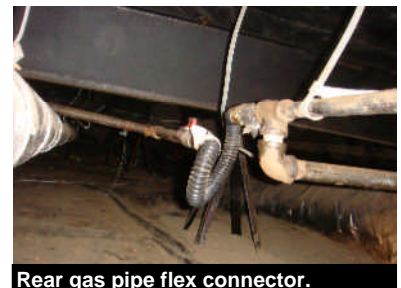
The rear flex connector label was not illegible for approved usage.

Rear gas pipe flex connector.

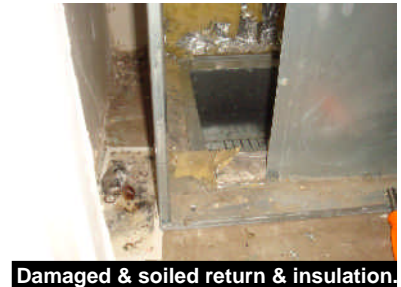
Damaged & soiled return & insulation.

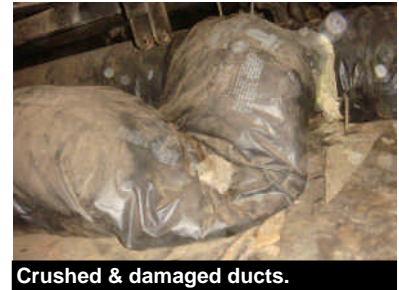
Crushed & damaged ducts.

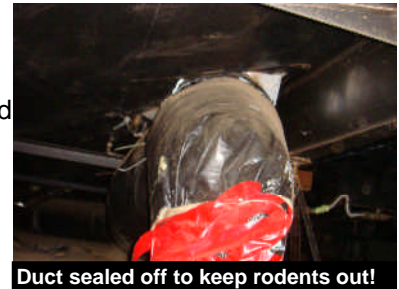
[CR] The living room supply ducts have been removed and sealed off below the furnace.

Duct sealed off to keep rodents out!

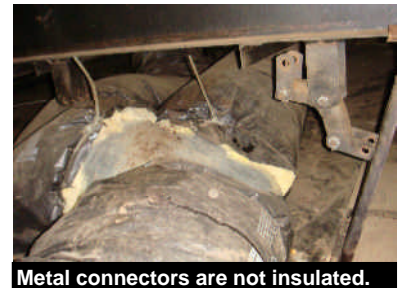
Metal connectors are not insulated.

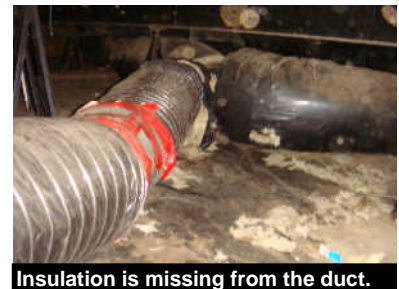
Insulation is missing from the duct.

All of the ducts should be replaced for health, and proper air supply.

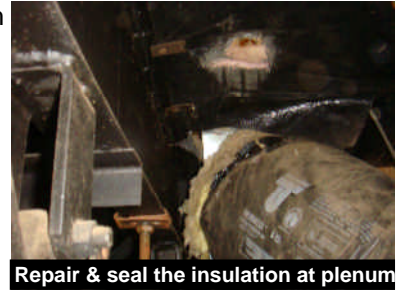
Repair & seal the insulation at plenum

[CR] The supply air plenums should be sealed off with the building underside insulation.

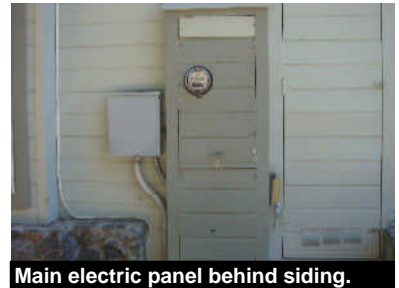
This condition is a safety concern and should be corrected.

Main electric panel behind siding.

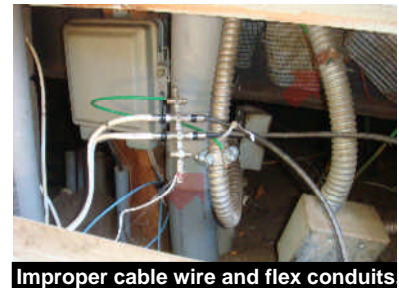
[CR] Two bare copper wires are attached improperly to metal flex conduits below the main electric panel.

Improper cable wire and flex conduits

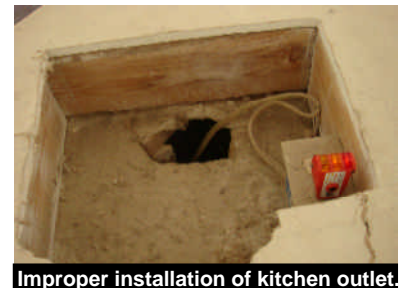
Improper installation of kitchen outlet.

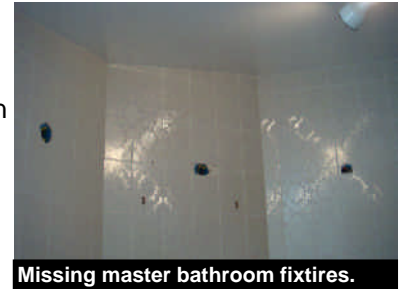
Missing master bathroom fixtures.

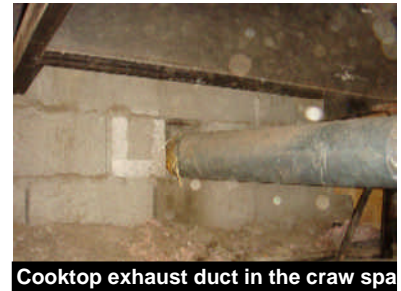
[CR] The exhaust vent duct has been blocked by the added patio.

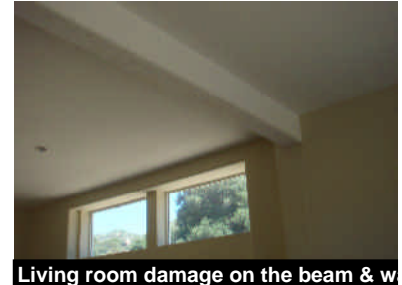
Living room damage on the beam & w

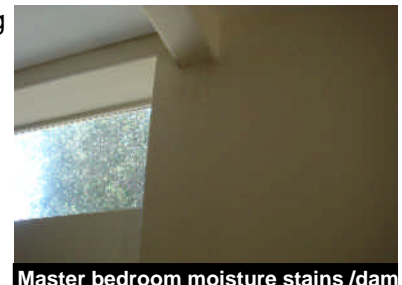
Master bedroom moisture stains /dam

I recommend replacing the roof with the proper roofing materials.
