# *Pre-purchase Home Inspection Report*

Exclusively for: Good client

33 year old 1,530 square foot attached house

***Steve Garcia Inspections***

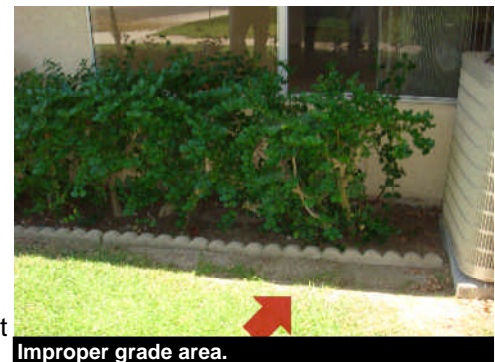
[CR] The grading at the right side, outside of the dining area is not adequately sloped away from the perimeter foundation. It is important the surface grade be sloped away from the building to prevent moisture accumulation next to the foundation, which may effect the foundation and slab.

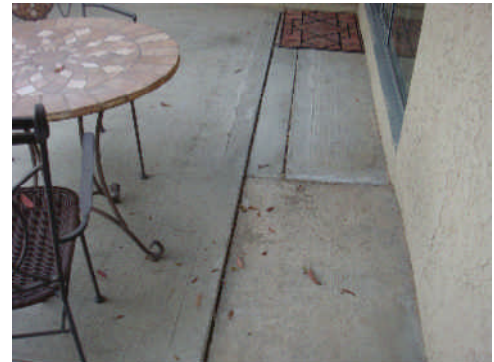
[CR] The slab is a bit uneven and the separation joints are open. The joints should be sealed /filled in.

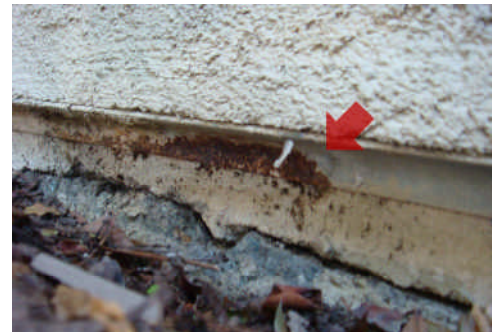
The stucco siding appeared functional, with cracks noted.

Rusting screed, clean and paint.

I recommend the stucco screed be cleaned and painted with an oil based rust inhibitor.

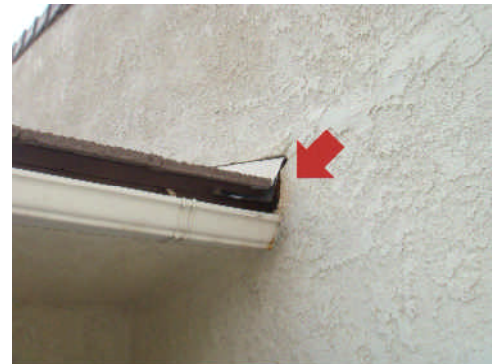
**320 FLASHINGS** [CR] There is improper metal flashing installation at the rear left building roof to wall intersection. The stucco wall is open. This condition is conducive to moisture intrusion.

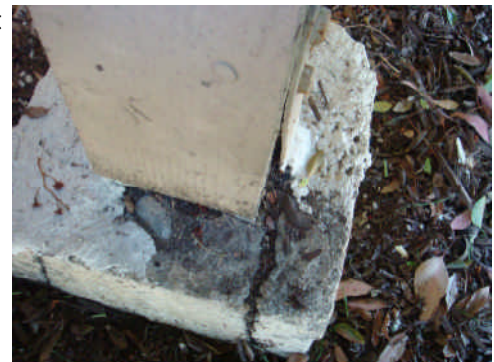
**321 COMMENTS** [CR] The front wood column concrete support pier is cracked and is not bermed to shed off water.

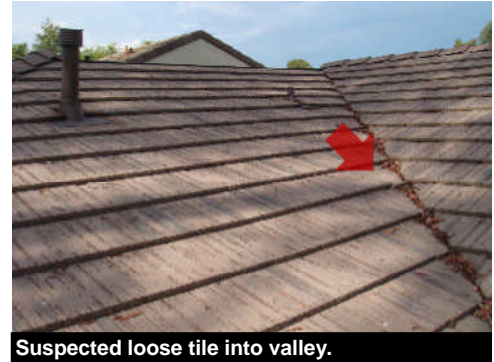
Suspected loose tile into valley.

[CR] Broken tile at the front valley area, loose hip tile at the front right, and suspected loose tile at the front valley.

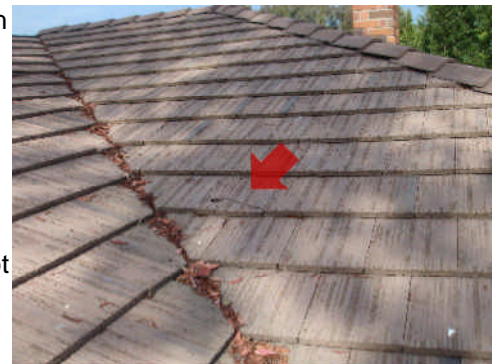
[CR] The tile installation in the valleys nearly butt-up to each other. This installation does not allow water runoff to wash debris out of the valleys.

I recommend the valley tiles be cut back for proper water runoff.

The excessive debris on the roof and in the valleys should be removed.

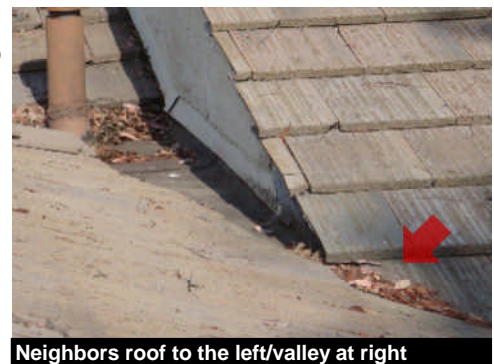
[CR] Debris should be removed from the tiles and valley flashing. I recommend the tiles be separated for proper water runoff.

Neighbors roof to the left/valley at right

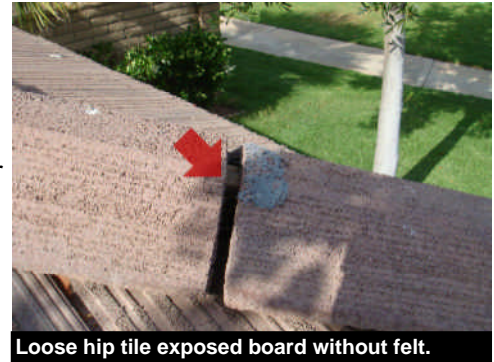
[FE] The underlayment felt is lacking over the hip ridge boards. This condition could be conducive to roof leaks.

[FE] There is gaps between the hip tiles and filed tiles. The hip tiles should be evaluated for proper fastening /installation.

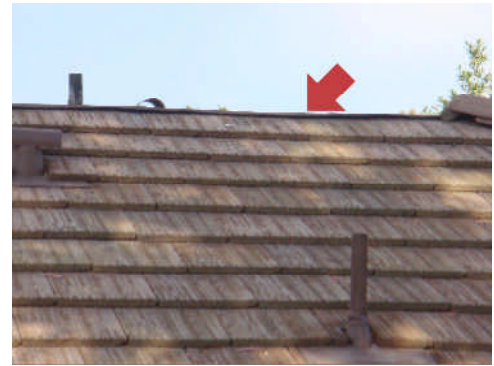
[FE] The roofing material appears to overlap the tiles in place of a metal flashing. The tiles should have proper head coverage.

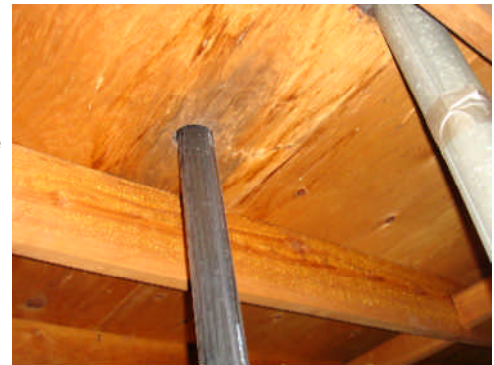
[FE] The low slope /flat roof plywood is moisture stained, and suspect damage /sag at the plumbing vent pipe.

[FE] The low slope /flat roof system should be inspected for water runoff, installation and condition.

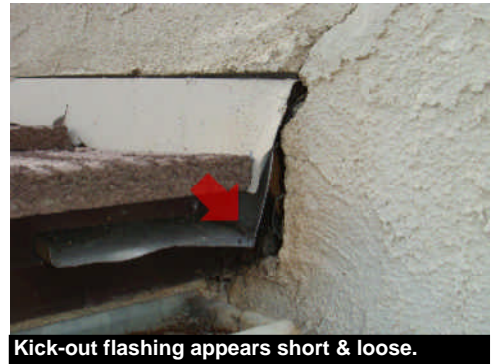
[FE] The kick-out flashing at the rear left wall does not appear to have been installed properly.

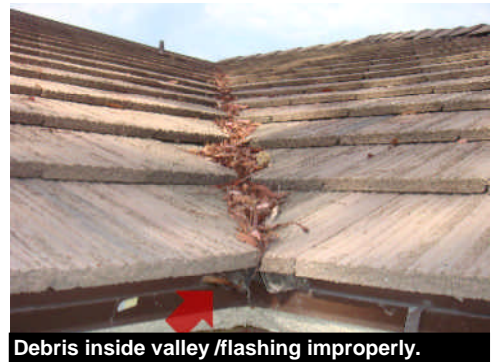
[CR] The valley flashings do not extend out over the edge flashing fully, and are full of debris improperly.

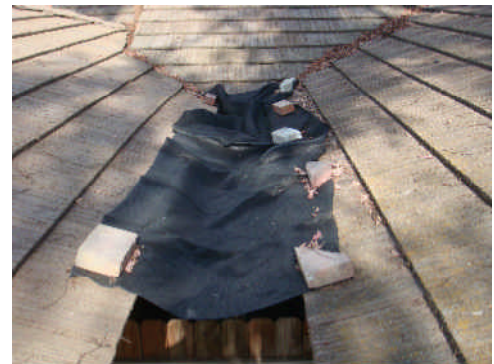
**527 COMMENTS** [CR] The roof valleys filled with debris could cause the water runoff to be diverted laterally onto the roofing felt. This condition will cause damage to the felt underlayment.

[RU] The blocks and material should be removed from the rear of the garage, and gutters with screens installed.

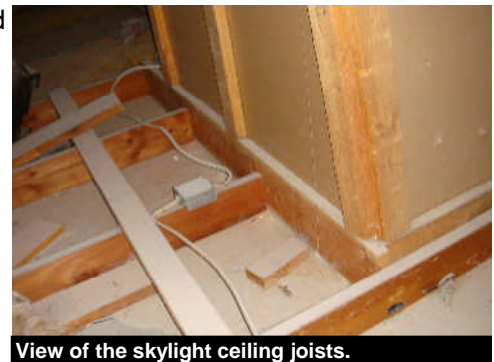
[CR] The suspected added skylight is lacking double headers and trimmers at the ceiling joists and roof rafters.

View of the skylight ceiling joists.

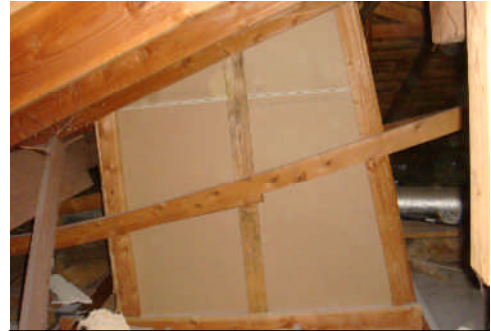
View of the skylight, lacking insulation.

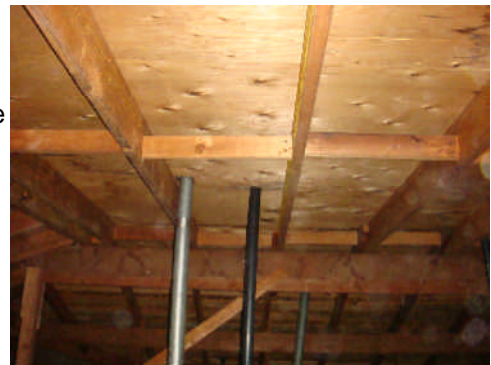
[FE] The low slope /flat roof area has moisture staining and suspect damage at the plumbing vent pipe.

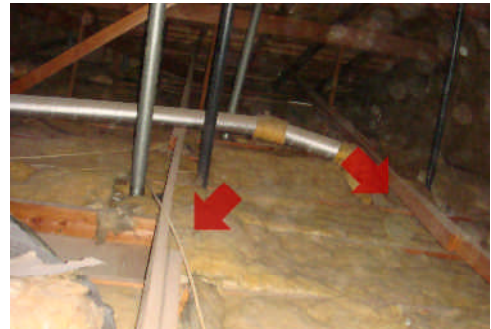
[CR] The wall ties are not connected properly and are loose.

Wall ties are from left to right walls.

The attic framing conditions should be evaluated and corrected by a framing specialist /contractor.

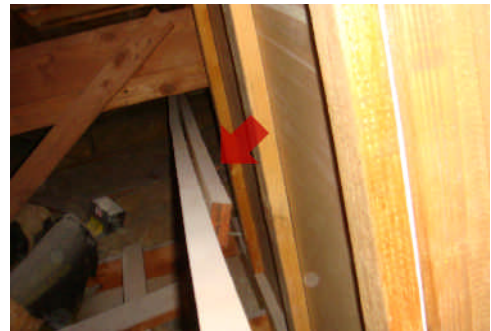
Unsecured and separating wall tie.

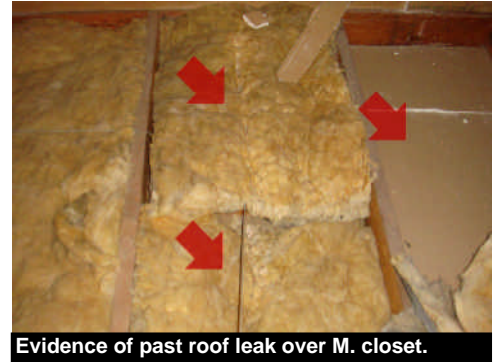
Evidence of past roof leak over M. closet.

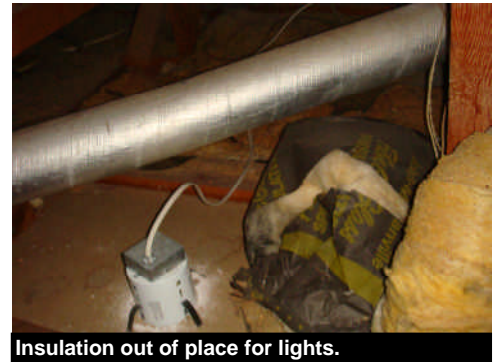
**618 INSULATION** [CR] The insulation is out of place/missing in areas. This condition minimizes the overall value of the insulation.

[RU] The hallway and area added recessed can lights are not IC rated for insulation contact.

Insulation out of place for lights.

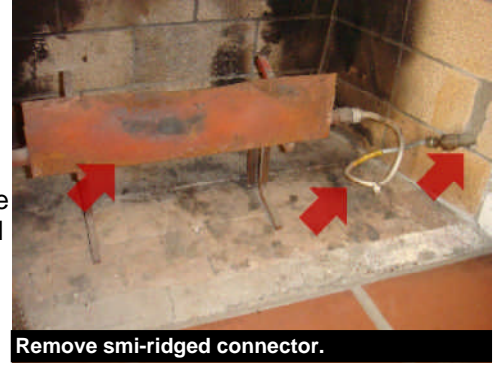
[SC] The gas pipe is not sealed properly at the wall where it enters the firebox. Sealed around with proper material.

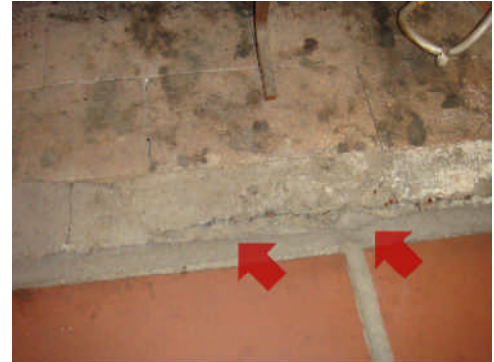
[CR] The hearth has broken up concrete.

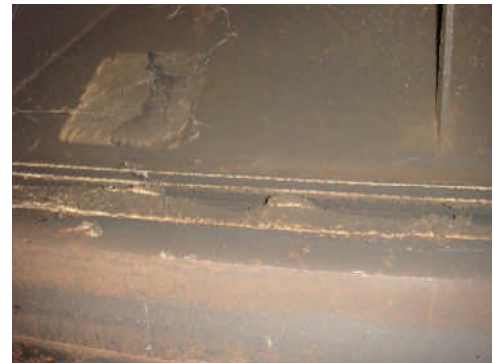
- 709 INSPECTOR RECOMMENDS [FE] I recommend evaluation of the exposed rebar above the firebox front opening.

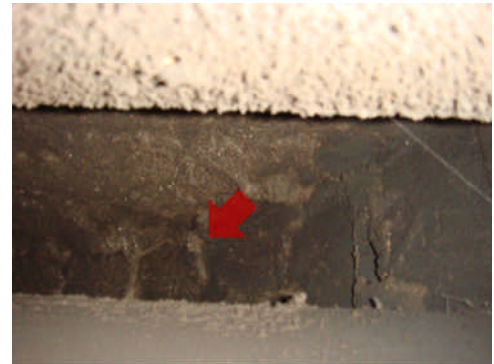
**710 COMMENTS** [FE] The throat above the firebox is a bit soiled and the mortar is not smooth.

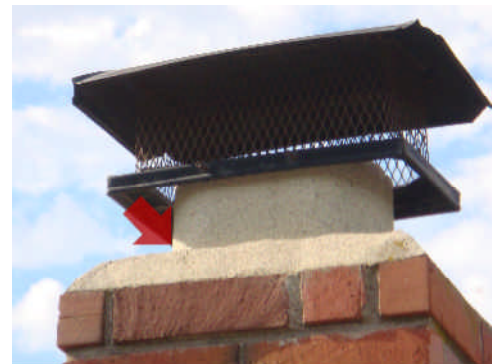
[CR] The mortar cap is cracked, and should be sealed to prevent moisture from damaging the bricks below.

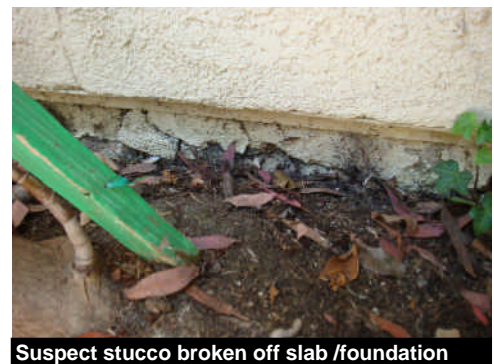
[FE] Areas of the foundation /slab has suspected stucco breaking off the perimeter.

Suspect stucco broken off slab /foundation

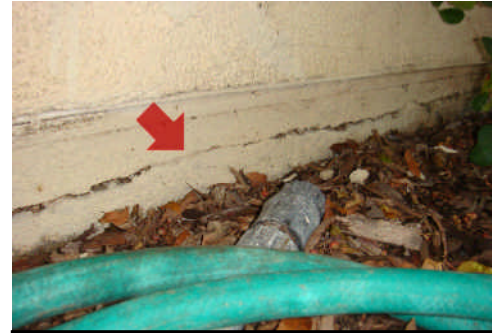
[CR] Horizontal cracks or separations known as cold joints are evident in the foundation. This condition appears to have been caused from the placement /installation of the foundation and slab. Sealing the separation / void with the proper material is recommended to prevent moisture intrusion into the foundation and slab.

Cold joint between foundation & slab.

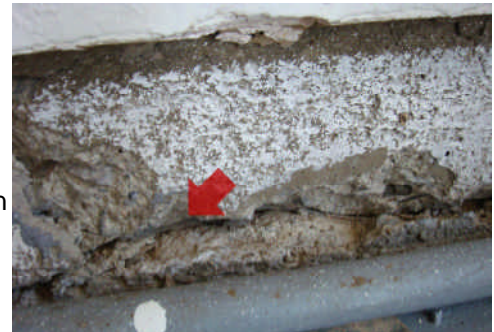
Garage right side foundation /slab.

[FE] The slab plastic vapor barrier is visible between the slab and stem wall. This condition is irregular and does not allow the foundation stem wall and slab to connect.

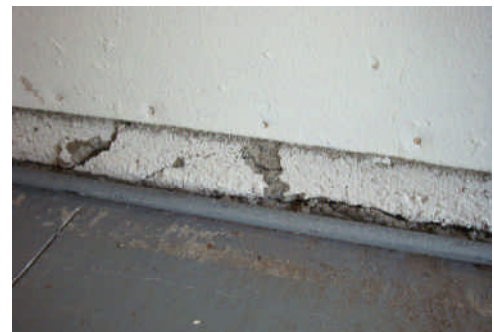
Garage broken concrete foundation /slab.

[FE] Evaluation of the loose concrete and stucco at the perimeter foundation and garage.

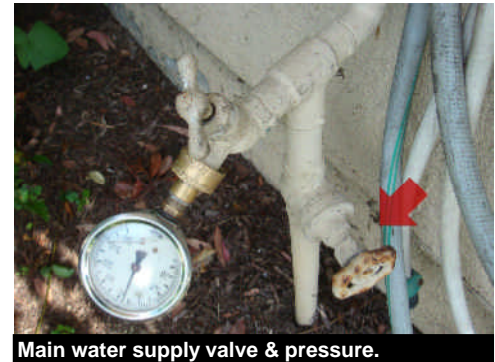
[RU] The static water pressure is on the high side. This condition could be conducive to plumbing leaks (pipes and faucets). I recommend installing a pressure regulator to limit the water pressure to or below 60 PSI, or appliance design limits.

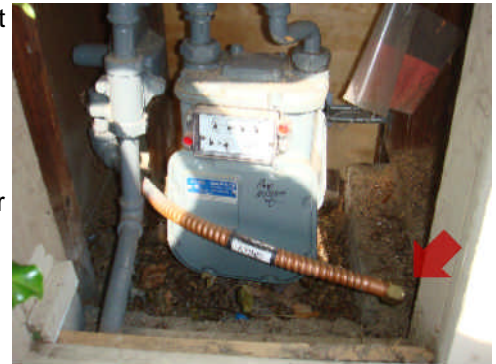
[FE] The gas meter has a vent connector that terminates in the cabinet. I recommend the gas company evaluate this condition.

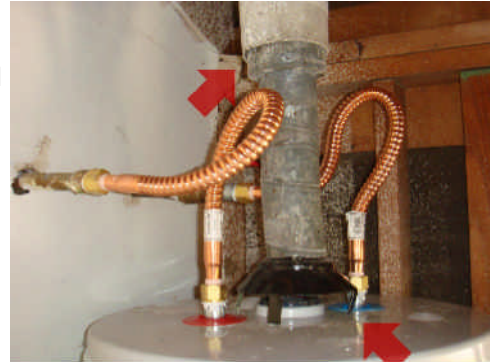
[CR] The shutoff valve and water supply connectors were functional. Valves are not operated. I recommend insulating the exposed water piping to minimize heat loss.

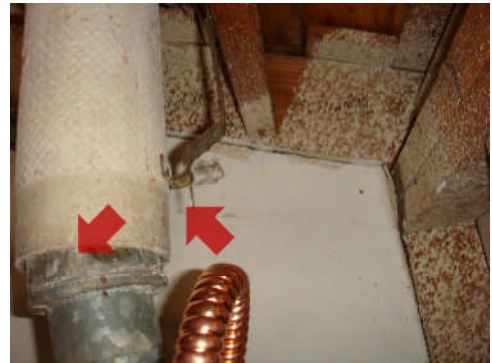
[SC] The flue vent pipe connector is installed with a material that is not rated for this location, is not secured properly, and the diverter is bent and not secured.

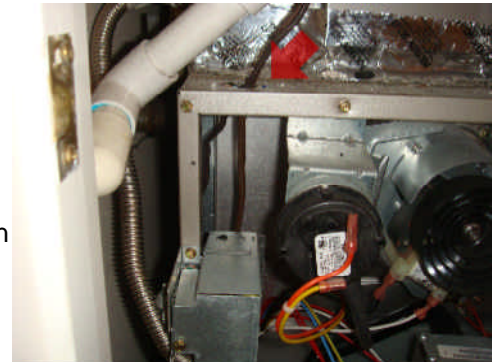
[CR] The low voltage wire is lacking protection from the top of the furnace added hole.

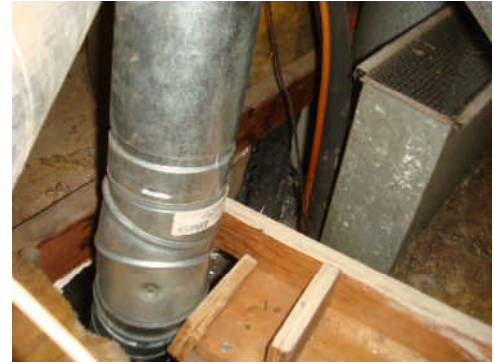
[SC] The flue vent pipe installation is substandard.

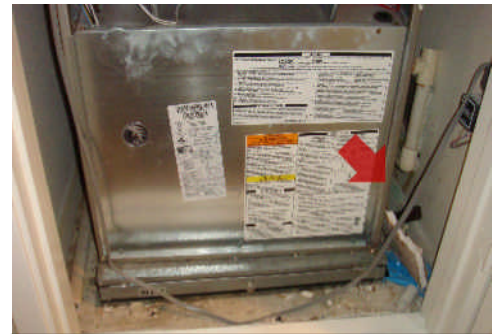
[CR] The closet ceiling has been broken out, leaving debris on the furnace platform.

Remove all debris and abandoned pipes.

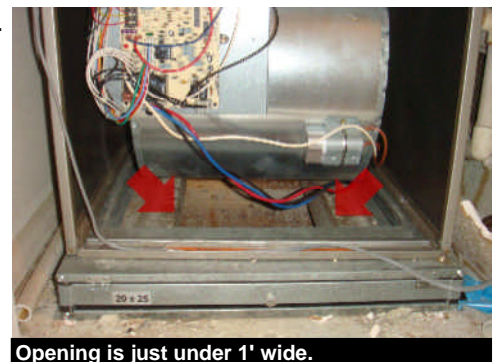
This condition could cause the heating and A/C system not to operate as intended, and the firebox may overheat reducing it's life.

Opening is just under 1' wide.

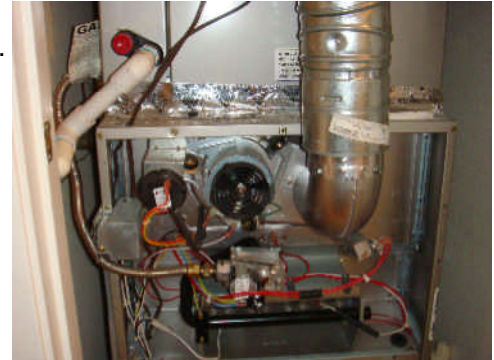
[SC] The flexible gas connector is too short and is susceptible to fracture and leakage.

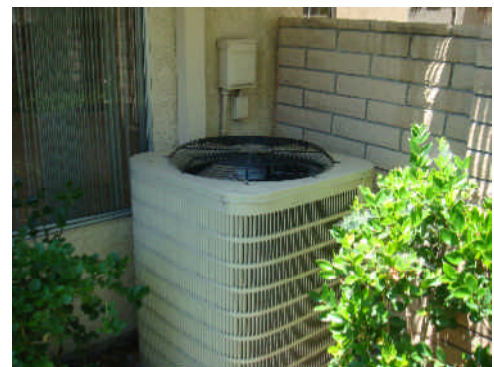
[CR] The coolant lines are not sealed to the wall flashing where they entered the building. This condition allows for rodent access.

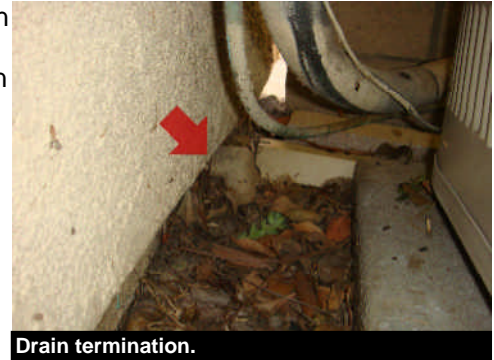
[FE] The termination point of the condensate drain line is between the condenser and foundation. I recommend extending the drain line away from the foundation.

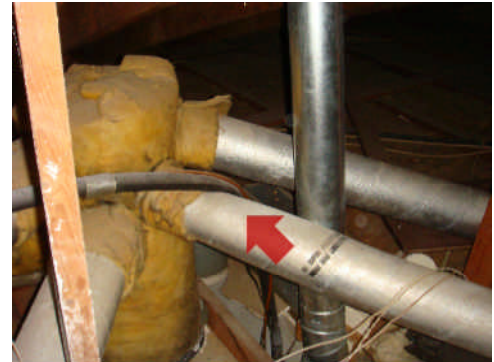
[CR] The coolant line is missing sections of insulation in the furnace closet, and the lines are not supported in the attic, and laying on a duct.

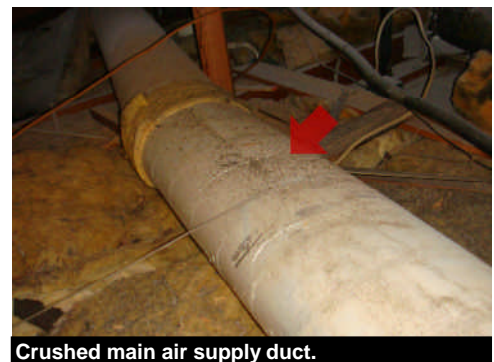
[FE] The original ducts appear to be ridged fiberglass or suspect asbestos ducts.

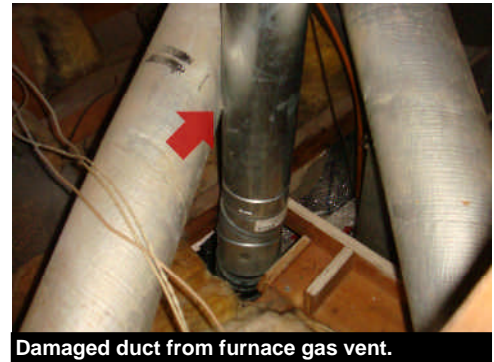
[CR] Some of the conditioned air ducts are dented/damaged in the attic.

Damaged duct from furnace gas vent.

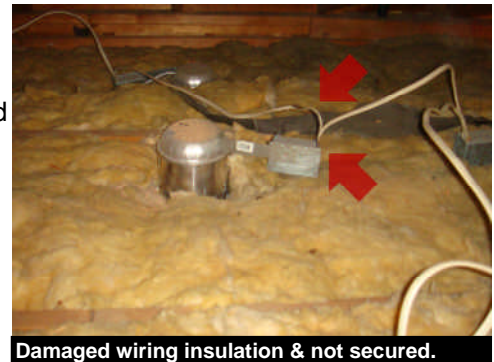
**Damaged wiring insulation & not secured.**

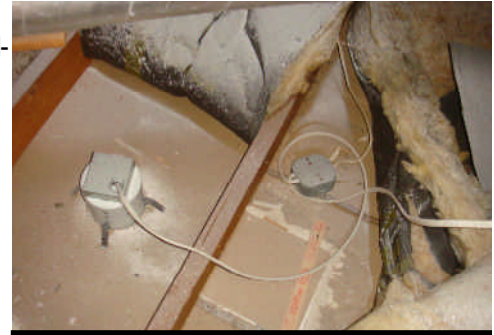
[SC] Improper wiring in the attic recessed lights, damaged insulation, unsecured wiring / boxes, and uncovered box.

Unsecured wiring and junction box.

I recommend the electrical system be evaluated and corrected by a licensed electrician.

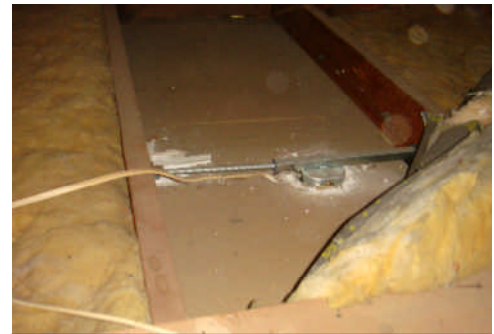
Unsecured ceiling fan wiring.

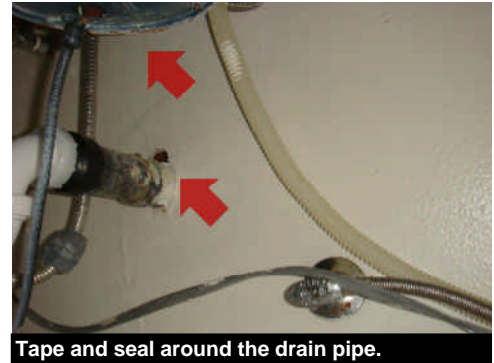
Tape and seal around the drain pipe.

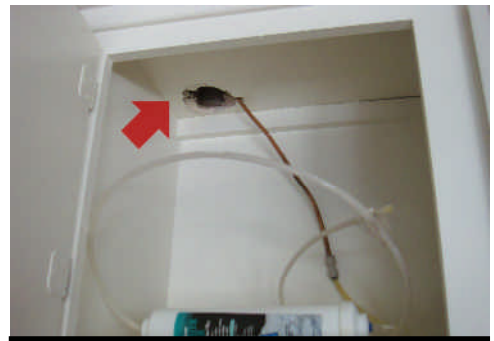
[CR] The refrigerator water supply tubing is installed improperly, and unsecured.

Hole in the ceiling, and unsecured line.

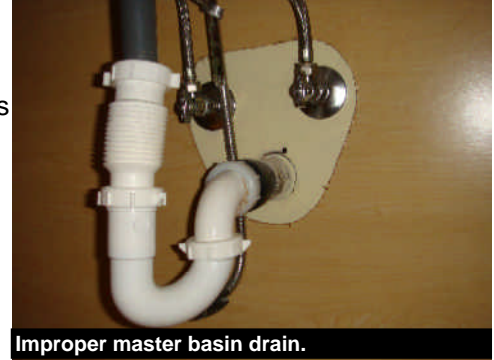
[SC] Corrugated plastic used as drain piping is improper. The corrugations trap bacteria.

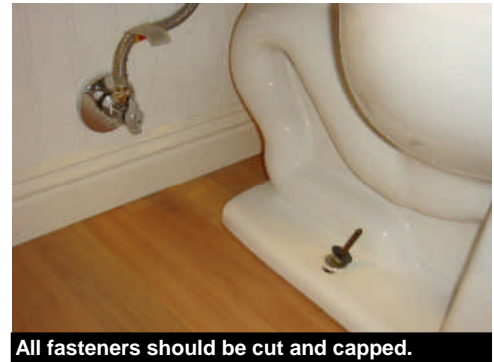
[CR] The hall toilet fastener is loose, and the fasteners are not cut-off and capped as required.

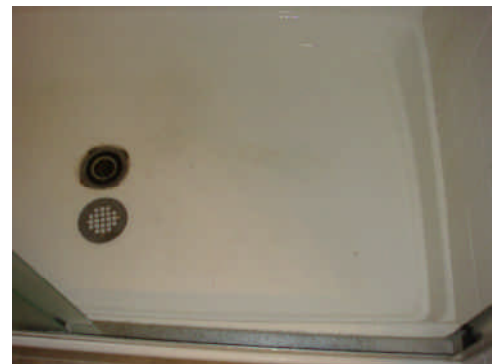
[CR] There are damaged spots in the fiberglass shower floor. This condition is conducive to leaks.
