Pre-purchase Condo *Inspection Report*

Sample of a 33 year old 1900 square foot Condo.

Steve Garcia Inspections

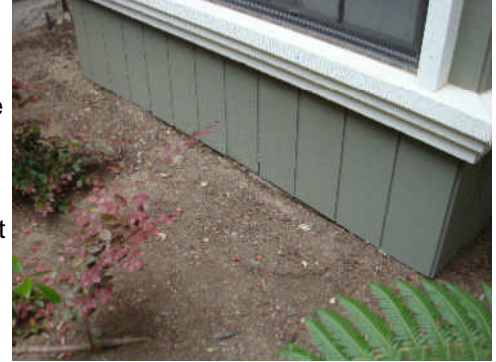
[CR] The grading at the left side fo the garage is not adequately sloped away from the perimeter foundation. It is important the surface grade be sloped away from the building to prevent moisture accumulation next to the foundation, which may effect the foundation and slab.

[CR] Sections of the siding are below or marginally above the exterior grade /soil. Grading modifications in these areas are required to maintain a minimum of 4 inches clearance between the earth and any wood portions of the structure including wood siding or wood framing.

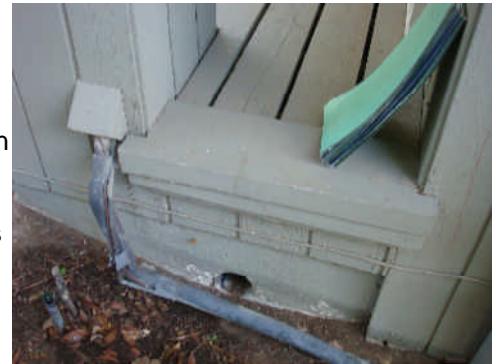
[CR] One or more of the drains /grate screens are missing and above grade. The entry court yard drain should be cleaned.

[FE] The wood pot shelf outside of the living room at the front is covering the lower grade below. An open drain termination is visible at the end of the shelf. The grade and surface drain below the deck was not visible.

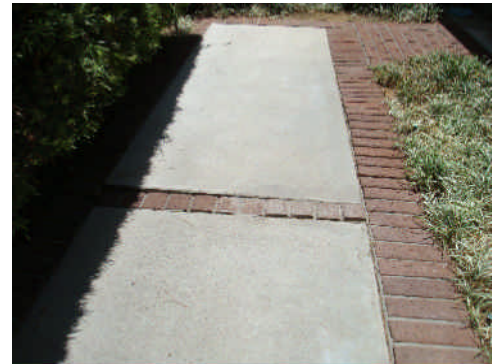
[SC] The driveway surface is raised, cracked and uneven. This is a potential trip hazard.

[SC] The entry walkway surface is raised / uneven. I recommend correcting any trip hazard conditions.

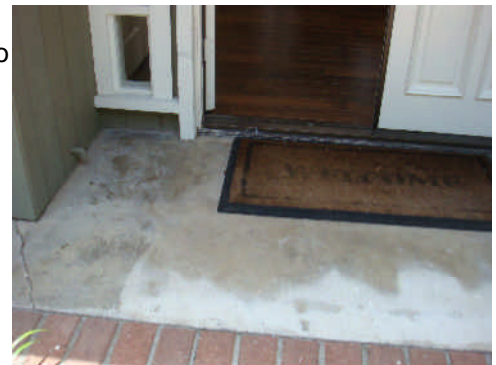
[FE] The concrete entry slab slopes towards the building. This condition may cause water to puddle.

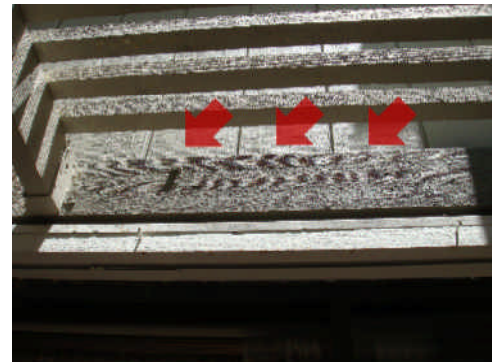
[CR] The sections are uneven /settled up to 1/4", and missing /damaged wood spacers.

[FE] The ledger board fastened to the building appears to have a gap /space. There is no flashing between the patio framing ledger and the wall. This condition could be conducive to moisture damage and intrusion into the wall from the lag screws.

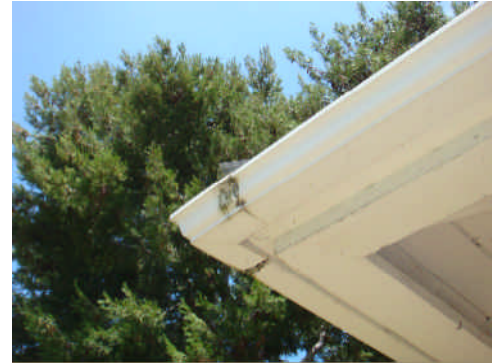
[CR] The gutter joint seams are leaking, and debris should be removed.

[CR] Sections of the gutters are improperly sloped.

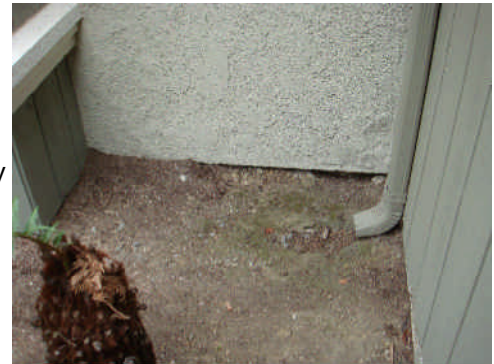
[CR] The front court yard downspout discharged next to the building. The downspouts should be routed sufficiently away from the building to prevent puddling and saturation of the soil adjacent to the foundation.

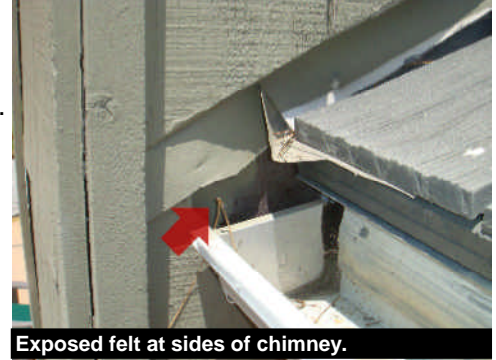
[CR] Exposed felt below the chimney flashing.

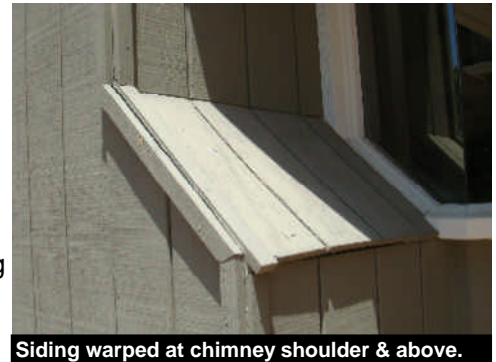
[FE] Portions of the wood siding lacked adequate clearance from or are buried in the ground and concrete. These conditions are conducive to moisture intrusion/deterioration.

[CR] There are gaps between the wood siding and adjacent materials. These conditions are conducive to moisture intrusion/deterioration.

[FE] The siding is warped at the chimney.

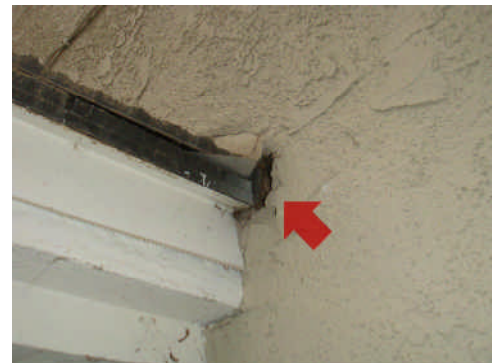
[CR] There is a void between the stucco siding and roof kick-out flashing.

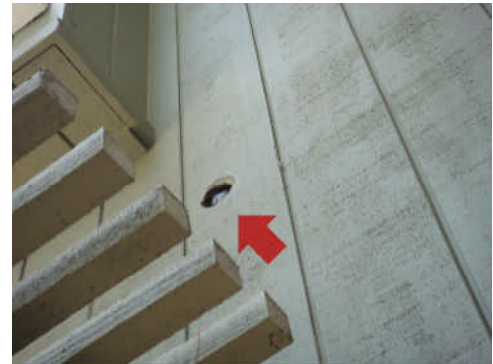
321 COMMENTS [CR] The drain clean-out above the master bedroom is improperly recessed in the wall. This condition could be conducive to moisture intrusion/deterioration.

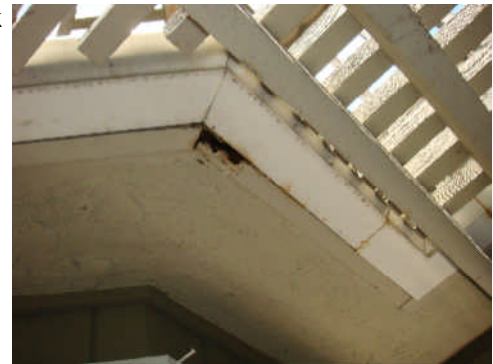
[FE] Moisture damaged fascia below the deck above.

[FE] I recommend the neighbors deck above the master bedroom be evaluated due to moisture stain on the ceiling and the condition noted above.

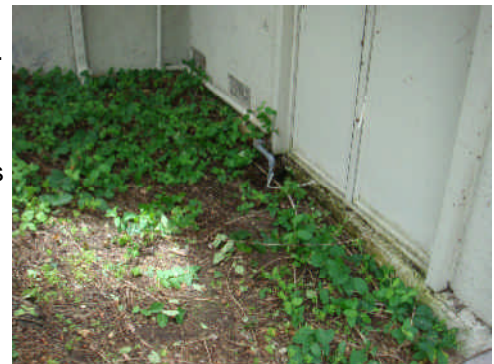
[CR] The grade at the left side slopes to the foundation and is too high onto the foundation.

[CR] This condition has caused moisture damage to the adjacent closet and interior sheetrock /drywall, the main gas supply pipe is rusted, and the concrete foundation is saturated.

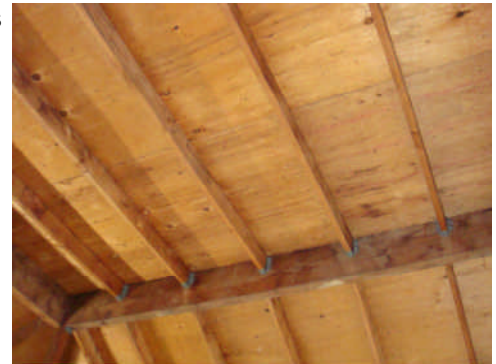
[FE] The flat roof deck rafters appear to sag and the sheathing is moisture stained.

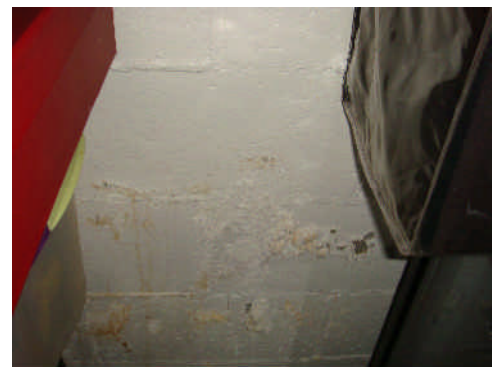
[CR] The concrete block walls have efflorescence (white mineral deposits) and moisture stains. This condition is an indication of moisture intrusion.

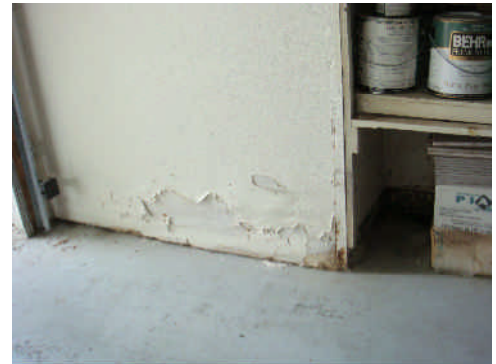
[CR] Moisture/stains and damage is evident on the sheetrock /drywall at the left side.

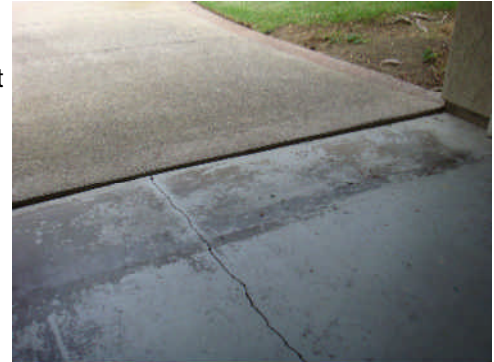
[CR] The concrete slab settled and cracked at the front left area. Improper grade and drainage is evident at the left side.

[SC] The driveway slab is 1 /1/4" above the garage slab. This condition is a potential trip hazard.

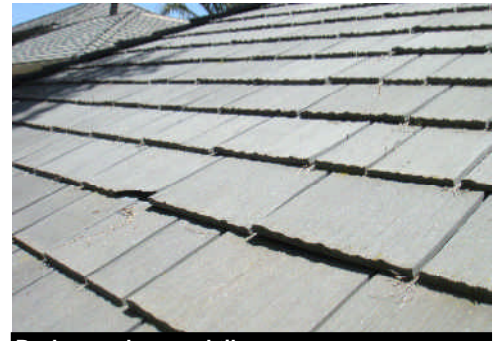
Broken and warped tiles.

[CR] There are a number of cracked and broken tiles on the roof. These conditions are conducive to roof leaks.

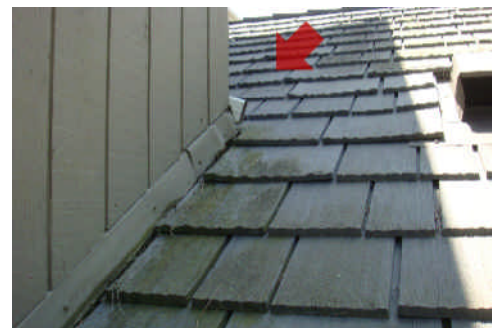
Back side chimney flashing not evaluated.

519 INSPECTOR RECOMMENDS Remove debris from flashing at the chimney.

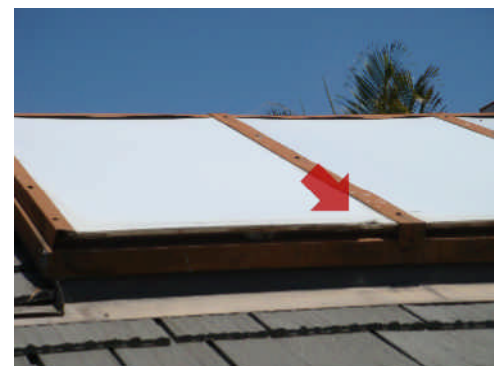
523 SKYLIGHT(S) [FE] one skylight lens edge is broken / damaged.

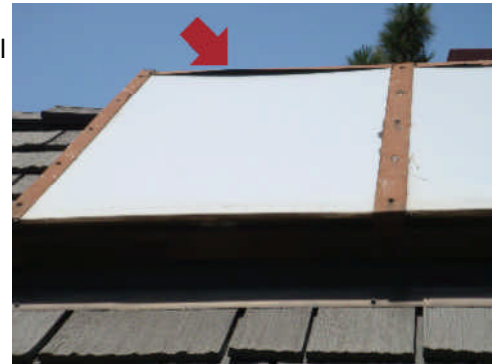
524 COMMENTS [FE] The skylights metal frame fasteners appear to be rusting, not sealed, and the metal edge is not flat onto the lens.

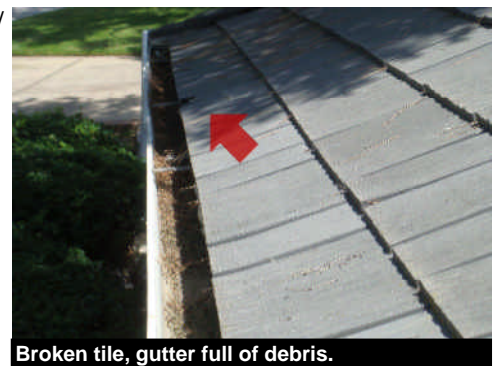
525 GUTTERS [CR] The gutters are in need of maintenance / corrections.

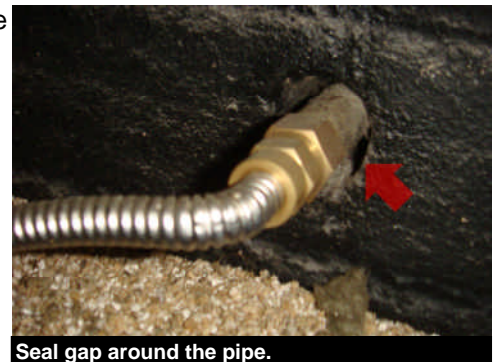
[SC] The gas pipe is not sealed at the wall where it entered the firebox. The pipe should be sealed around with the proper material.

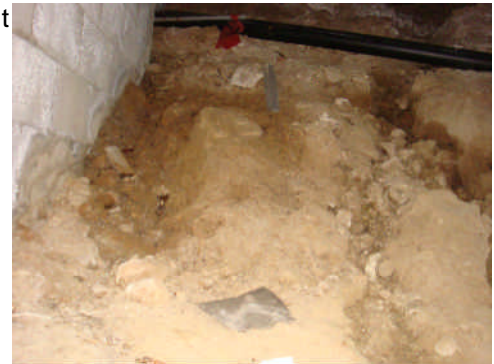
815 COMMENTS [CR] Improper drainage conditions are evident from the upper slope draining down into the space adjacent to the bedroom and master bathroom.

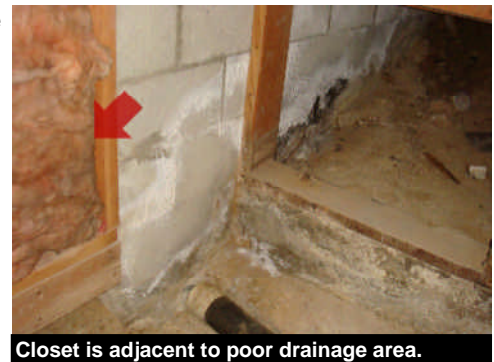
[CR] The bedroom closet is adjacent to the poor drainage area, and soil in contact with mud sill.

Closet is adjacent to poor drainage area.

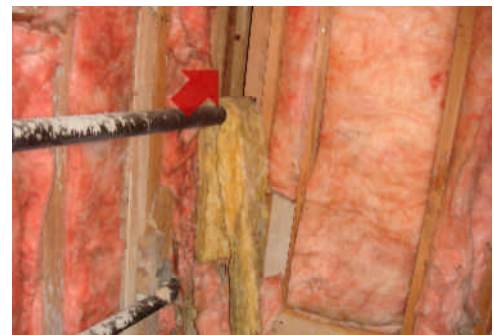
[CR] The insulation should be secured and in contact to the interior walls without voids and gaps.

Secure insulation & install between frame.

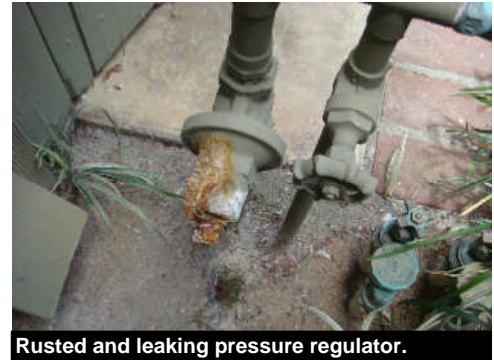
[CR] The static water pressure was measured at an exterior hose faucet and was 99 PSI. This condition can be conducive to plumbing leaks (pipes and faucets). I recommend replacing the rusted and leaking pressure regulator to limit the water pressure to or below 60 PSI, or appliance design limits.

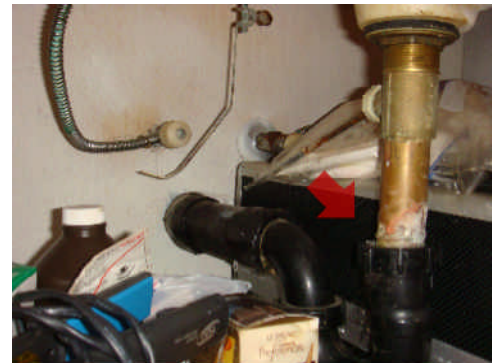
[CR] The master bathroom left basin drain leaks.

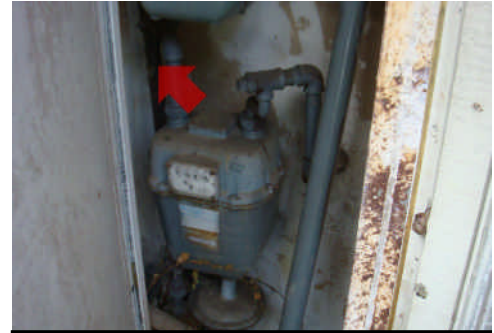
View of the gas meter. Valve is behind.

[CR] The main gas supply pipe is corroded / rusted in the gas meter cabinet due to poor landscaping /drainage.

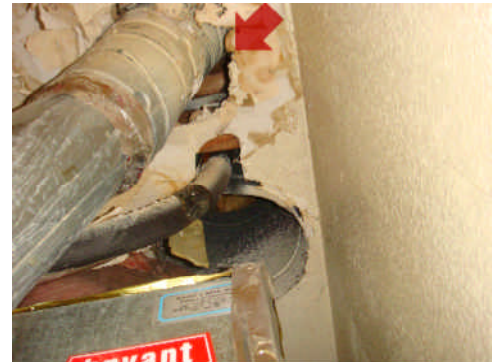
[CR] The ceiling and flue are moisture stained, and the ceiling is damaged /broken open.

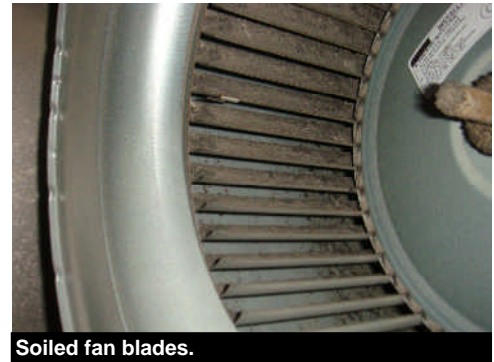
[CR] Dust /debris is built up on the fan, motor and in the fan compartment. I recommend having the system cleaned and serviced by a heating contractor /professional.

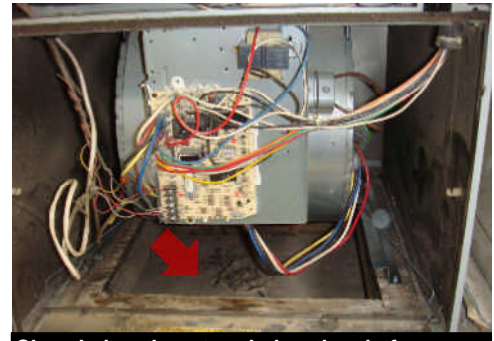
[FE] The return air plenum is soiled, and should be cleaned.

Clean below the return below the platform.

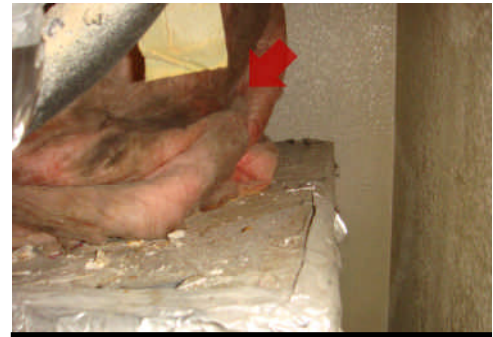
[FE] The air supply plenum appears to be undersized and does not match the cooling coil or furnace. See air supply system below.

Suspected undersized supply plenum on coil

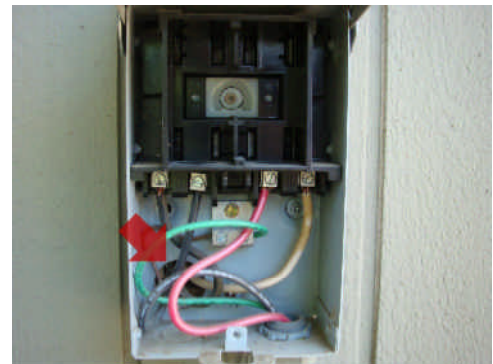
[CR] There is no bushing in the electrical disconnect to protect the entrance wires.

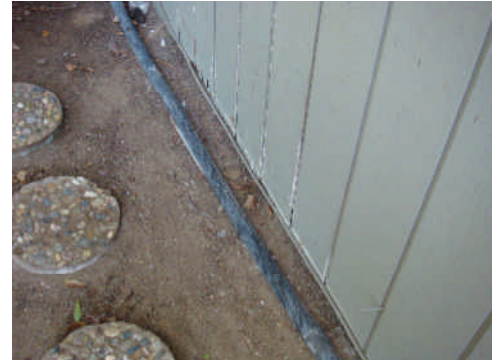
[RU] The insulation on the coolant line is deteriorated.

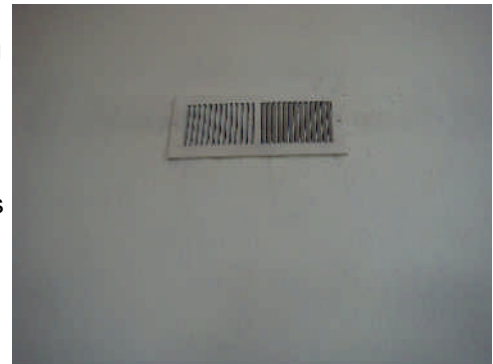
[CR] There is little/no air flow from the registers in the master bedroom and bathroom. The air flow from the other registers is also a bit low.

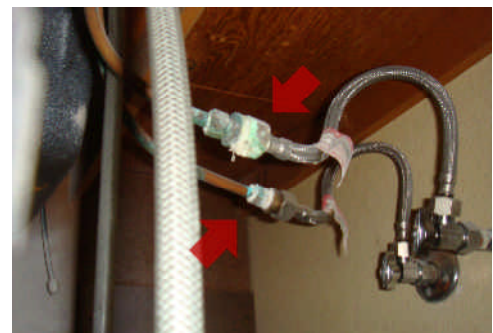
[RU] The water supply connectors and dishwasher angle stop /valve are corroded.

Corroded connectors.

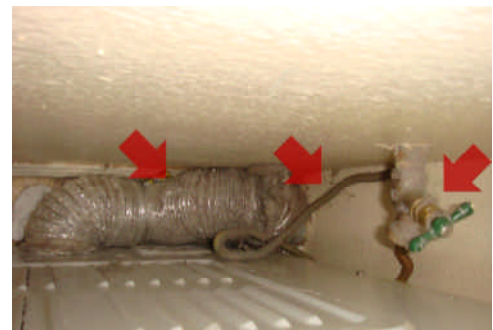
Irregular location of faucet & not tested.

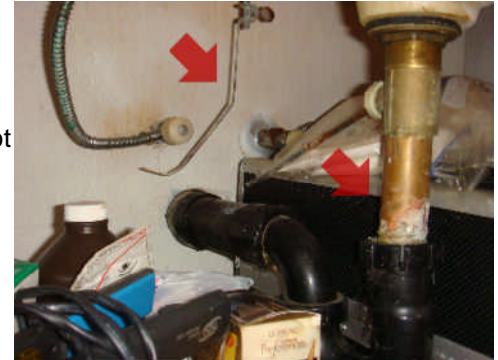
[CR] The master under mounted basins are lacking one of 4 securing clips.

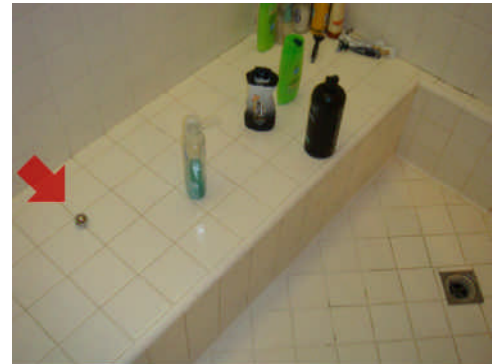
[FE] The horizontal seat /ledges in the master shower does not slope properly and may hold water. This condition is prone to leakage. Any horizontal areas in a shower should be wiped dry after use as a precaution against moisture intrusion into concealed spaces.
