Pre-purchase Home Inspection Report

Exclusively for: Good Client

Sample of a 45 year old 1,600 square foot house

Steve Garcia Inspections

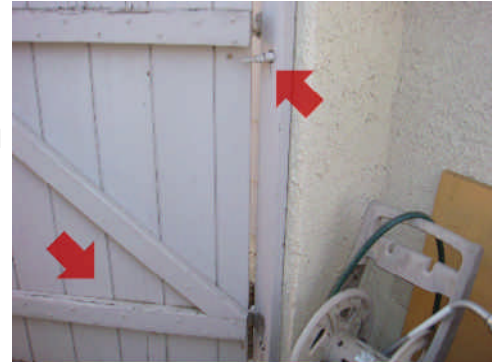
[CR] The right gate is moisture /insect damaged, the gate hinge fastening board lag fasteners are loose on the wall, and the latch is loose.

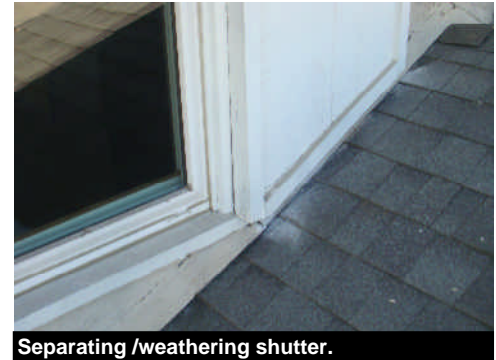
[CR] There is chipping and deteriorated paint on the trim materials and shutters.

Evidence of improper substandard painting / spray.

Separating /weathering shutter.

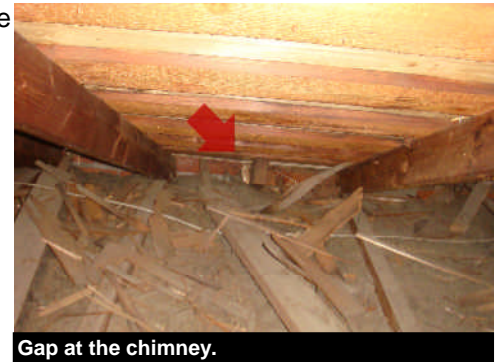
[CR] Seal the gap at the chimney and eave.

Gap at the chimney.

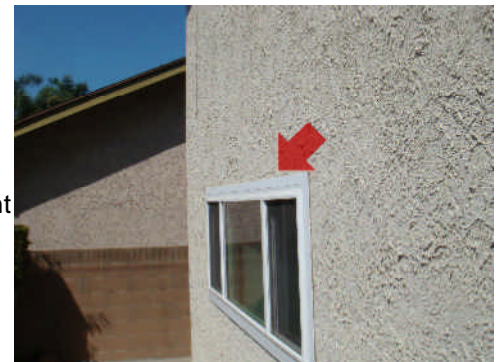
The exposed window heads caulking and paint at the rear windows should be maintained.

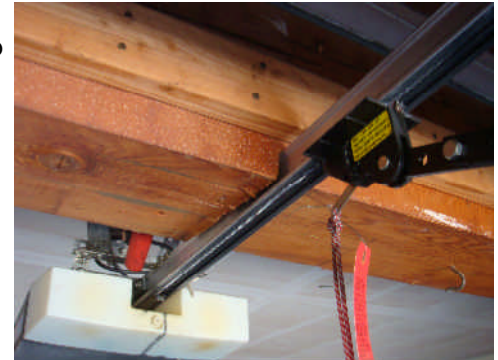
[CR] The large beam supporting the second floor and roof has been notched improperly up to 1 1/2" at the bottom center of the beam.

I recommend the beam be evaluated by a structural engineer.

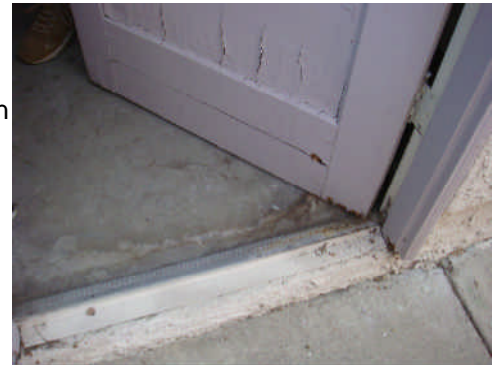
[CR] The door and jambs are moisture damaged/deteriorated.

[CR] There was evidence of moisture intrusion at the loose threshold of the exterior exit door. When replacing the door replace the threshold.

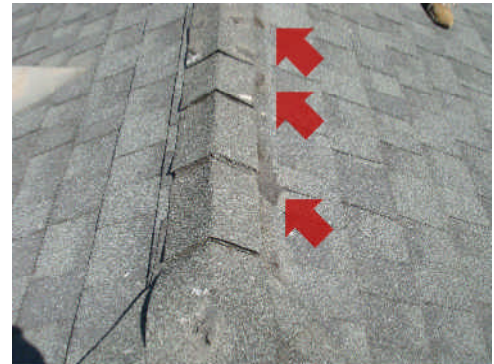
[CR] The ridge course shingles are over-exposed with exposed fasteners. This is an improper installation at the upper ridge.

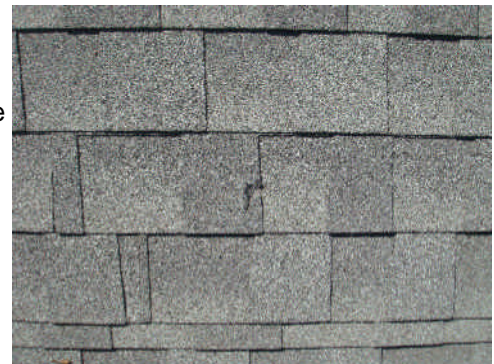
[CR] Couple damaged shingles at the front are evident, and the valley tabs are trapping debris.

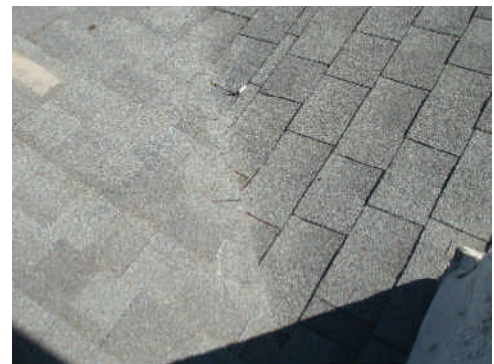
516 COMMENTS [CR] The valley shingles are trapping debris and will trap moisture improperly causing premature failure of the shingles.

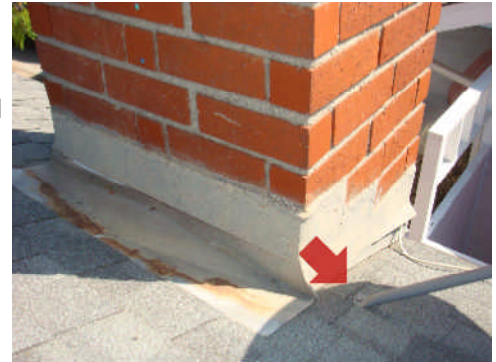
The chimney flashing is rusty. I recommend the flashing be cleaned and painted with an oil based rust inhibitor.

[CR] The dish fasteners were not sealed before installing.

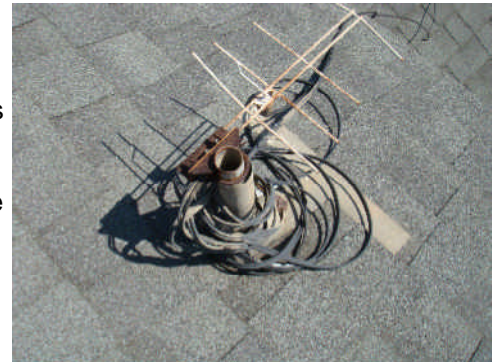
[CR] The water heater vent flue is lacking a storm collar.

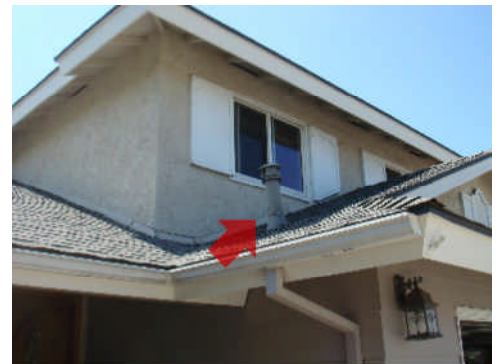
[CR] The water heater flue pipe is improperly terminated, too close to the building and 5' from the open-able window.

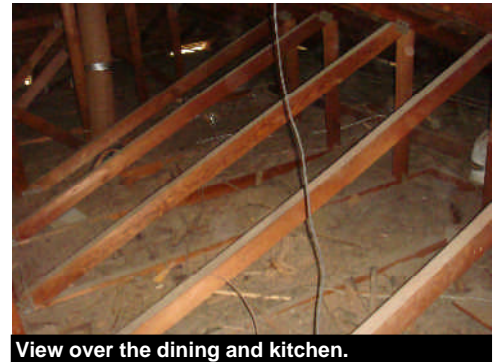
The attics are is fully accessible, with the exception of the wood shingle debris.

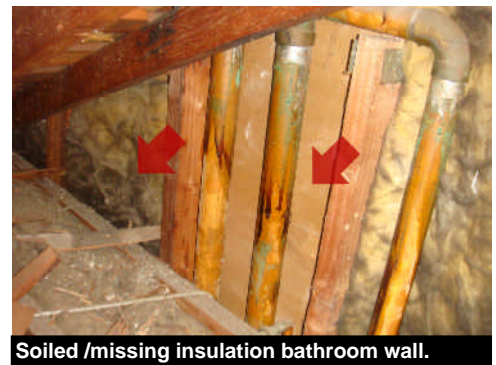
The soiled insulation is from air passing through the insulation. This is an indication of air exchanging from the attic space to another space.

Soiled /missing insulation bathroom wall.

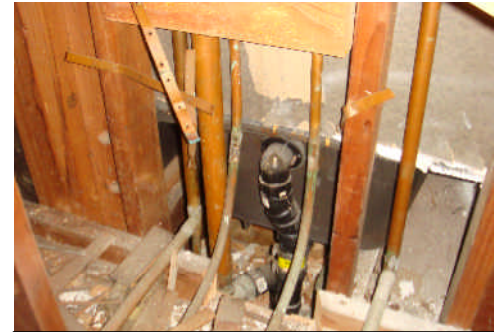
Open area should be sealed off /insulated.

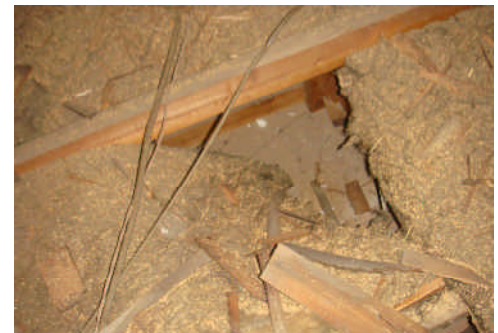
[CR] Insulation is missing on the wall, and voids are noted at the tub /floor and kitchen ceiling.

Void /lacking insulation over the kitchen.

[RU] The attic space has minimal insulation installed. I recommend installing additional insulation for energy efficiency and comfort.

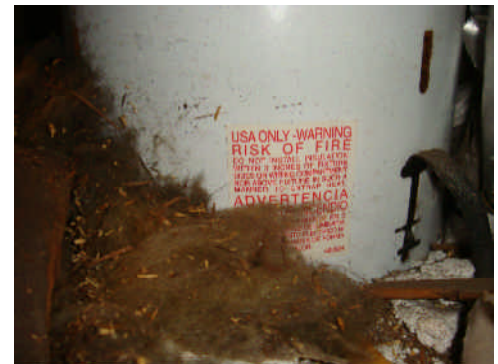
[SC] The insulation is improperly in contact with the recessed luminaries [lighting fixtures]. The ceiling recessed light fixtures are not "IC-rated for insulation contact.

[RU] Non-IC rated can lights are not energy efficient.

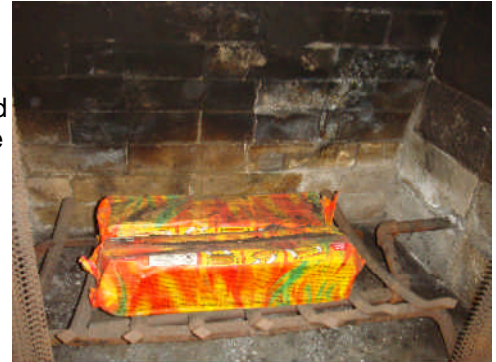
[CR] A few of the rear bricks are cracked, void in the mortar, and there is efflorescence (white mineral salts) deposits in the bricks. This condition is an indication of moisture intrusion.

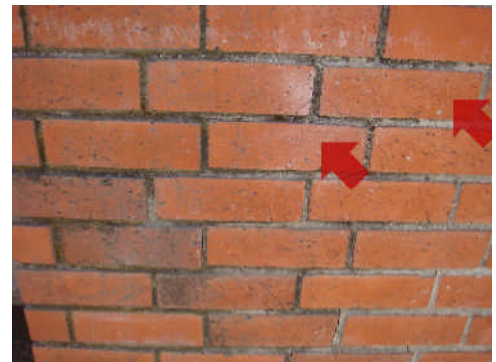
- 710 COMMENTS** [FE] The fireplace exterior bricks adjacent to the firebox are cracked, and the mortar is deteriorating. Algae and staining is evident from excessive moisture.

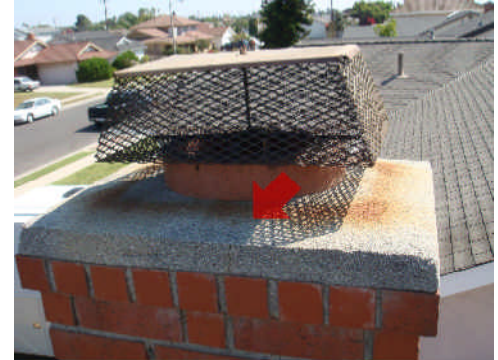
[CR] The mortar cap is cracked, and should be sealed to prevent moisture intrusion / deterioration of the bricks below.

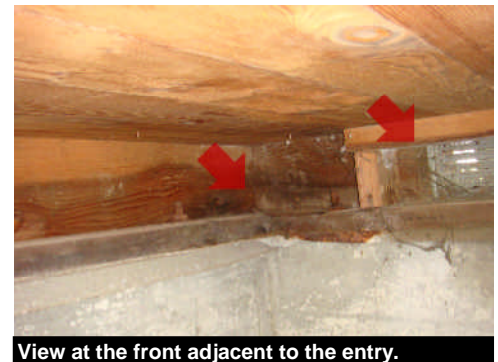
[FE] The crawl space sub-soil is moist a few of the mud sill plate bolts and nuts are rusting. I recommend applying a rust inhibitor on the nuts and bolts.

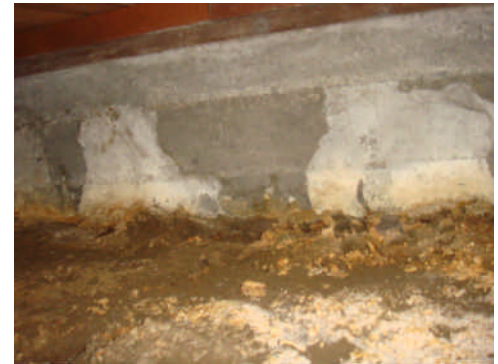
[FE] There is a condition known as efflorescence on portions of the foundation walls. This is a salt deposit left when moisture in the foundation evaporates. It indicates that the foundation is experiencing wet and dry cycles. I recommend the exterior grading and drainage be improved to divert moisture away from the foundation.

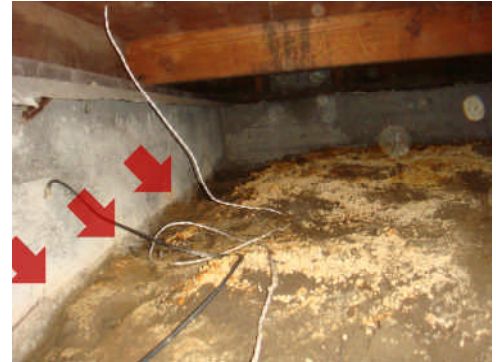
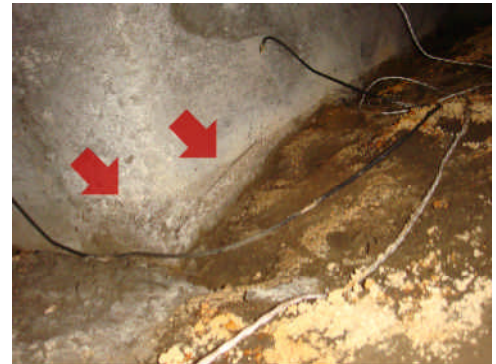
815 COMMENTS Second picture of #814. This foundation area is below the entry.

[CR] I recommend installing roof gutters and downspouts to direct water away from the house or into a drainage system to prevent unwanted moisture from saturating the crawl space sub-soil.

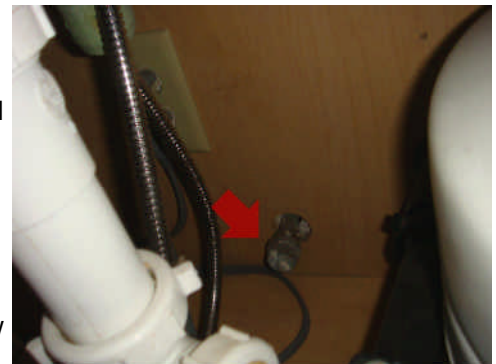
[CR] The kitchen dishwasher supply pipe below the sink is capped with a galvanized cap improperly. The cap should be replaced with a brass cap.

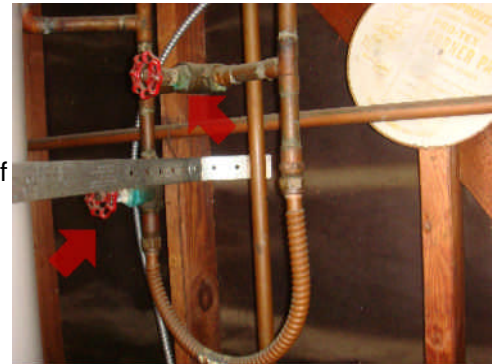
[CR] The abandoned suspect water softener piping, flex connector and valves should be replaced with solid copper pipe.

The valves are corroded and water flowing through the flex connector causes restriction of flow.

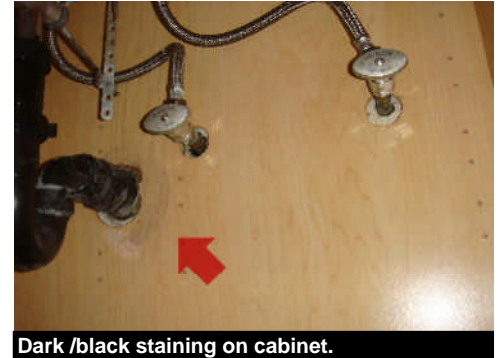
[FE] The first floor bathroom basin drain pipe and cabinet have evidence of previous leakage. Dark stain noted on the cabinet around the pipe.

Dark /black staining on cabinet.

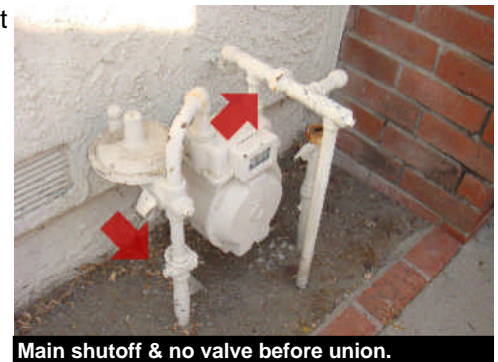
[RU] The main gas supply shutoff was not operated. There is no emergency shutoff wrench present. I recommend providing a wrench or installing a seismic automatic shut off valve for emergencies.

Main shutoff & no valve before union.

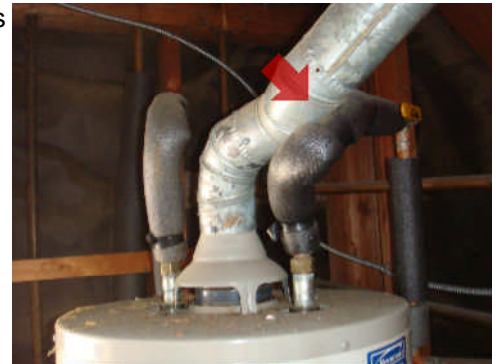
[CR] The flue vent is improperly in contact with the insulation.

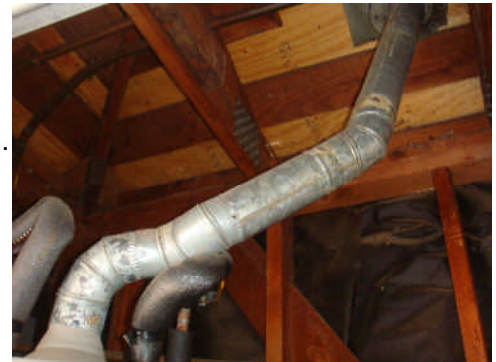
[CR] The single wall vent connector has been installed in an-un-workman like manner.

A B-vent double wall vent connector should have been installed due to the garage location.

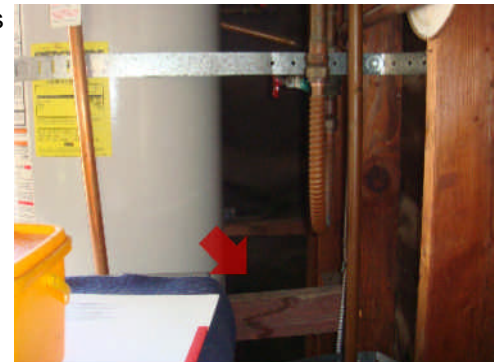
[SC] The water heater is double strapped, it is not stabilized/blocked properly to resist movement as required by the State Architect.

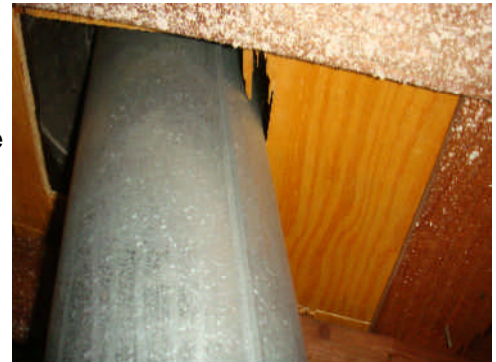
[SC] The flue vent pipe is lacking proper clearance from combustible materials at the roof. This condition is a potential fire hazard.

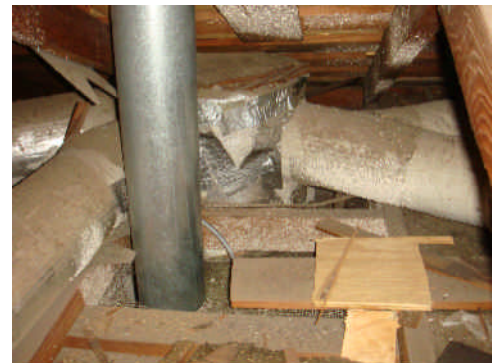
[FE] There is Asbestos-like insulating materials on the plenum that is taped up with duct tape. Information about Asbestos is available in the "Homeowners Guide to Earthquake Safety & Environmental Hazards" pamphlet.

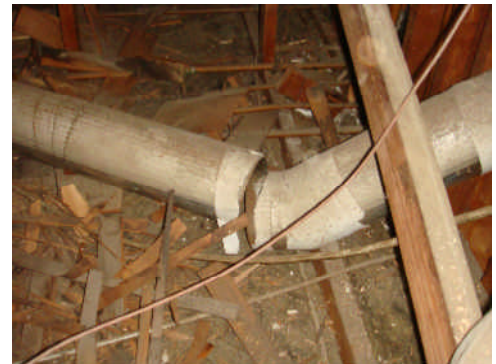
[CR] The duct adjacent to the second floor bathroom is separated.

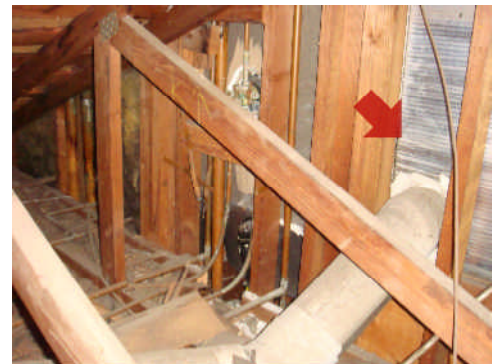
[FE] The wall adjacent to the furnace may be an asbestos material.

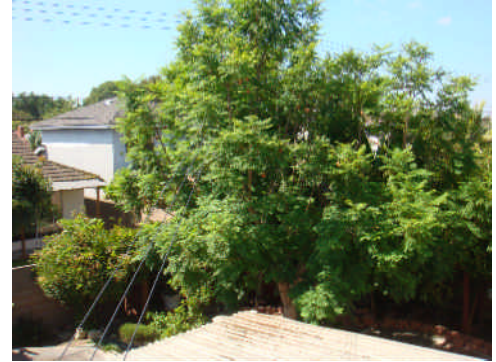
[SC] Tree branches are in contact with the overhead service cables improperly.

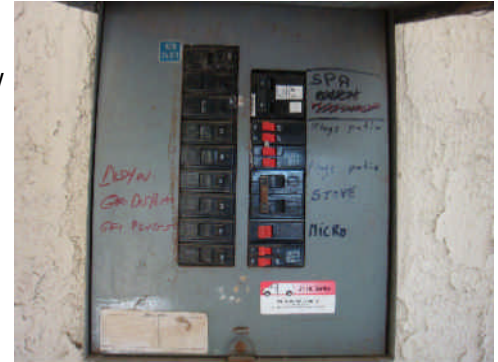
[CR] A number of the circuit breakers are not labeled or labeled properly. The circuit breakers should be accurately labeled to allow individual circuits to be shut off for maintenance or emergency needs.

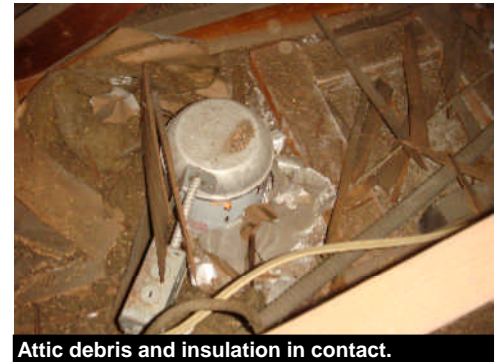
[SC] The insulation is improperly in contact with the recessed luminaries [lighting fixtures]. The ceiling recessed light fixtures are not "IC-rated for insulation contact.

Attic debris and insulation in contact.

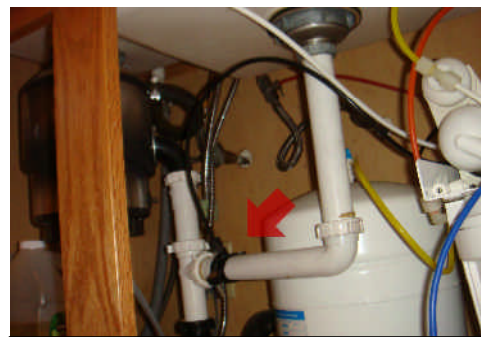
Improper saddle clamp on drain pipe.

[CR] Improper saddle fitting connection on the drain pipe for the drinking water filtration system purge tube under the kitchen sink.

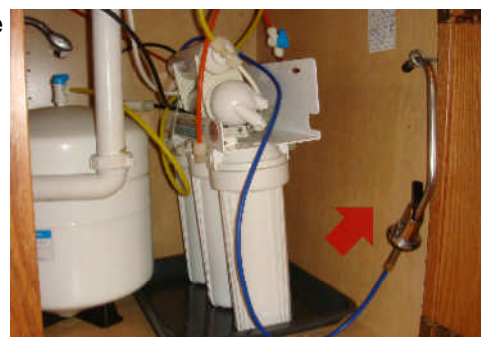
Irrigular location of filtered water spout

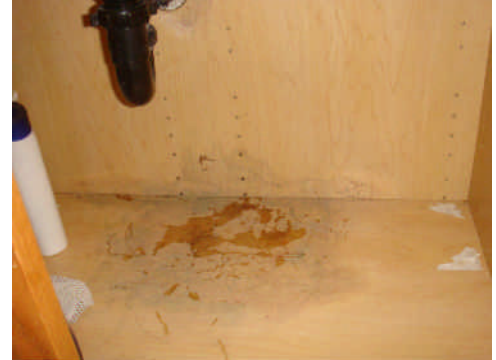
[FE] Under the first floor basin there is moisture stains in the cabinet. I recommend locating and correcting the source and any damaged materials.

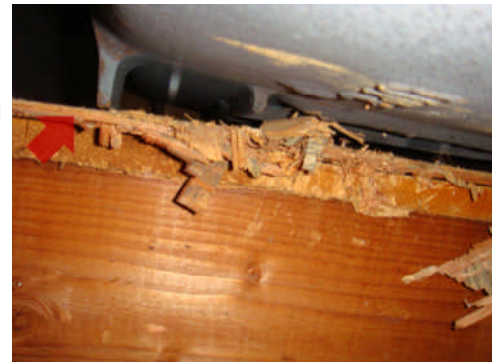
[FE] One visible tub support leg is not bearing on the plywood floor.

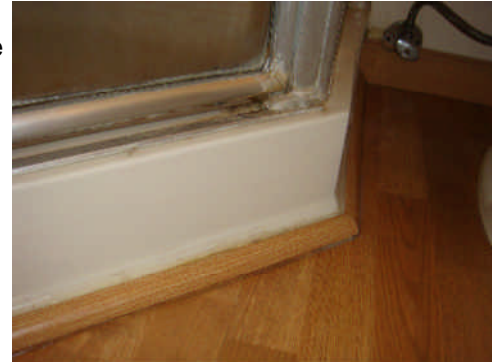
- 1407 ENCLOSURE(S)** [CR] There is leakage from the stall shower enclosure. The rubber sill is damaged, and the enclosure is corroded.
