Pre-purchase Home Inspection Report

Sample of a 1958 yr. 1395 square foot house

Steve Garcia Inspections

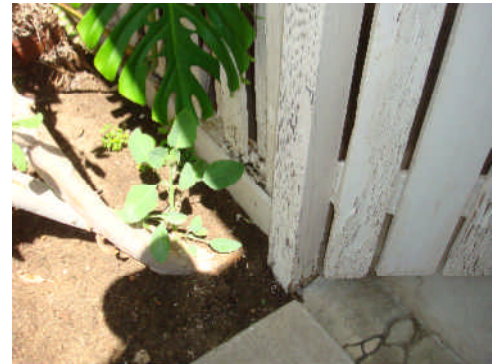
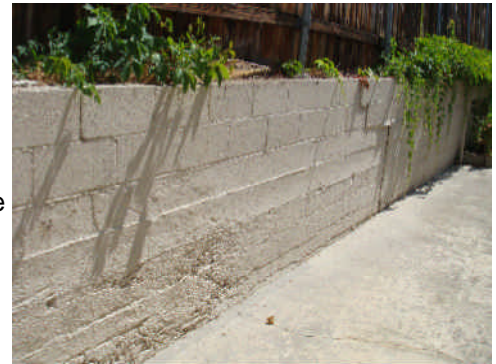
- 215 RETAINING WALL(S)** [SC] The visible concrete /block retaining wall at the right side is cracked and leaning up to 6". The wall should be repaired for safety, and to prevent damage to the neighbors site / property.
[FE] The rear and left side retaining walls were not visible, and not inspected. The walls should be inspected from the neighbors property.
[SC] Guardrail is lacking at the front left retaining wall. Any wall above 30" from grade is required to have fall protection today.

- 216 LANDSCAPING** [FE] I recommend considering removing the trees. As the trees continue to grow in size, damage may occur to the retaining walls.
- NOTES** [FE] Sprinkler systems are outside the scope of this inspection. I recommend that an Irrigation Specialist evaluate the entire system prior to the completion of this real estate transaction.

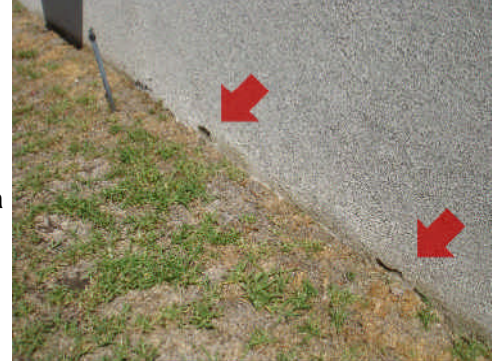
This building was constructed in an era before weep screeds were installed at the bottom edge of the stucco siding, to separate the stucco from the grade /soil. The stucco lacks a drainage plane. This condition does not allow moisture to dry, causing the stucco to blister and flake off. I recommend minimizing moisture around the building to help protect the stucco and the building from moisture.

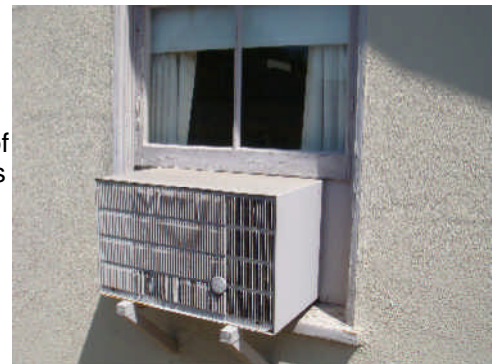
[CR] The south side window frames /sills are weathered and cracking.

[CR] There are damaged and missing window screens. The screens should be repaired or replaced as needed.

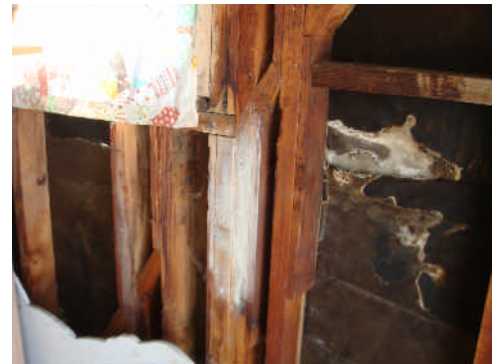
[CR] The front wall stucco felt wrap is damaged.

[CR] The framing below the window is moisture damaged.

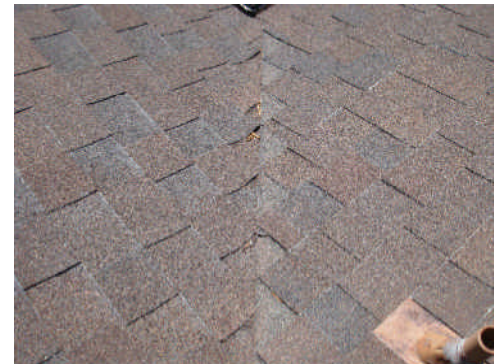
[CR] The valley shingle tabs are trapping debris, and could prevent proper water runoff.

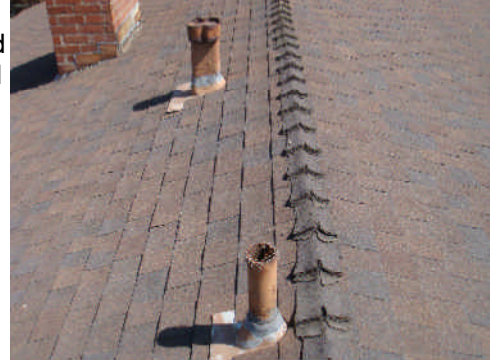
[FE] The roofing material appeared functional at this time with signs of weathering, aging and cracking. I recommend a licensed professional roofing contractor evaluate the material for the estimated remaining life.

[CR] The ridge cap material is damaged and deteriorated. The cap should be replaced.

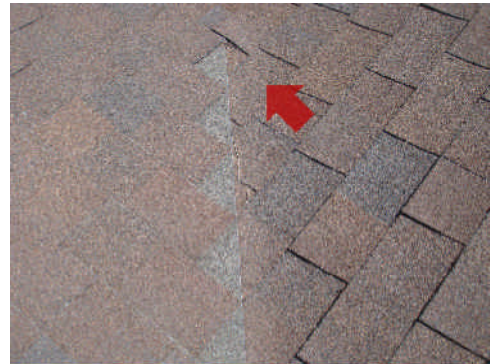
516 COMMENTS The valley shingle tabs are trapping debris, and could prevent proper water runoff.

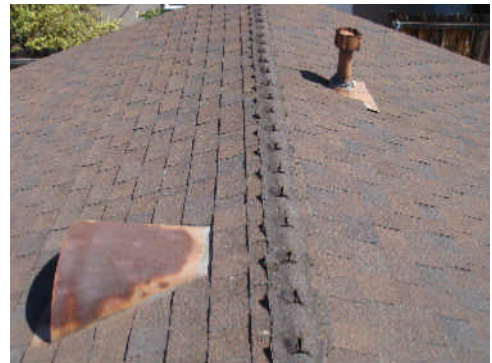
518 FLASHINGS [FE] The edge flashing is improperly on top of the roofing felt.

[FE] Some of the flashings are rusty. I recommend they be cleaned, painted with an oil based rust inhibitor and/or replaced as needed.

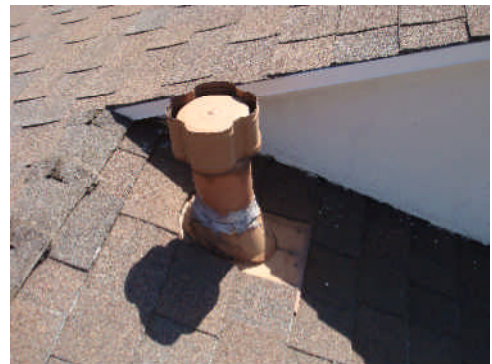
[CR] The gas flue pipes are lacking storm collars.

[CR] Water heater flue pipe is improperly terminated (too short).

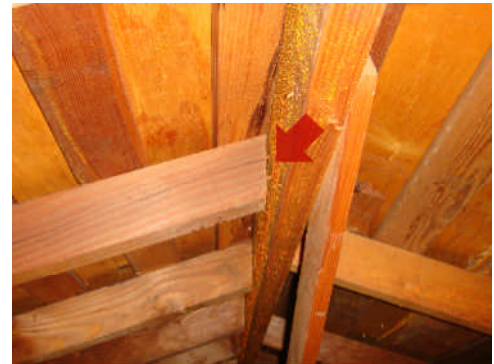
[CR] The upper ends of the rafters at the left area have a 1/4" separation from the ridge board. I recommend installing hangers for proper connection.

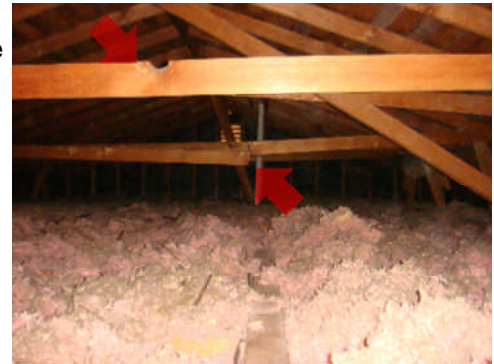
[FE] The suspected un-necessary collar ties are broken from knots and people entering the attic.

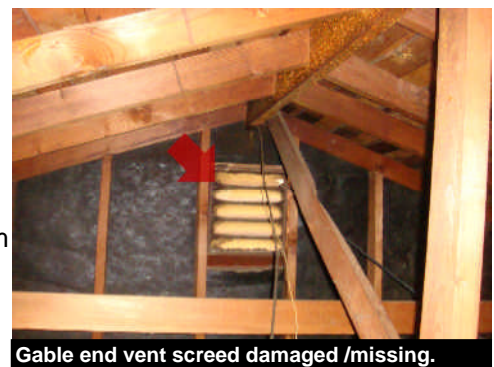
[CR] The attic has minimal ventilation. This condition is conducive to excess heat build-up in the summer.

[CR] The gable end vent screens are damaged, deteriorated and missing. The screens should be replaced with 1/4" screen mesh, to prevent birds, rodents or other animals from entering the attic space.

[RU] I recommend installing 3 turbine roof vents close to the ridge. During the winter the turbines could be covered with heavy mill plastic trash bags to prevent the attic heat from escaping. This will keep the heat in the house during the winter months.

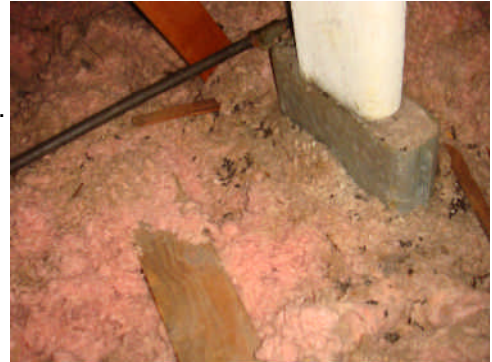
619 COMMENTS [CR] Rodent droppings are in the insulation around the dining area furnace vent flue.
I recommend the soiled insulation be replaced.

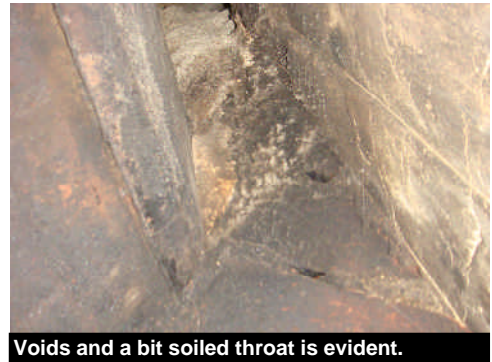
[FE] A couple of the rear bricks are slightly cracked.

[FE] There is efflorescence (white mineral salts) deposits in the fireplace. This condition is an indication of moisture intrusion.

706 DAMPER [SC] When a gas appliance or log set is installed in the fireplace. The flue damper needs to be blocked/clamped in the open position to prevent products of combustion from spilling out into the room.

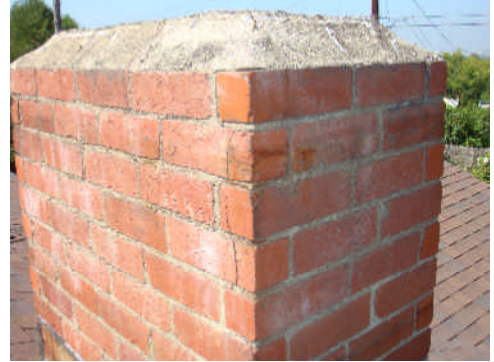
[FE] The chimney mortar cap is cracked and weathered.

[FE] The chimney bricks are cracked up to 1/8".

[FE] The chimney does not have a liner, only parg coated. See #713 picture.

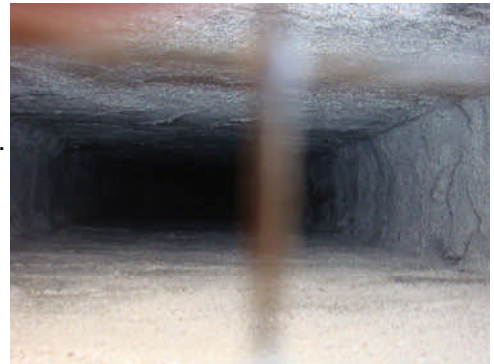
[RU] There is a flat screen spark arrester installed on the chimney. I recommend upgrading by installing rain cap type spark arrester to help minimize moisture entry into the flue and prevent the escape of hot embers.

I recommend an inspection by a qualified fireplace specialist. My inspection of the chimney flue is limited to the readily visible portion from the firebox and top only. The inner reaches of a flue are inaccessible. A qualified fireplace specialist will remove the screen and use a specialized video camera as needed to evaluate the flue.

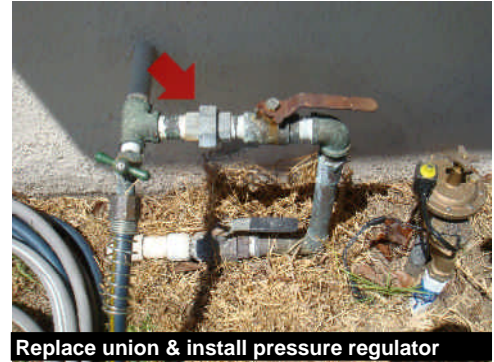
[CR] The rusting galvanized steel union connector should be replaced with brass.

Replace union & install pressure regulator

[RU] The static water pressure was measured at an exterior hose faucet and was 75 PSI. This condition can be conducive to plumbing leaks (pipes and faucets). I recommend installing a pressure regulator to limit the water pressure to or below 60 PSI, or appliance design limits.

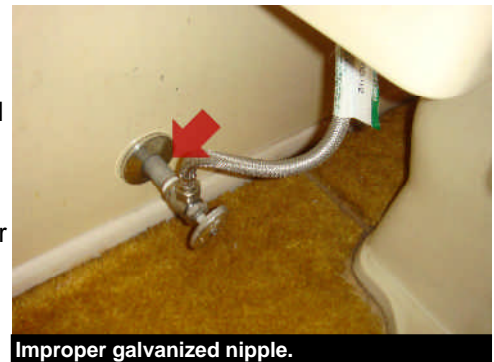
[CR] Copper and galvanized nipple may be in contact with each other at the master bathroom toilet supply. This condition can lead to corrosion/electrolysis between these dissimilar metals.

Improper galvanized nipple.

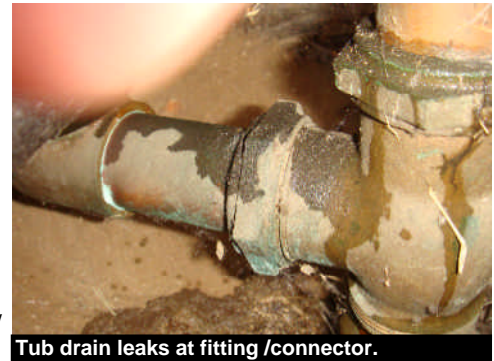
[FE] The drain piping is not visible due to slab on ground construction, other than the leaking tub drain.

Tub drain leaks at fitting /connector.

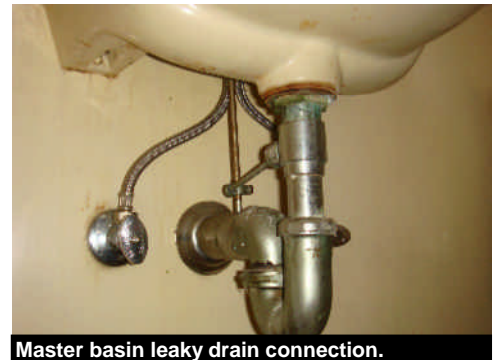
[CR] The master basin and tub drain leaked.

Master basin leaky drain connection.

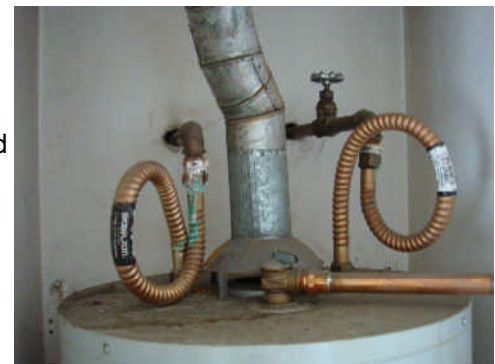
[CR] The water supply connectors are corroded.

[RU] The water supply connectors are not insulated. I recommend insulating the exposed water piping to minimize heat loss.

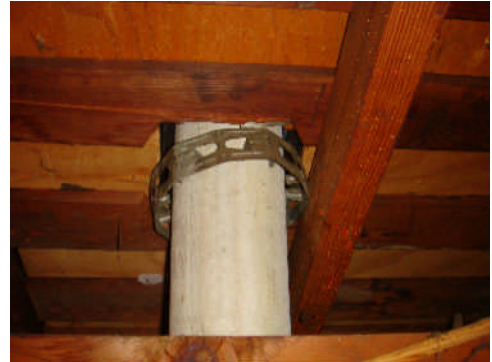
[SC] The flue vent piping is close to or in contact with combustibile materials at the roof. This condition could be a potential fire hazard.

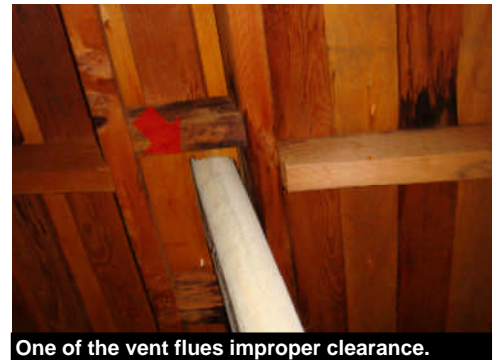
[SC] The flue vent pipes are lacking proper clearance from combustible materials at the roof. This condition is a fire hazard.

The two furnace gas vents and the water heater vent /flues are transite pipes. This material may contain asbestos.

One of the vent flues improper clearance.

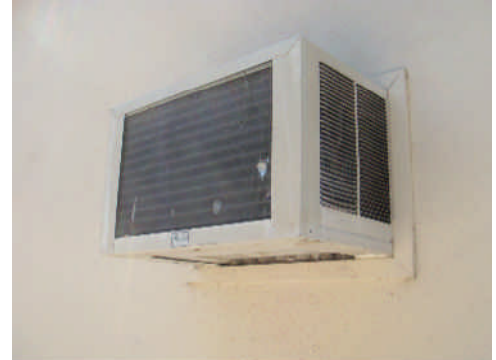
[SC] The bedroom unit does not operate and should be removed as required for fire exit.

[CR] The dining added 110 volt wall mounted unit did not cool.

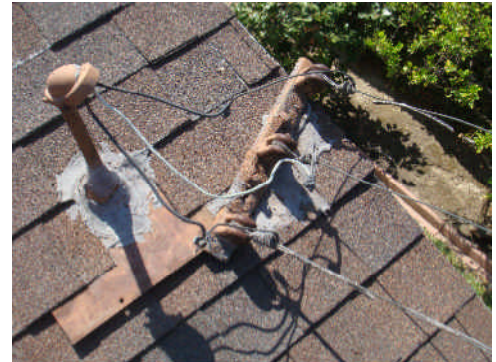
[SC] The overhead service entrance cables have damaged/deteriorated insulation and exposed wiring /connections.

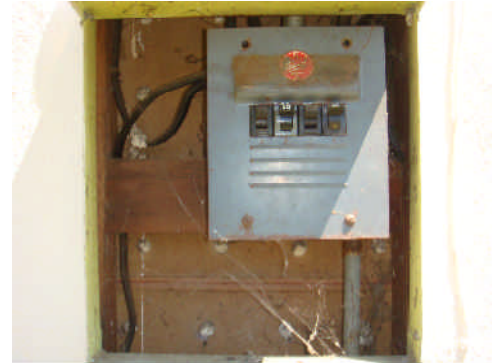
The main panel only has 4, 110 volt circuit breakers.

Today kitchens, just the kitchens are required to have 4, 110 volt circuit breakers.

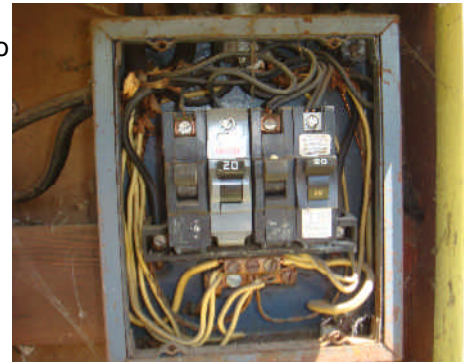
[SC] Double lugging is noted at the circuit breaker(s) in the panel. This condition is due to undersized panel.

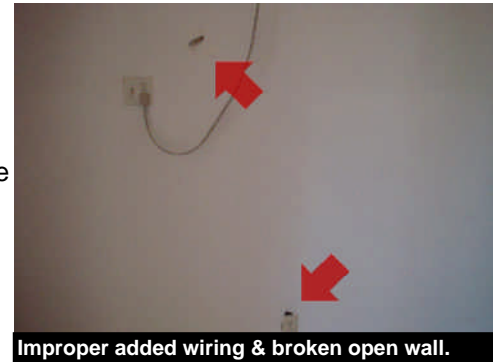
[SC] There is improper added wiring in the garage, and exterior added wiring for lights at the rear and right side of the house.

[CR] The dining area wall has a added receptacle and wiring for the wall A/C unit. The wall is broken open exposing the improperly added wiring.

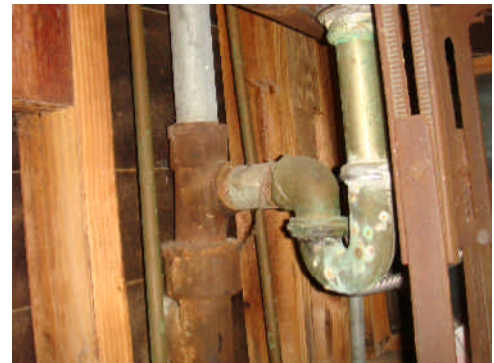
[CR] Corrosion is evident on the laundry sink drain pipe.

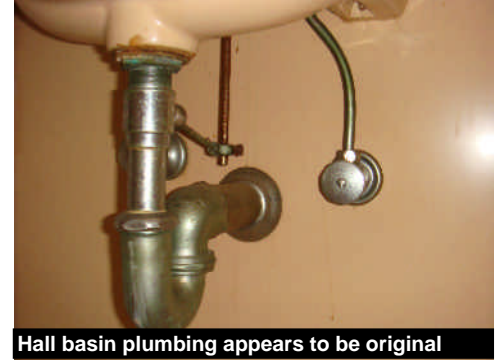
[SC] The hall basin has improper clearance from the bathtub, only 13"

Hall basin plumbing appears to be original

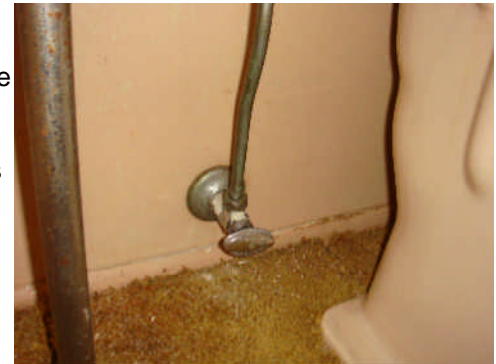
[CR] The hall bathroom tank flapper should be replaced to flush properly.

[RU] The hall toilet supply angle stop /valve is corroded.

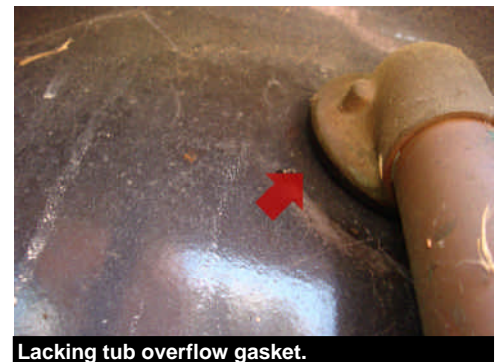
[CR] The tub overflow drain cover gasket is lacking. This condition is a potential leak.

[CR] The drain pipe fitting leaks.

Lacking tub overflow gasket.

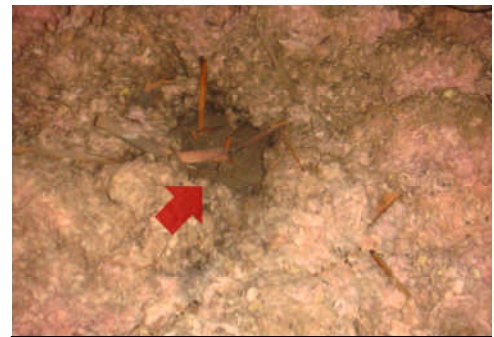
Shower stall ceiling vent screen in attic.

[RU] I recommend removing the shower stall vent screen, and installing an exhaust fan with approved wet location light.
