# *Pre-purchase Building Inspection Report*

Exclusively for: Mr. Johnson

Irvine, CA.

***Steve Garcia Inspections***

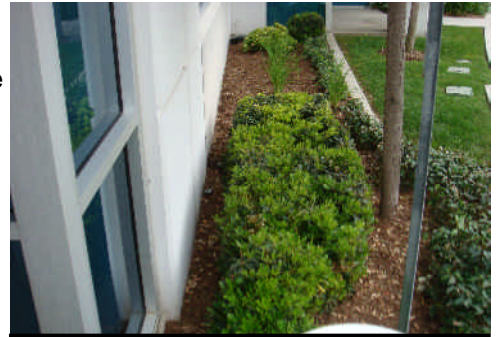
[CR] The grading at the front and left side is not adequately sloped away from the foundation. It is important that surface grade be sloped away from the perimeter foundation to prevent moisture accumulation next to the foundation, which may infiltrate below the building effecting the structural integrity of the building support systems.

Front grade /planter, no visible drains.

[FE] The interior slab/floor level is marginally above the exterior landscaping. I recommend modifications in these areas to maintain a minimum of 2 inches clearance between the grade and slab/floor level.

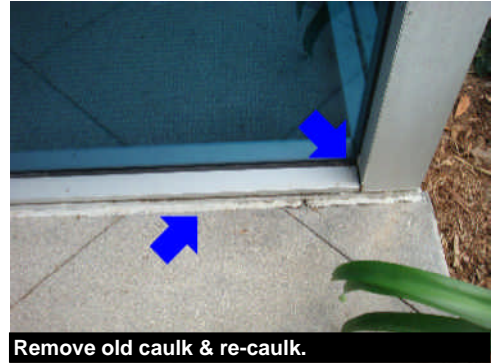
[CR] The right side adjacent window frame caulking is not maintained.

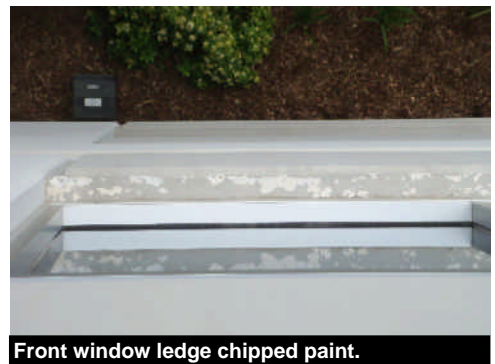
[CR] The concrete walls finish /paint appeared worn, weathered and chipping at the front second floor window ledge.

[CR] There are cracks in the concrete walls. These conditions are conducive to moisture intrusion/deterioration.

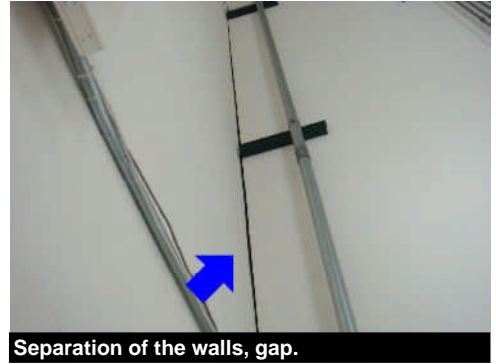
[FE] The exterior wall appears to be bowed out at the rear right corner of the warehouse. A gap is evident between the interior wall.

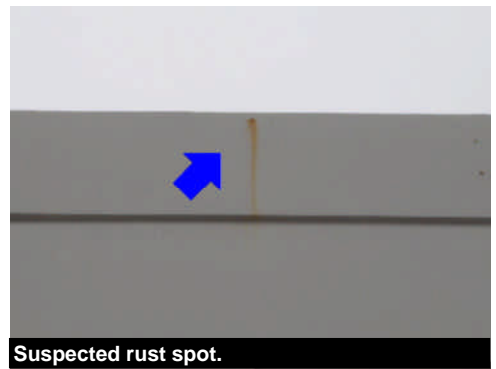
[FE] There is a suspected rust spot at the rear upper right area.

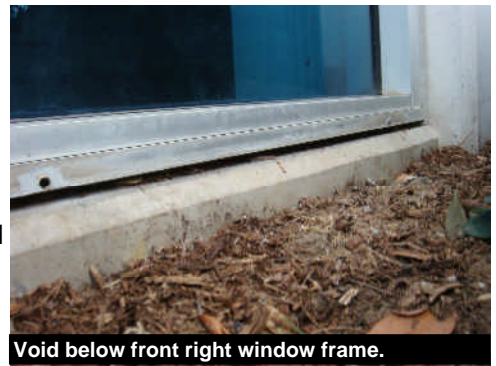
[CR] The front window frame is not sealed at the base. Moisture intrusion is evident.

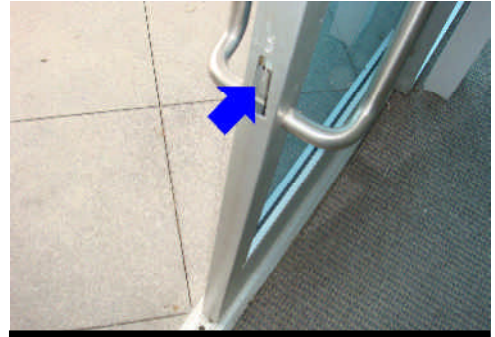
[CR] The left door upper pin locking mechanism is sticking. The door does not latch with the lock bolt key.

Door pin only latched by pushing up.

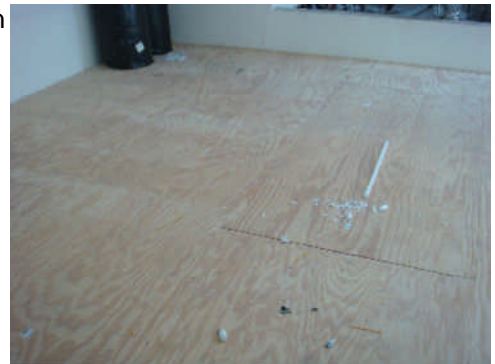
[SC] One florescent bulb fell and is broken on the plywood above the added room.

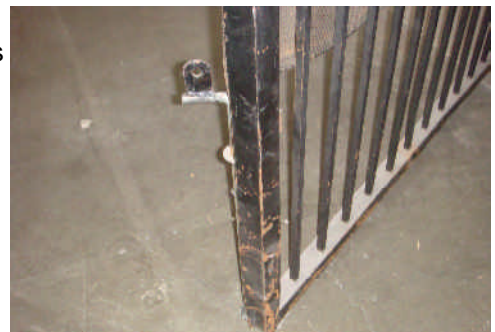
[CR] The added metal rear gate drags on the slab, and the iron wall fastener plate is missing fasteners.

Gate is bent /damaged at bottom.

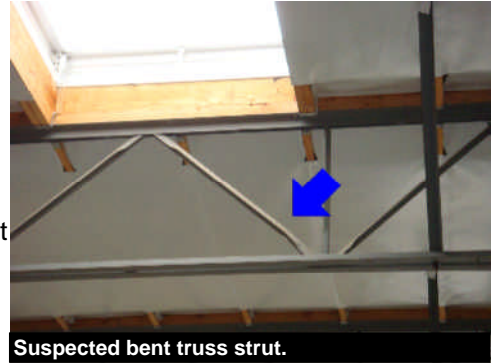
[FE] Suspected bent truss strut at the front right area of the warehouse.

Suspected bent truss strut.

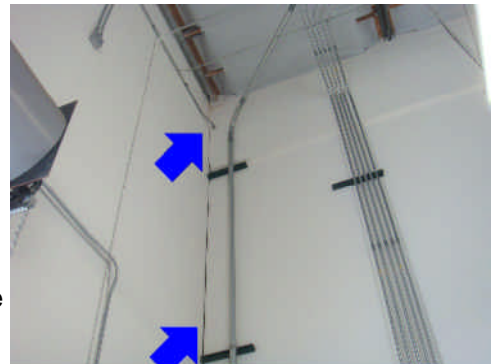
[CR] The center of the right side wall board has impact damaged.

[CR] All gaps and voids should be sealed with proper fire rated materials.

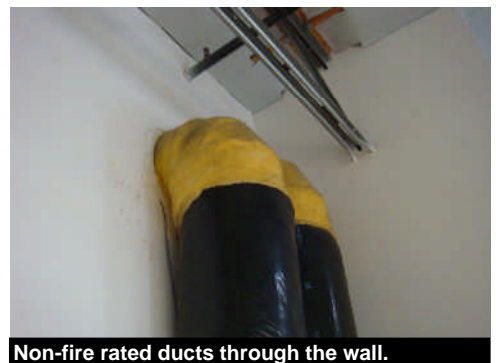
[CR] The office walls and ceilings fiberglass batt insulation is out of place and missing.

Non-fire rated ducts through the wall.

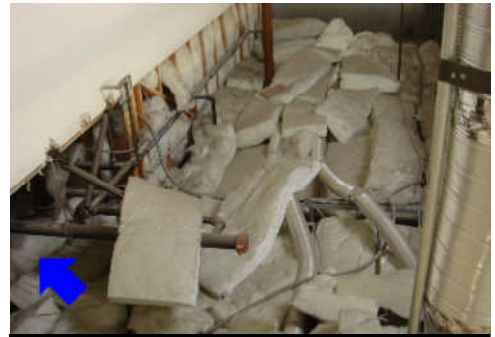
[SC] Fire separation between the office spaces and the wearhouse is lacking.

No fire separation wall /ceiling.

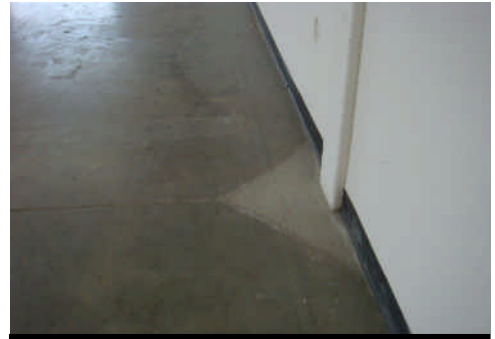
[FE] The slab concrete has a few pop-outs.

Grind the bolts down to prevent tripping.

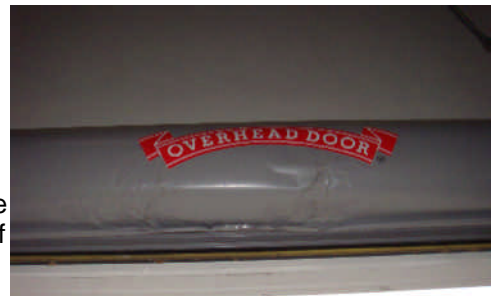
The rear door cover is bent and damaged. This condition did not impede the operation of the door.

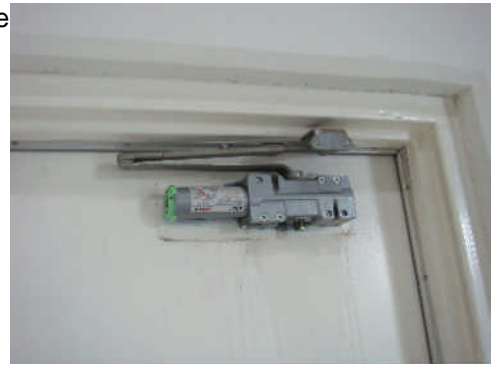
[CR] The left door threshold is loose and missing a fastener. The door closing device should be adjusted to close slower for safety. The closer cover is missing.

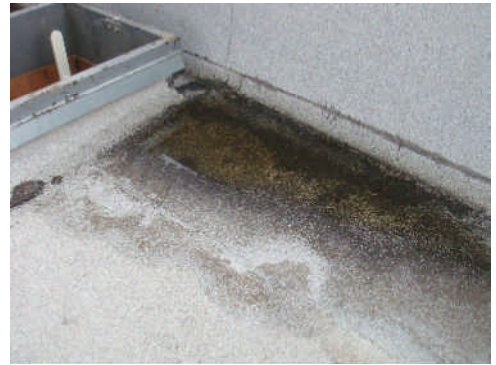
[SC] The roof access metal ladder fastener is loose at the top.

[SC] The access roof deck puddles water adjacent to the access ladder. Poor drainage area is a slip and fall hazard.

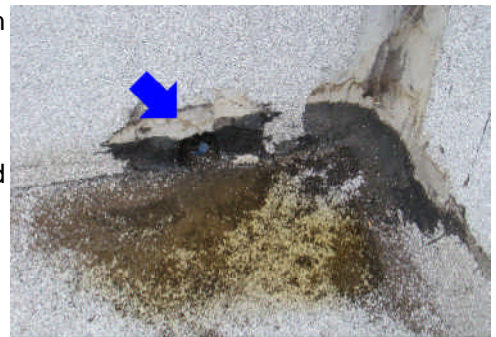
**Rear left roof scupper.**

[FE] The rear left roof scupper is restricted by roofing material. The opening is between 2" - 3". This condition could cause puddling of water during excessive rains.

[FE] Puddling is evident adjacent to the scupper. Regular maintenance of the areas is vital to prevent the build-up of vegetation, debris, sagging and possible damage to the roof.

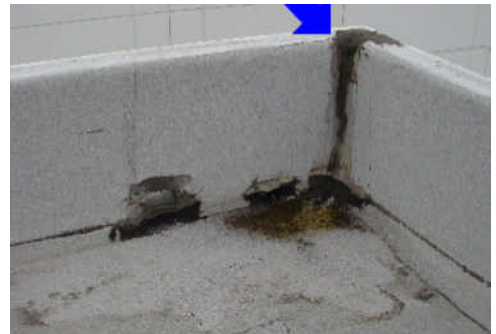
**Mastic patching at the rear left corner.**

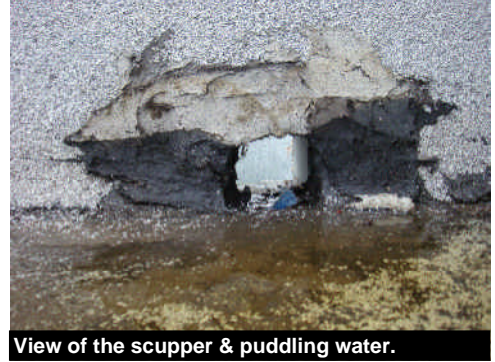
View of the scupper & puddling water.

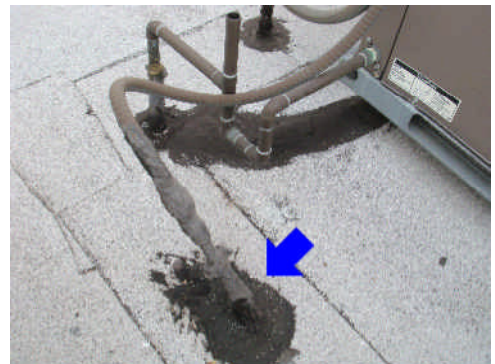
518 FLASHING(S) [FE] The electrical conduit pipes do not appear to have jack flashings. One of the conduits is leaning over.

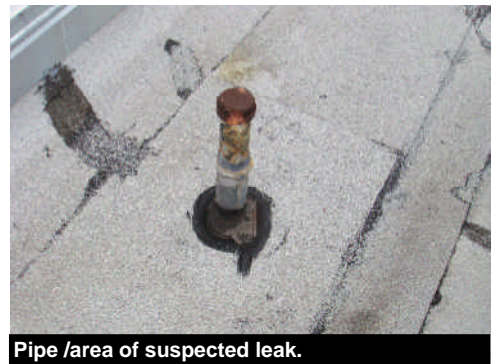
The front iron pipe appeared to have leaked onto the second floor left office ceiling panel. The pipe is sealed at the roof.

The second floor center office area has a slight stain on the ceiling panel. This stain appears to have been from an unsealed plumbing vent pipe that is sealed at this time.

Pipe /area of suspected leak.

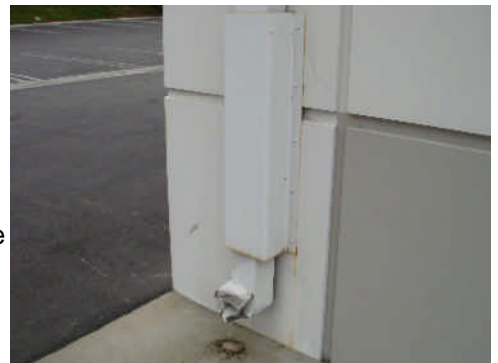
[CR] The rear left corner downspout end is crushed /damaged.

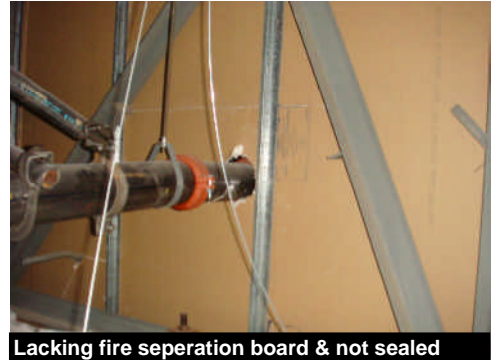
**602 COMMENTS** [CR] The visible right side joining wall above the suspended ceilings are lacking fire separation board on this side of the framing.

Lacking fire seperation board & not sealed

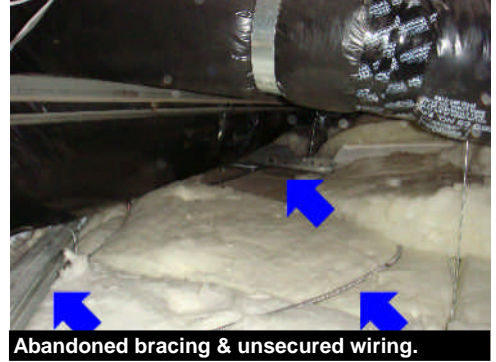
[FE] It appears partition walls have been altered leaving metal braces abandoned and hanging above the second floor ceiling.

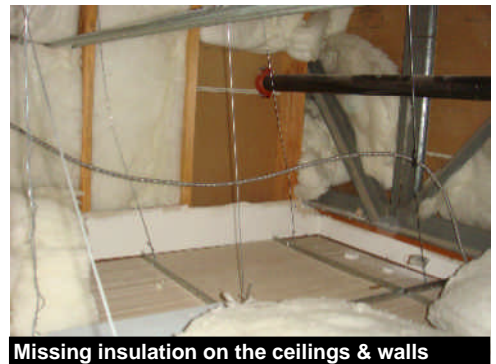
[CR] The insulation is out of place/ missing in areas of the ceilings and walls.

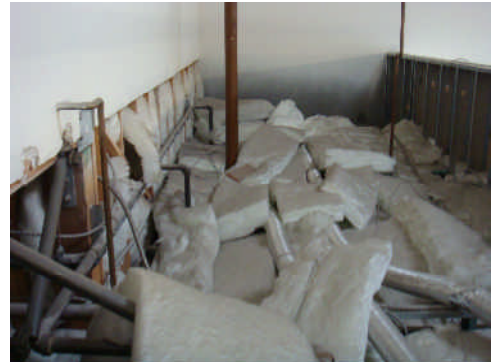
[CR] The insulation over the bathrooms and walls has been improperly installed.

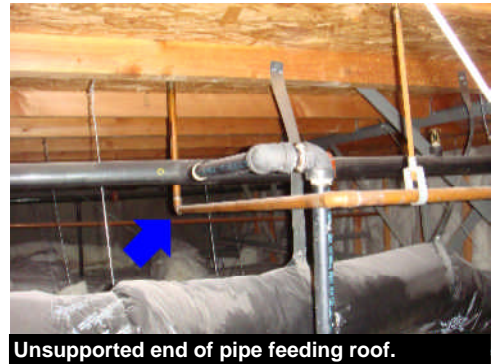
[CR] The water supply pipe feeding the roof faucet does not appear to be supported properly below the roof.

Unsupported end of pipe feeding roof.

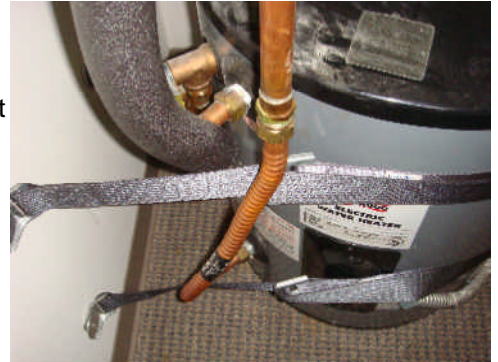
[FE] The water supply connectors have slight corrosion evident.

[RU] The shutoff valve and water supply connectors appeared functional. Valves are not operated. I recommend insulating the exposed water piping to minimize heat loss.

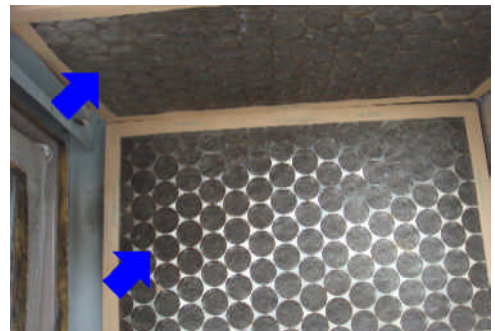
Cheap filters in the units.

[RU] I recommend pleated type filters be installed into the office ceilings return air grills, to prevent the return air ducts from becoming soiled, and having to access the roof, open the covers and replace the filters.

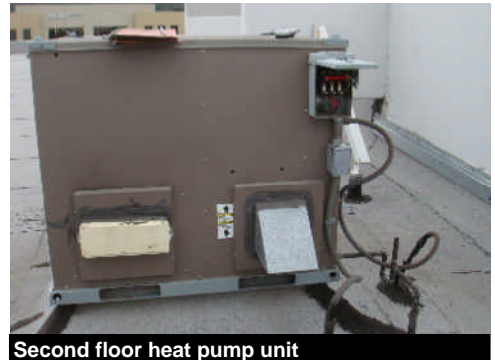
[CR] Each unit is missing one cover securing screw.

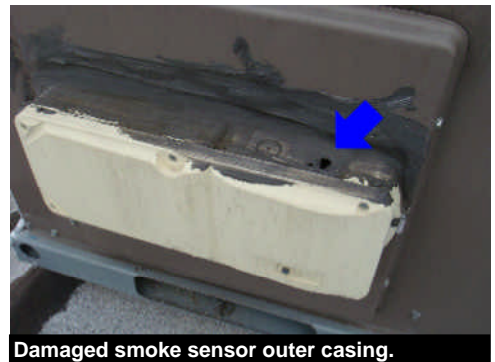
[FE] The automatic smoke /fire detector outer cover is damaged on one of the units. I recommend these devices be evaluated.

Damaged smoke sensor outer casing.

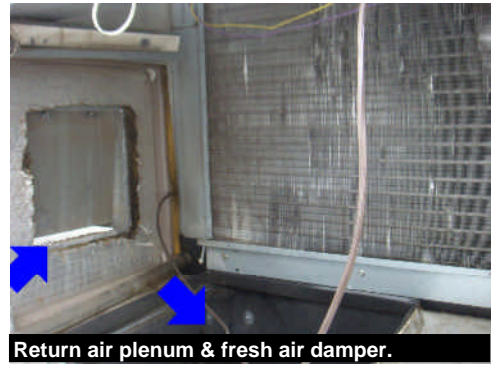
[FE] The second floor unit damper sticks open on the hood.

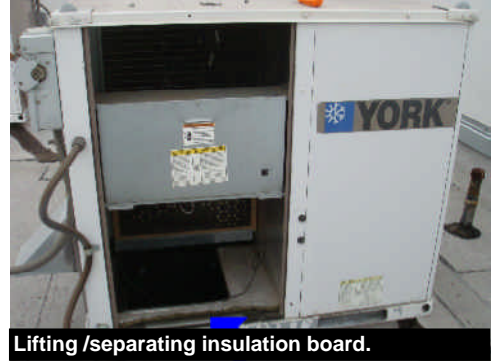
[FE] The insulation board is starting to separate inside of the units. I recommend bonding the insulation down.

Lifting /separating insulation board.

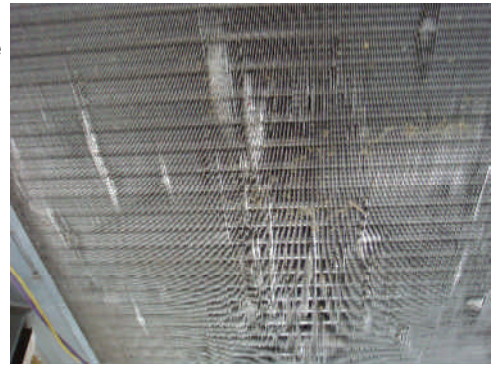
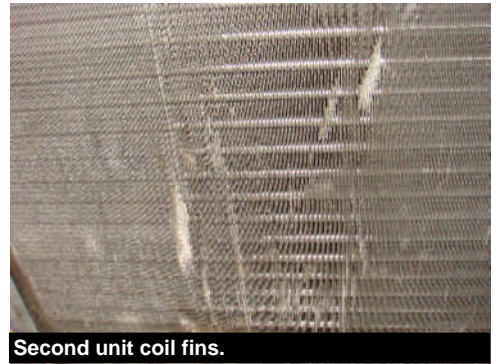
[FE] A number of the heat pump coil fins are bent down. This condition can reduce the units overall performance.

Second unit coil fins.

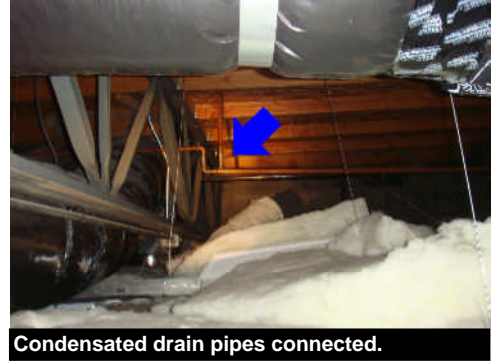
[FE] The drain pipes are connected to each other. The termination of the pipe is connected into the men's bathroom basin drain pipe.

Condensated drain pipes connected.

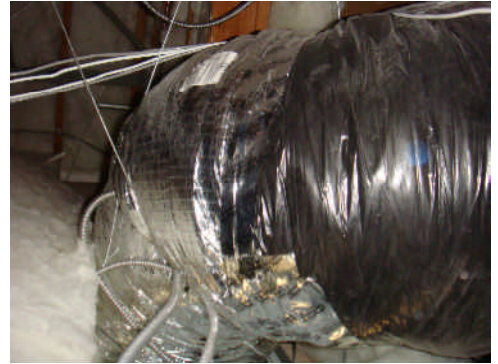
[FE] The duct connections /splices do not appear to have metal connectors.

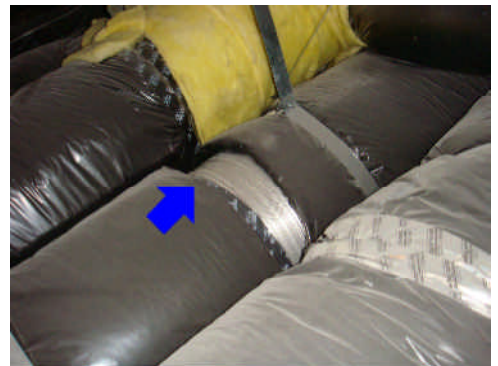
[CR] The duct insulation is lacking at a couple of areas.

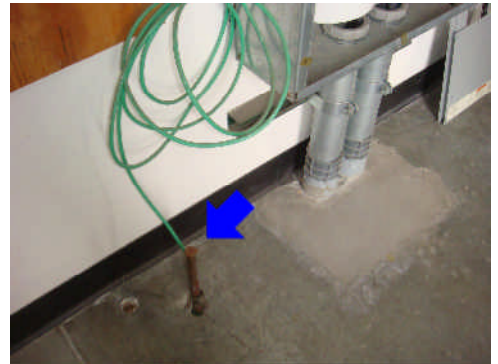
There is an abandoned grounding rod adjacent to the panel. The function of the rod is unknown.

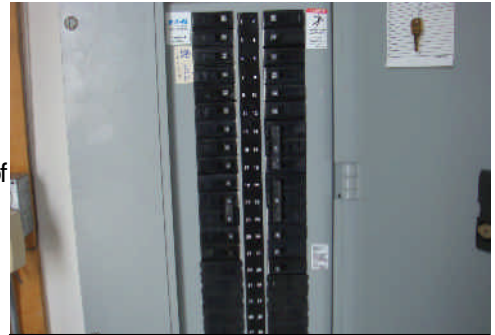
[SC] The panel cover exterior is not identified /labeled properly. The labeling of the cover should be corrected.

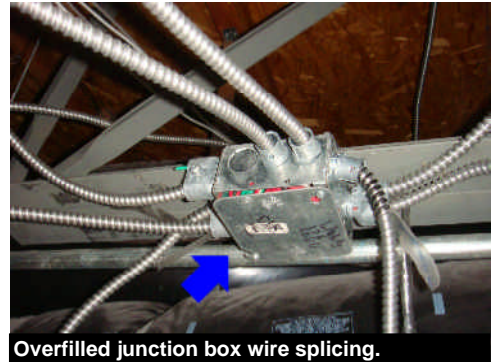
[SC] Above the second floor ceiling is a junction box overfilled with wiring splices. The cover is not secured.

**Overfilled junction box wire splicing.**

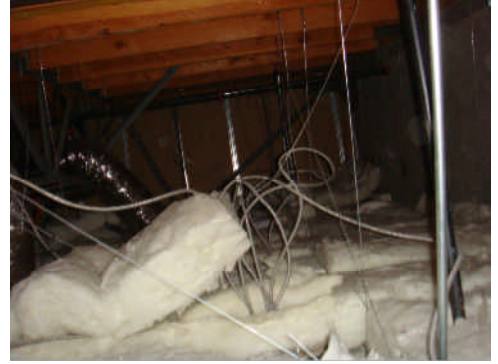
[CR] The wiring above the second floor center office suspended ceiling is not secured properly.

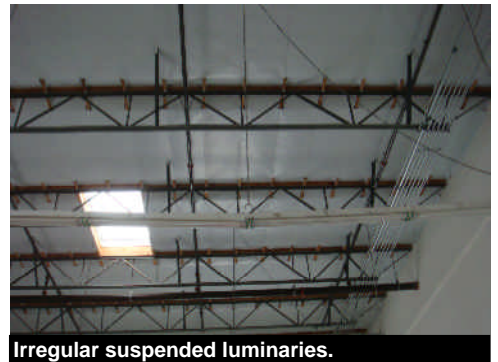
[CR] The warehouse suspended luminaries are hung in an irregular manner. One tube fell onto the plywood above the utility room.

**Irregular suspended luminaries.**

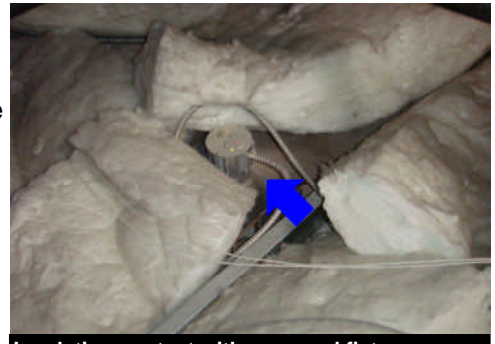
[FE] It is unknown if the ceiling recessed light fixtures are "IC-rated for insulation contact. I recommend the light fixture trims and bulbs be removed to expose the manufactures label to determine the rating.
