Pre-purchase Home Inspection Report

Sample report of 9 year old 4,000 square house

Steve Garcia Inspections

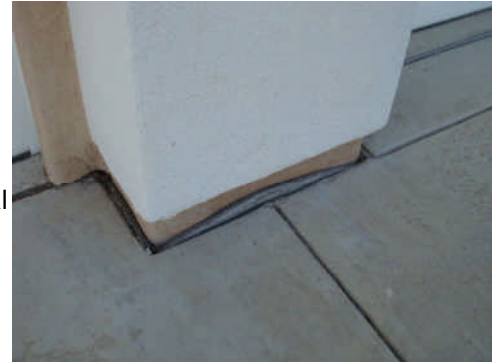
[CR] The separation /expansive joint between the driveway and garage /slab is lifted and damaged. I recommend replacing the material and filling in the void with the proper material to prevent moisture intrusion below the slabs.

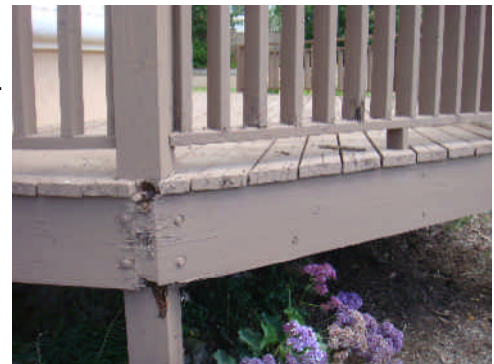
[CR] The deck support wood posts and framing is damaged and deteriorated. The wood frame deck is at the end of its useful life.

[SC] The wood deck damage is excessive, resulting in trip hazards due to lifted fasteners, broken and lifted deck planks.

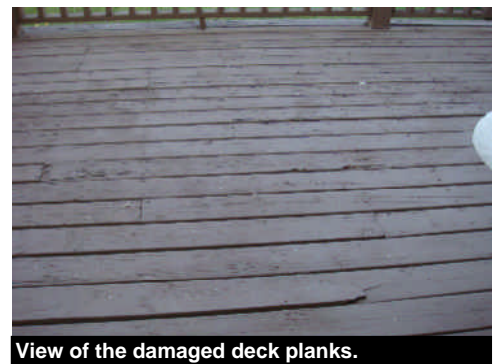
[SC] The deck stairs are lacking handrailings.

View of the damaged deck planks.

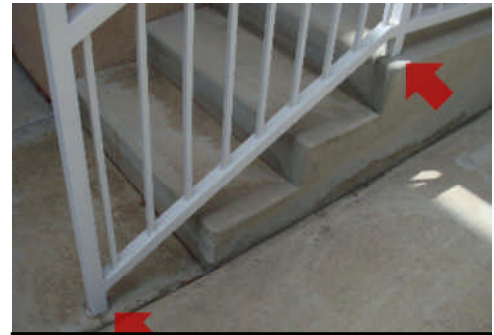
[CR] The metal railing into the concrete stairs at the left side are not bermed at the base to prevent rusting.

Berm posts and concrete.

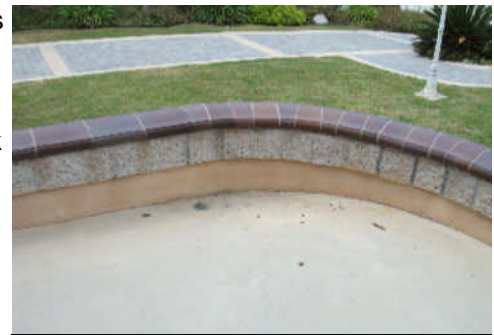
[SC] There are no guardrails at the front block walls 30" above the grade as required for safety.

Front walls are lacking guard railings.

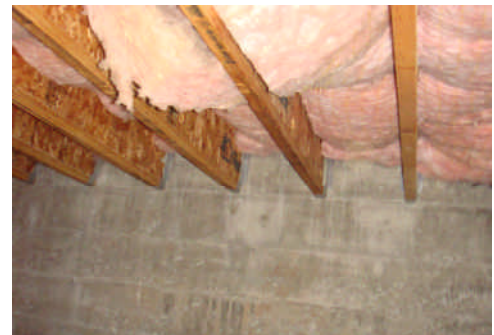
[FE] The raised planter enclosure adjacent to the foundation at front right of the house has been added, which now raises the soil level above the stucco screed improperly. This condition is conducive to moisture intrusion and deterioration of the stucco wall.

View of the foundation adjacent to planter

No visible moisture in the craw space adjacent to the planter area.

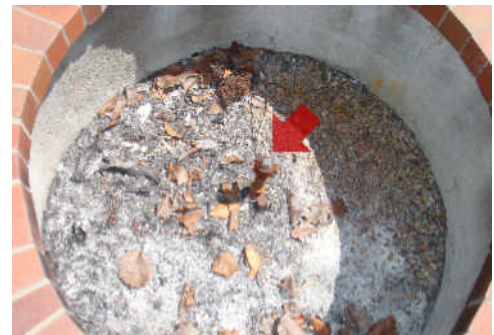
[FE] The gas pit pipes are rusty and should be fully exposed for evaluation.

Water came out of the pipe when operating.

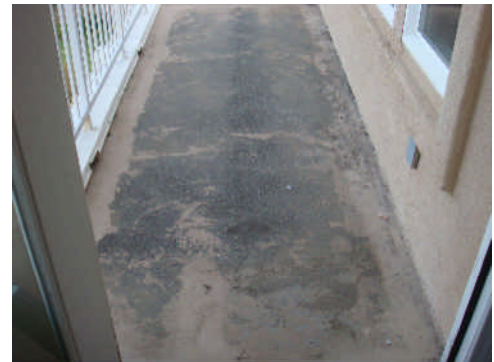
[CR] The master bedroom balcony deck's waterproof covering /coating is damaged and deteriorated.

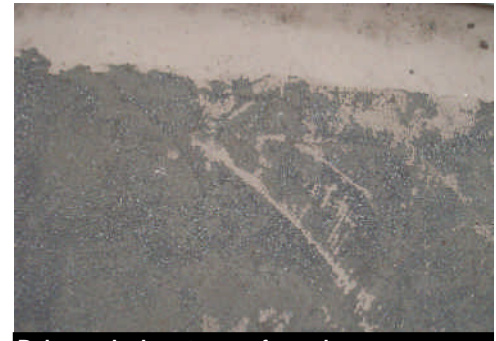
[CR] The deck waterproof material is deteriorated and cracking.

Balcony deck waterproof membrane.

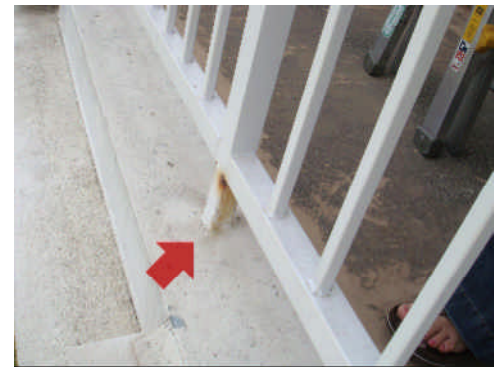
The metal railing is rusting at the base posts.

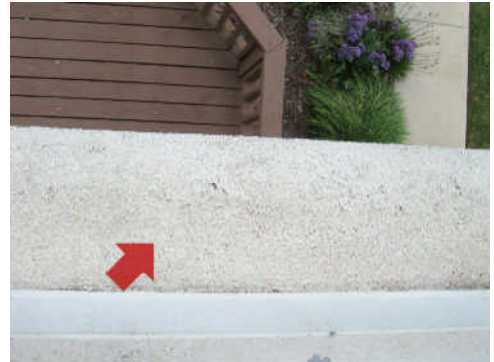
[CR] The paint on the bands is weathered / worn, chipping and cracking.

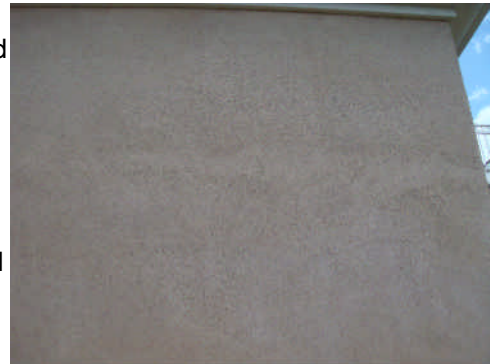
[CR] There are cracks in the stucco siding. This condition is conducive to moisture intrusion and deterioration.

[FE] The front right patio/walkway surface and planter has been installed above the metal stucco weep screed along the bottom edge of the stucco siding. These conditions are conducive to moisture intrusion/deterioration of the wall.

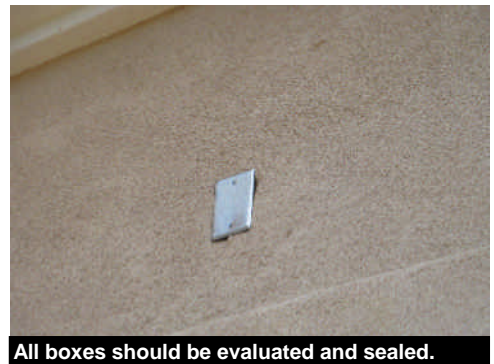
[CR] The covered junction boxes do not appear to be sealed at the stucco walls.

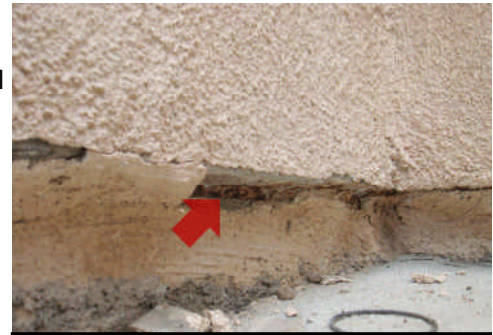
The stucco metal weep screed along the bottom of the stucco walls has stucco attached. This condition could cause the metal screed to rust. I recommend cleaning off the stucco below the stucco screed and painting the metal with an anti-corrosive paint.

The stucco screed is rusting.

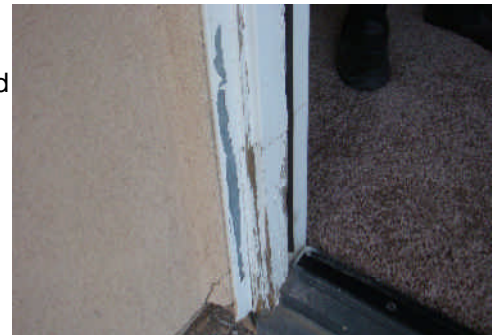
[CR] The trim paint finish is weathered beyond normal wear, and is chipping off exposing the wood.

Master bedroom door jamb /trim.

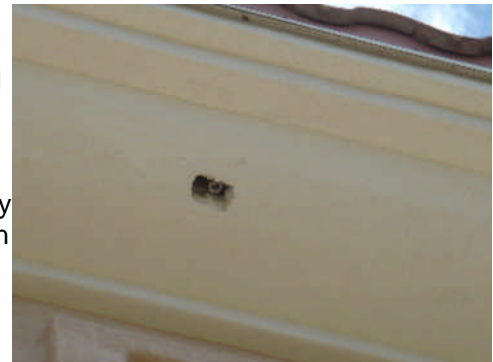
[CR] A hole /opening is evident at the rear left soffit. It appears the A/C cooling coil secondary condensate drain pipe terminates improperly in the soffit.

[FE] The A/C condensate drain lines are not fully visible in the attic due to the insulation and ducts.

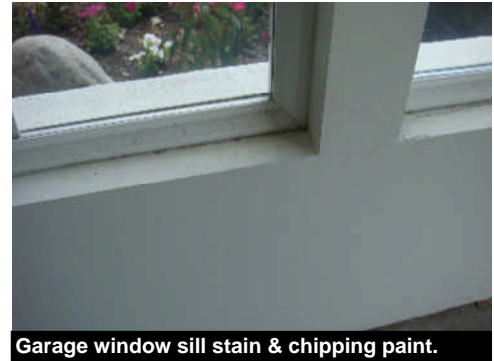
[CR] The garage window appears to have leaked. The sheetrock at the head of the window and sill is stained, blistered and damaged.

Garage window sill stain & chipping paint.

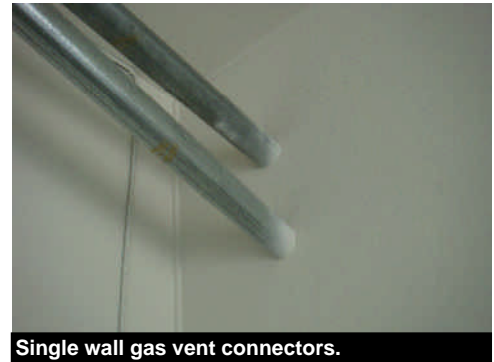
[SC] The added wall is improperly in contact with the water heater gas vent connectors.

Single wall gas vent connectors.

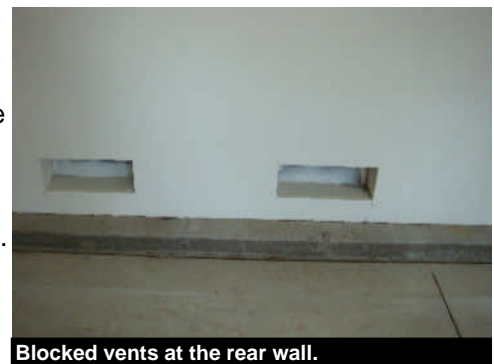
[CR] The air vent openings are blocked by the building wrap /felt improperly. These vents provide combustion air for the fuel-burning appliances located in the garage and remove possible contaminated air from exhaust fumes.

[CR] Vents should have been installed adjacent to the water heaters. The added wall blocks off ventilation for the water heaters.

Blocked vents at the rear wall.

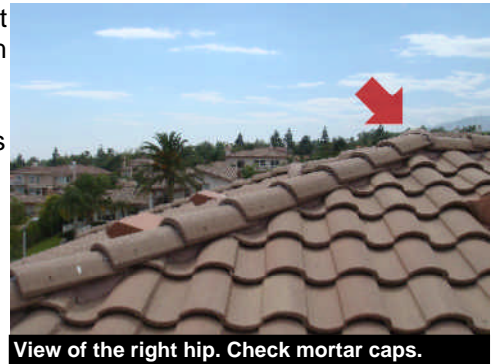
View of the right hip. Check mortar caps.

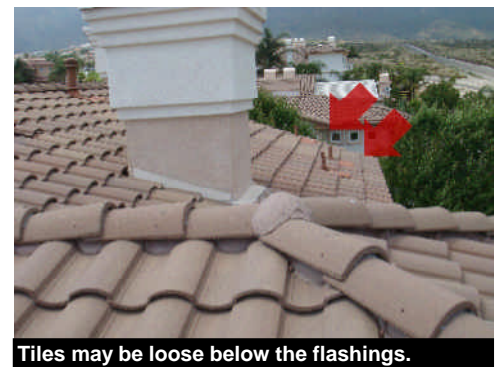
[FE] Suspected loose tiles at the rear left below the vent flashings.

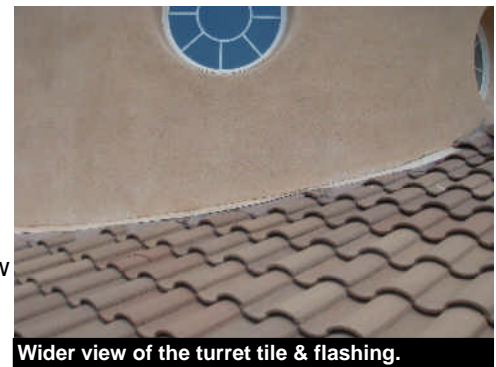
[CR] There are cracked /broken tiles evident. These conditions are conducive to roof leaks.

[CR] There are a number of unsecured or improperly fastened tiles. These conditions are conducive to roof leaks.

[CR] There are mortar plugs or caps that are cracked and loose. These conditions can allow moisture intrusion into concealed spaces.

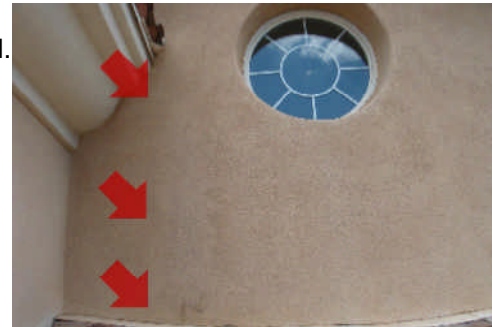
[FE] The stucco wall below the upper roof channel /pan flashing termination is discolored. Below this area in the entry area the stucco ceiling appears to have moisture stains.

Discolored stucco below roof flashing.

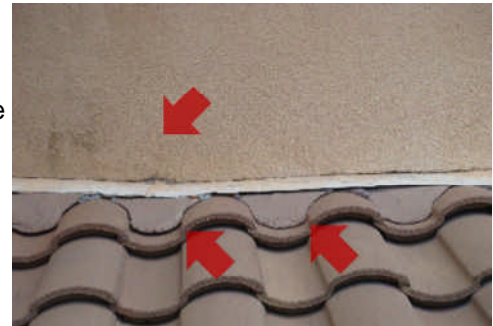
Stained stucco & loose mortar plugs.

[FE] I recommend full evaluation of the stucco discoloring, and staining at the entry ceiling.

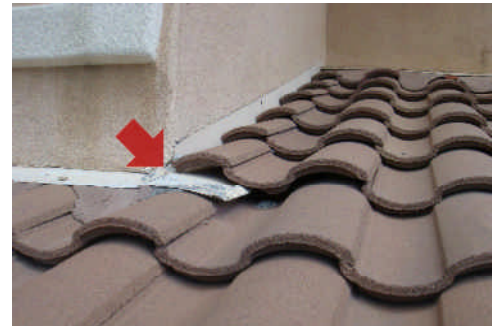
[CR] There are lifted reverse slope, crushed pan flashings and voids evident at the front and left side walls /pan flashings.

Lifted pan flashing & void at the front.

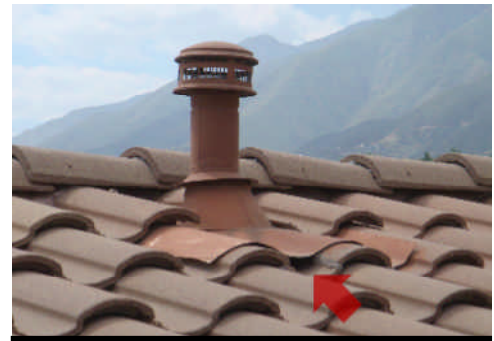
[FE] The bottom end of a couple the flashings are lifted.

Void /opening below flashing.

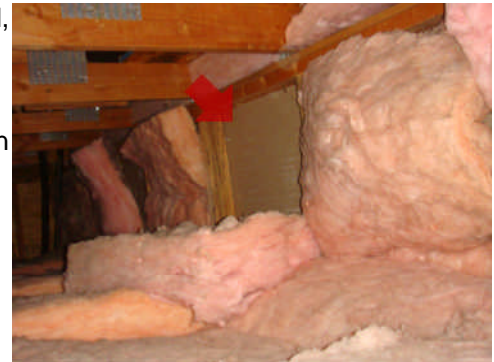
[CR] The insulation is out of place, and separated from the master wall. This condition minimizes the overall value of the insulation.

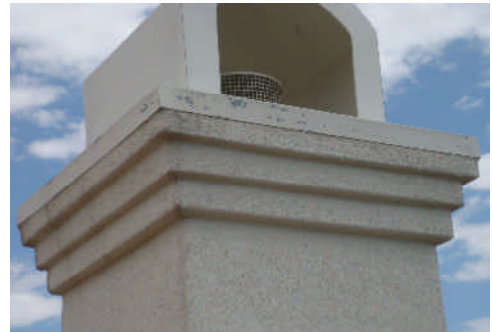
[FE] The chimneys are not accessible to inspect. I recommend the metal chase caps and flue terminations be evaluated.

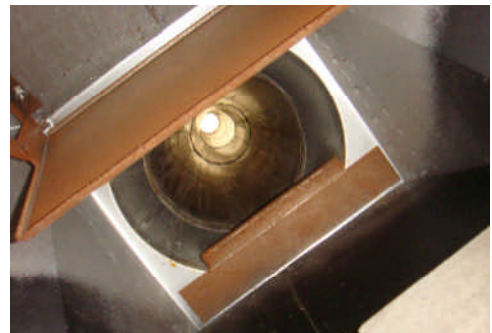
713 COMMENTS [FE] The chase caps should be evaluated for proper slope for water shedding. Some moisture stains are evident in the living room flue.

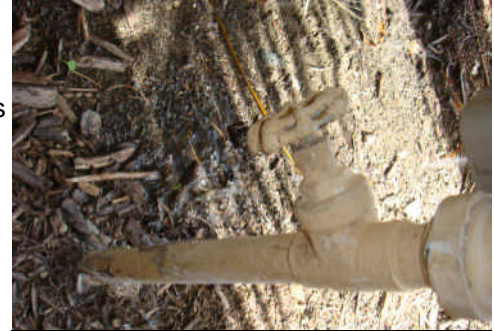
[CR] The valve did not turn. I recommend the valve be updated with a 1/4 turn ball valve.

View of the original main water valve.

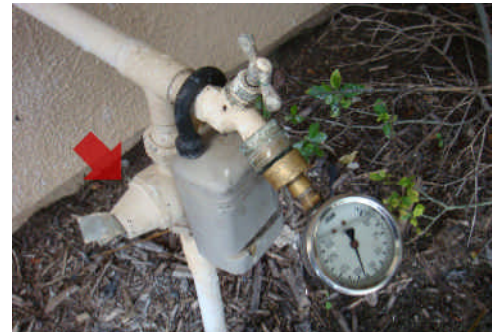
[CR] The static water pressure was measured at an exterior hose faucet and was 93 PSI. This condition can be conducive to plumbing leaks (pipes and faucets). I recommend installing, adjusting or replacing the pressure regulator to limit the water pressure to or below 60 PSI, or appliance design limits.

Excessive water pressure. Replace Reg.

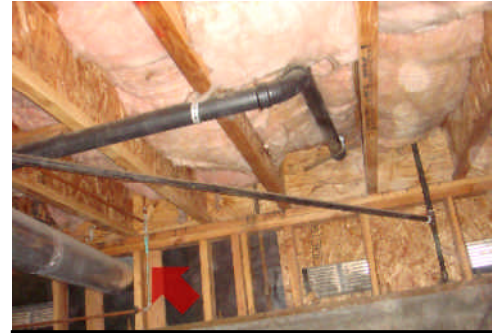
[RU] There are un-insulated water supply pipes in the crawl space. Hot water supply pipes should be insulated to help minimize heat loss.

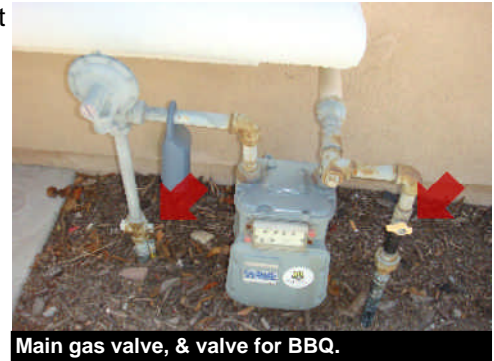
[RU] The main gas supply shutoff was not operated. There is no emergency shutoff wrench present. I recommend providing a wrench or installing a seismic automatic shut off valve for emergencies.

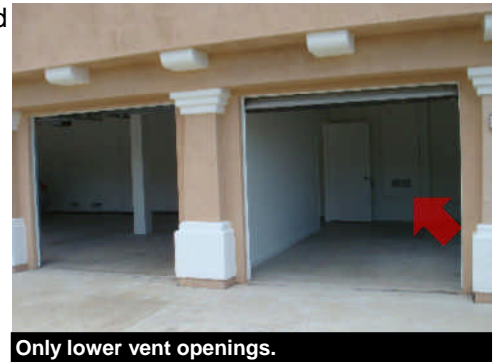
[CR] The sheetrock enclosure has been added without proper vent openings.

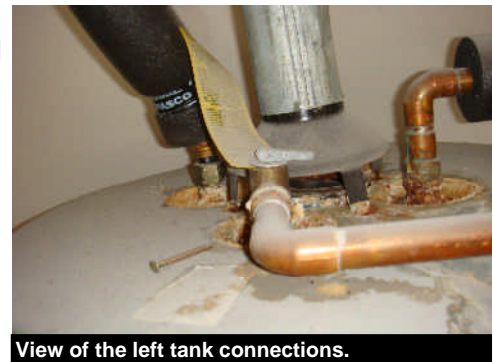
The shutoff valve is original. Replace with a ball valve when replacing the tank.

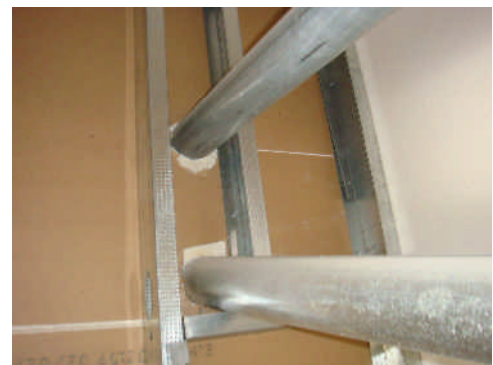
[SC] The flue vent piping is improperly in contact with combustible materials /wall, this condition is a potential fire hazard.

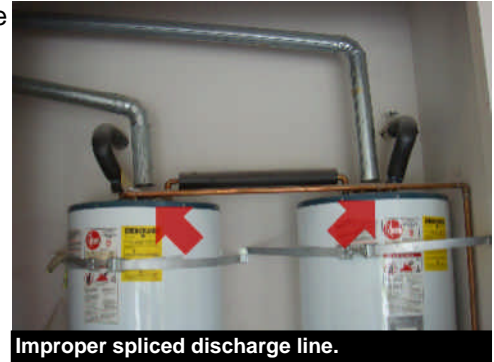
Discharge lines should be installed at each TPR valve and extended to the exterior and terminating close to the ground facing downward.

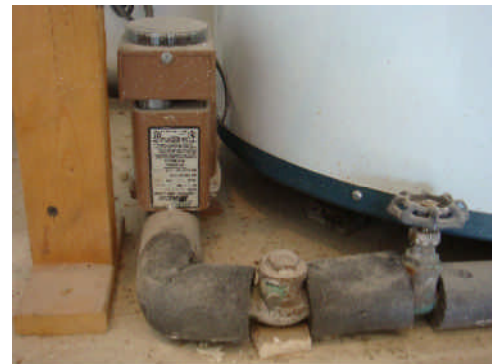
[CR] The water supply valves and back flow check valve are corroding.

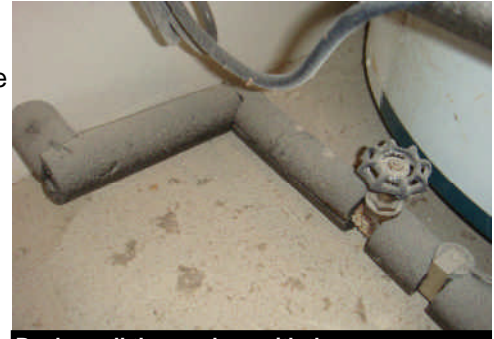
The re-circulating system /pump appears to have been running continuously. This condition is not energy efficient, and can erode the pipes. I recommend using the time clock device to limit the use of the pump.

Replace all three valves with the pump.

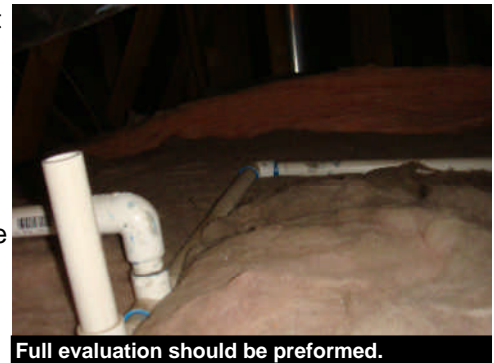
[FE] I recommend installing a trap on the primary condensate drain lines to prevent the loss of conditioned air and to guard against the introduction of contamination into the system. Traps and vents are required by various manufacturers but not all. Compliance to specific manufacturers' specifications is beyond the scope of my inspection. To determine if a trap and vent is required I recommend further evaluation by a factory qualified technician of this specific manufacturer.

[CR] The condensate drain line has an improper slope to provide for adequate drainage and blockage may result.

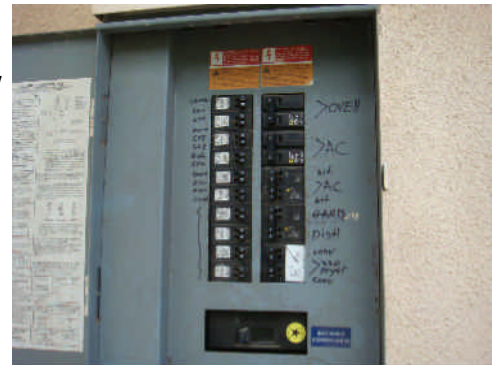
[CR] Screws are missing at the front cover of the panel.

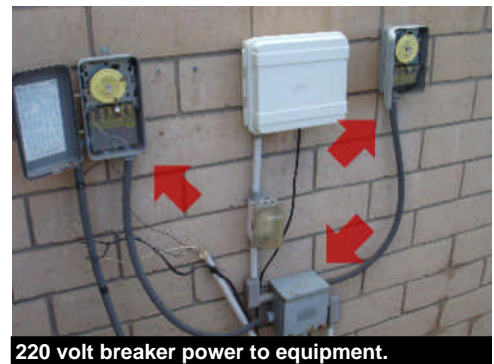
[SC] The 50 amp. 220 volt breaker labeled yard 220 volt is feeding the fountain electrical. The fountain electrical wiring is not protected from the 220 volt breaker.

220 volt breaker power to equipment.

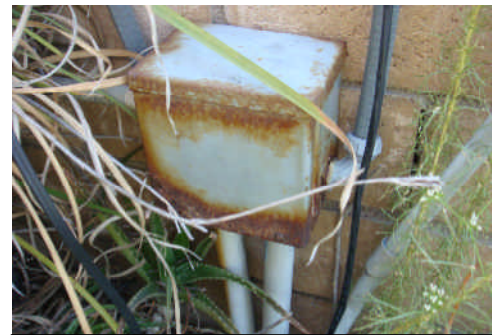
[CR] The exterior metal junction boxes on the front and rear block walls are rusted.

Rear rusted junction box.

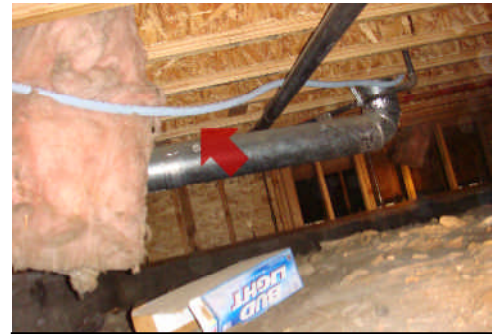
[CR] Unsecured wiring in the crawl space below the kitchen.

Unsecured wiring & insulation below kit.

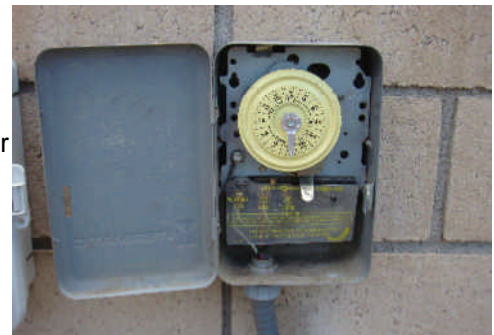
[RU] I recommend updating the light timers for energy efficiency.

Time clock is lacking pins to set time.

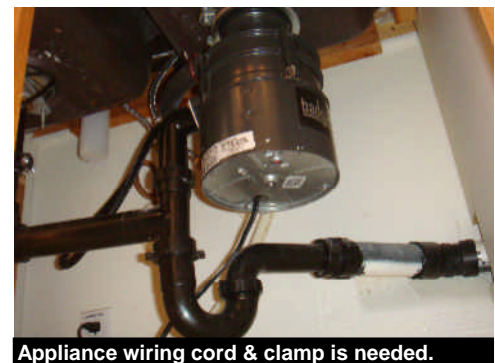
[CR] The disposal made unusual noises.

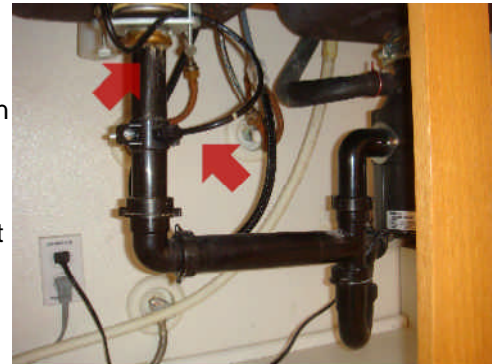
[CR] The soap dispenser is loose and not sealed to the sink.

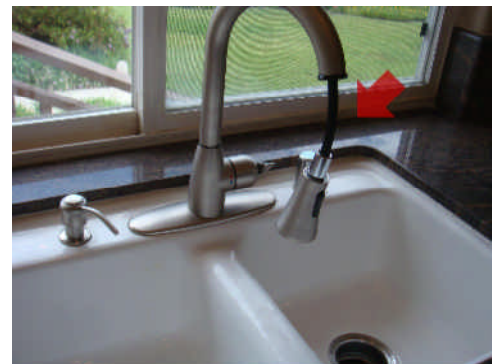
[CR] The faucet spray hose is lacking a counter weight.

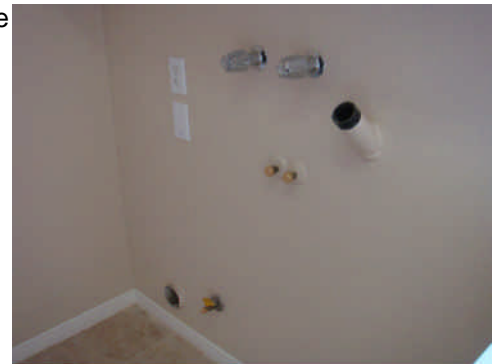
[RU] A leak pan and drain line below the washing machine is not provided.

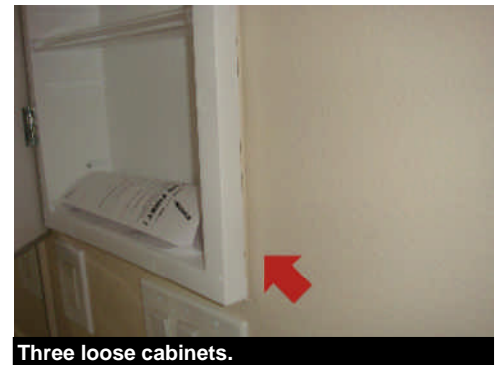
[CR] The three second floor bathroom medicine wall cabinets are not secured properly.

Three loose cabinets.

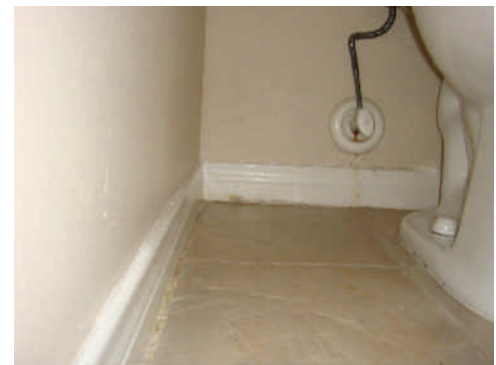
[FE] There is evidence of past leakage at the water supply valve /connections in the master bathroom.

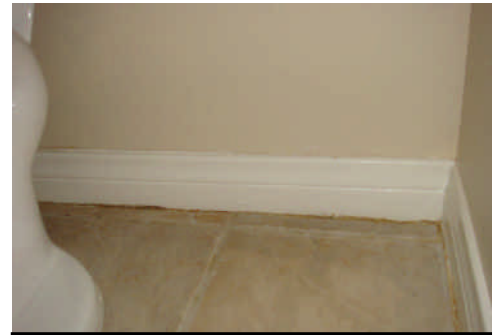
[FE] The master bathroom walls and floor should be evaluated for moisture damage.

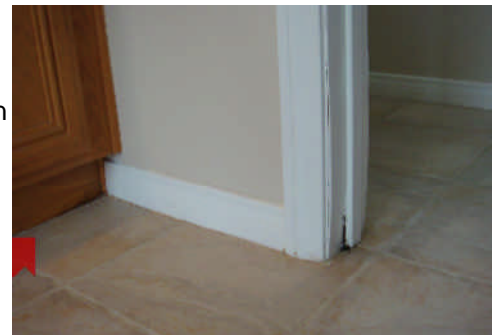
[CR] Moisture stains and damage is evident in the master bathroom door jamb and cabinet.

Master bathroom damaged jamb & staining.

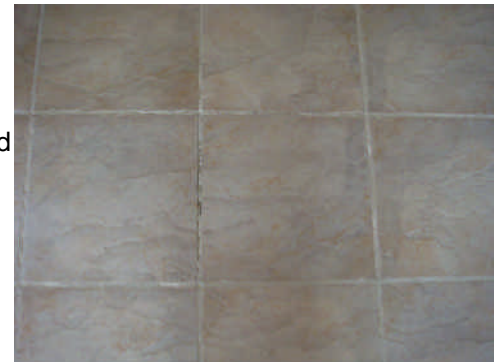
The tile flooring appears to have been installed improperly.

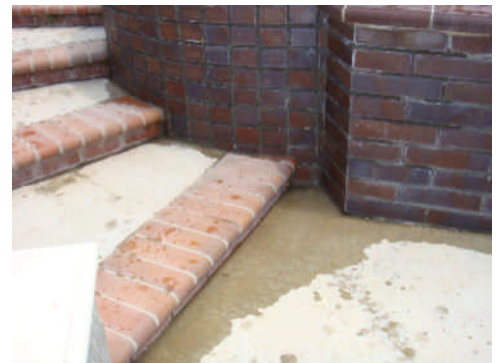
1608 DECKING The walkway decking is functional.
[SC] The leaking water is a potential slip hazard.

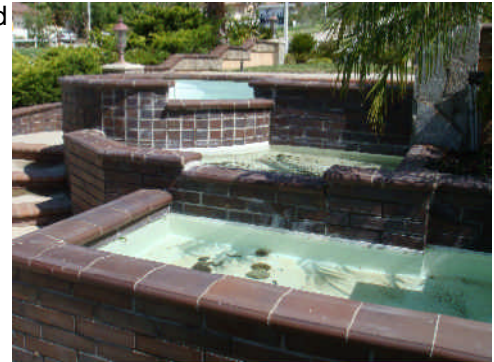
1618 HOUSING [CR] The fountain housing is deteriorating and leaking through the bricks.

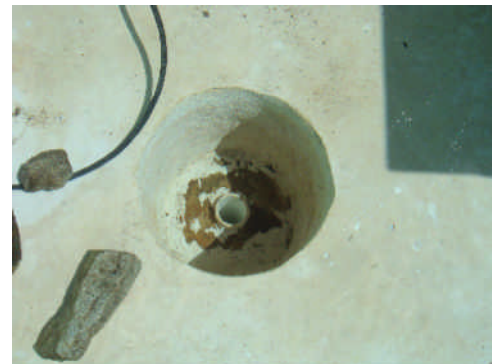
1619 VESSEL [CR] The coating is chipping off and worn.

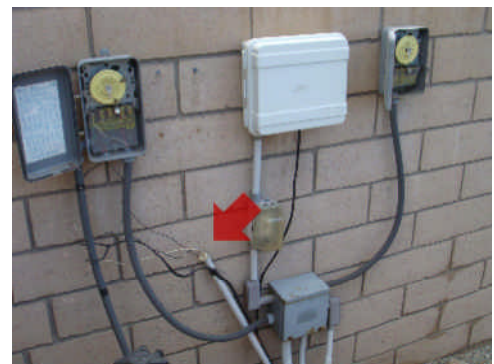
[FE] The fountain light appears to have been disconnected at the equipment.

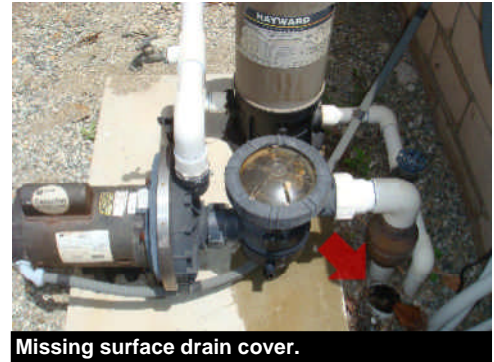
[FE] The pump/motor functioned. The pump appears to leak.

Missing surface drain cover.

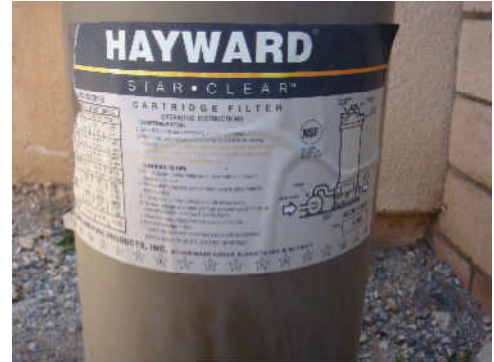
[CR] Leaks are evident at the cartridge filter body lid.

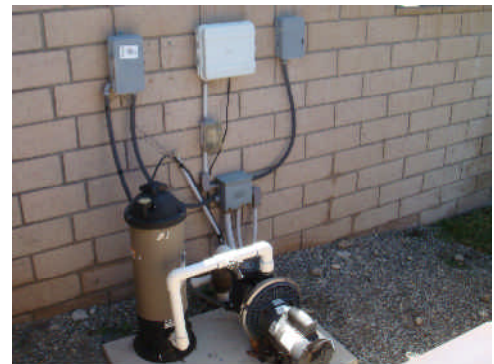
[FE] The power supply from the main electric panel should be evaluated for safety.
