Pre-purchase Home Inspection Photo Supplement

337 East Lincoln Avenue, Pomona, CA. 91767

Photo Supplement to the Itemized Building Inspection Report

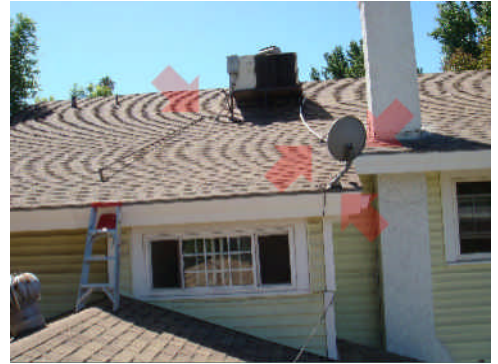
PHOTO # 1

[FE] At the rear of the roof is what appears to be an abandoned plumbing vent pipe.

[FE] [CR] Two satellite dishes are provided, one visible in the picture and another on the addition roof picture #2. The fasteners should be sealed.

[CR] Electrical conduit pipe is in contact with the roof improperly. The addition roof conduit is trapping debris and will cause damage to the shingles.

[CR] The A/C condensate drain line terminates improperly at the upper roof edge. Roof gutters should be installed to direct the condensate water to the driveway.

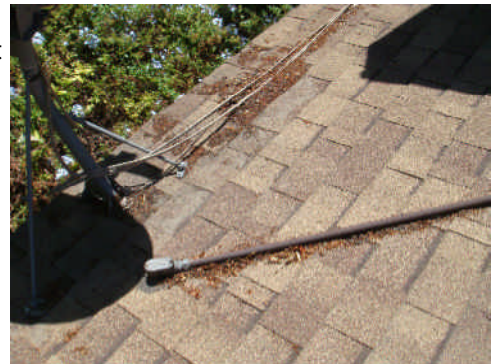
PHOTO # 2

Second picture of #1 the electrical conduit should be supported on painted wood blocks.

[CR] The low voltage wiring should not be laying on the roof trapping debris.

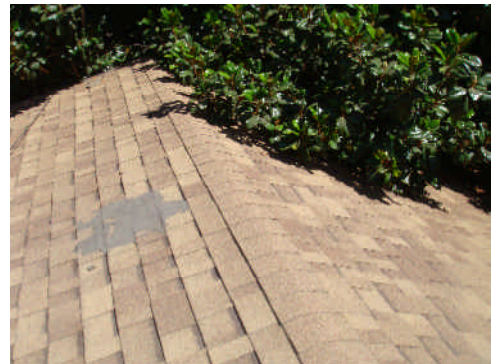
PHOTO # 3

The tree should be cut back from the addition roof.

[CR] Roofing shingles are damaged and missing from the tree branches.

[FE] Evidence of mastic /tar patching.

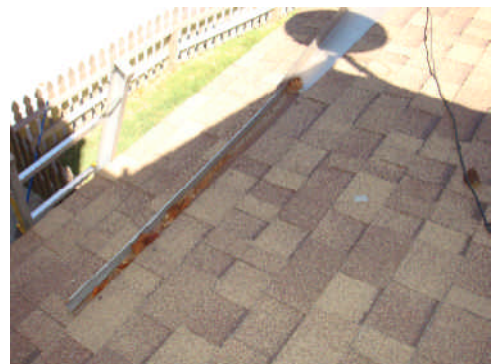
PHOTO # 4

[CR] The metal diverter over the left exit should be removed, and a gutter installed to prevent damage to the shingles.

Roof gutters are recommended to direct water runoff to the street.

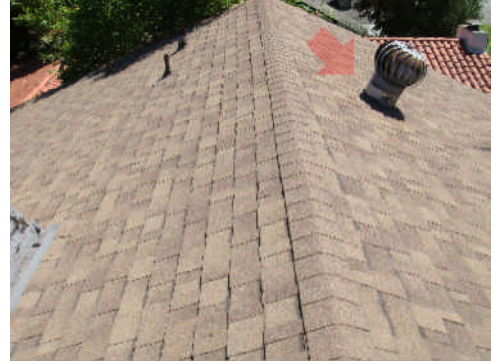
PHOTO # 5

Two attic vent turbines are provided, one over the the main house attic and one over the rear addition.

[CR] The turbines have been installed improperly, without proper flashing and fastening or leveling.

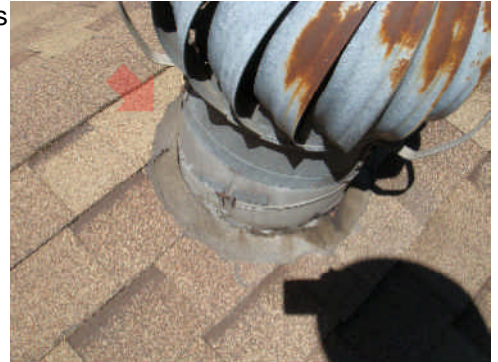
PHOTO # 6

[CR] The addition turbine mastic sealant is separated and the turbines are rusty.

The attic ventilation is minimal. I recommend installing eave vent openings and updated turbines, two over the rear addition and three over the original attic.

The turbines could be covered with heavy plastic trash bags during the winter to keep the heat in the building.

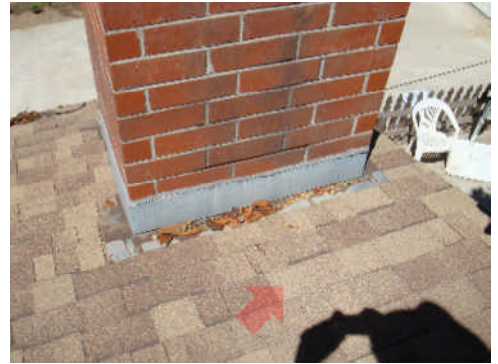
PHOTO # 7

[CR] The addition chimney is lacking a cricket to divert water around the base flashing properly.

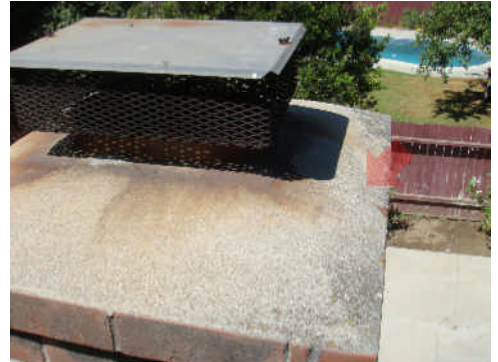
PHOTO # 8

[CR] The chimney cap has a small crack that should be sealed to prevent moisture intrusion.

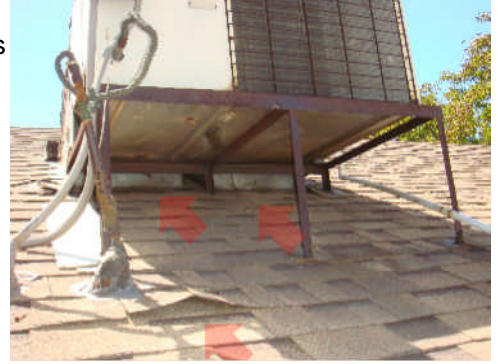
PHOTO # 9

[FE] [CR] The package heating and A/C unit flashing is lifted and evidence of leaks in the attic.

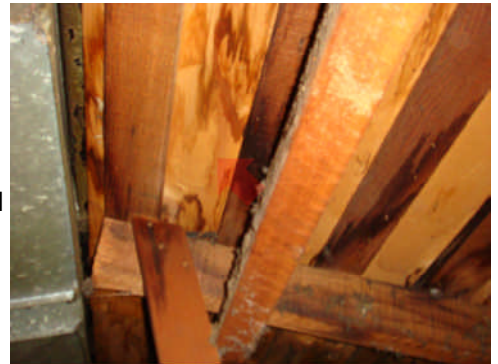
PHOTO # 10

[CR] Second picture of #9 of the moisture stained added plywood sheathing below the packaged unit.

The house original roof deck sheathing was spaced planks for the original wood shingles. Plywood sheathing was installed over the planks for the composition shingle roof.

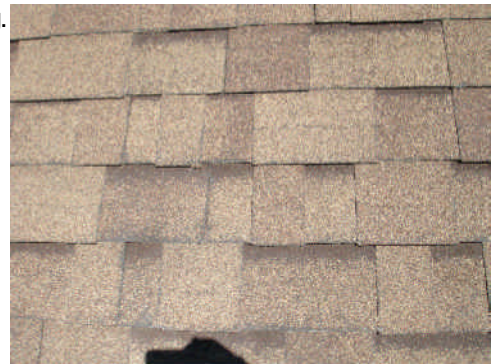
PHOTO # 11

The shingles are weathering and cracking. This picture is of the south facing shingles.

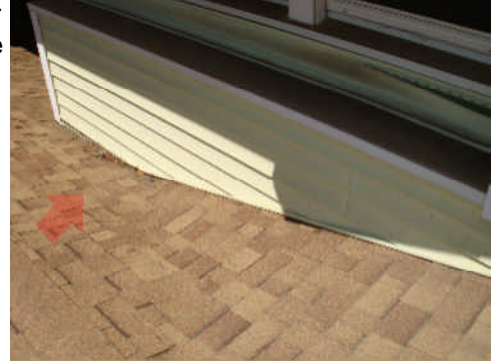
PHOTO # 13

[CR] The front lower roof is lacking proper valley flashing. Improper installation of the shingles at this location.

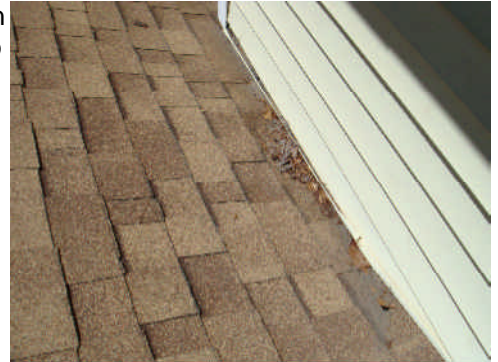
PHOTO # 14

[CR] Second picture of #13. This condition can result in moisture intrusion damage to the house.

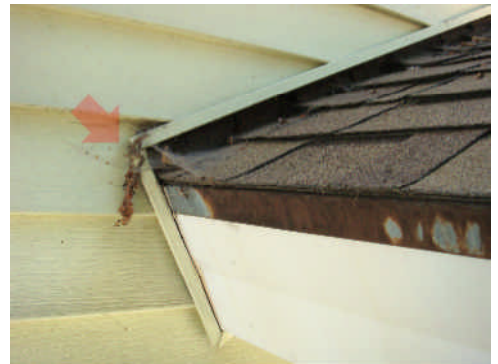
PHOTO # 15

[CR] Kick-out flashing is lacking at the carport to wall intersection, to direct water away from the wall siding.

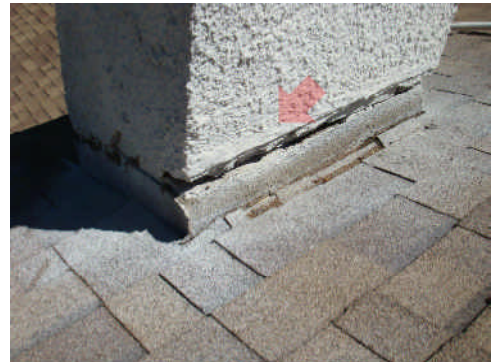
PHOTO # 16

[FE] [CR] The original chimney flashing appears to have been removed, leaving a gap between the brick course and broken bricks.

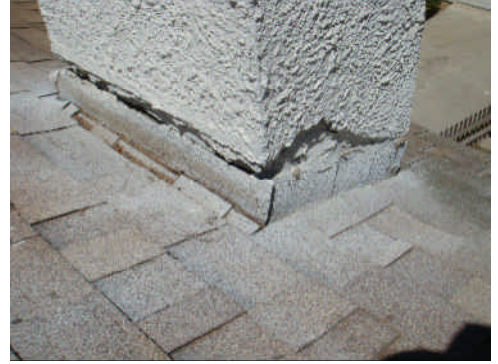
PHOTO # 17

Second picture of #16. Cricket flashing is recommended.

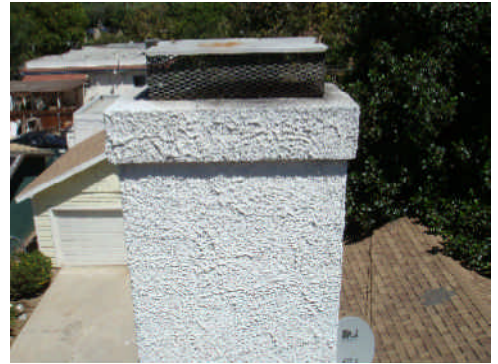
PHOTO # 19

[SC] [FE] The original chimney is not lined. I recommend a certified chimney inspector camera /scope the chimney.

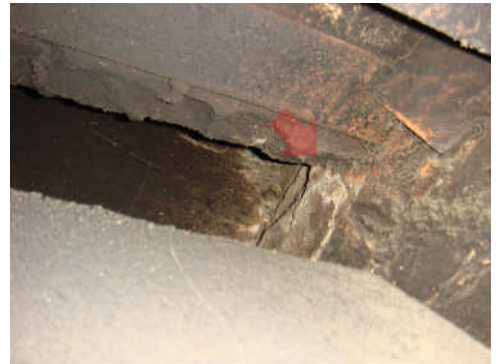
PHOTO # 20

[FE] Efflorescence from moisture is evident above the original fireplace firebox.

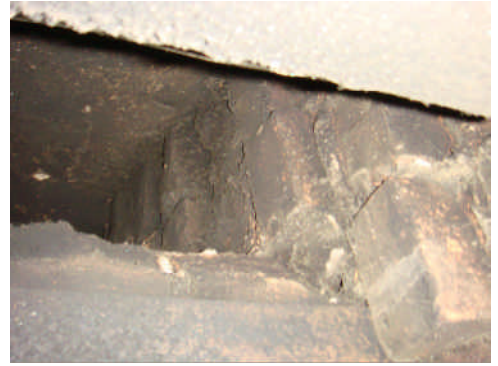
PHOTO # 21

[CR] Second picture of #20. The bricks are not parg coated above the firebox.

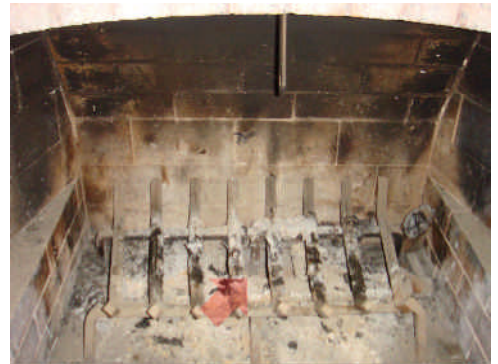
PHOTO # 22

[FE] The original fireplace firebox has been rebuilt.

[CR] The ash dump hearth cover is missing and the ash dump is full of ash.

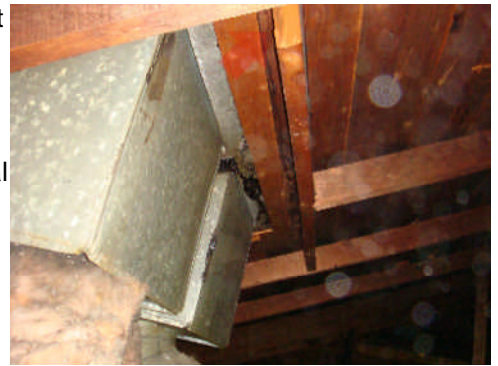
PHOTO # 23

[CR] One of the roof rafters have been cut off and not framed properly for the installation of the package heating and A/C unit.

This unit is an added load onto the original excessively wide spaced roof rafter framing.

[SC] This condition is a safety concern during seismic movement.

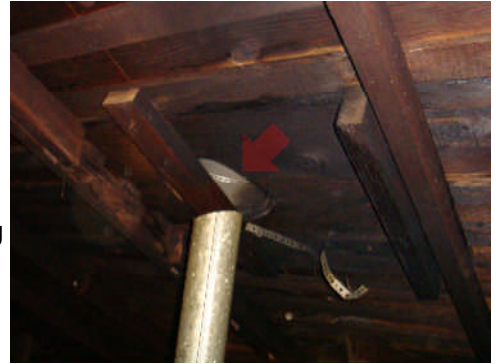
PHOTO # 26

Second picture of #25. The attic vent turbine is the opening in the roof.

[FE] [RU] The wide spaced roof rafter framing should be evaluated, and hardware /seismic improvements made.

The roof framing is supporting one roofing layer at this time. I recommend not installing an additional layer of roofing material onto this framing system. Remove the material before re-roofing.

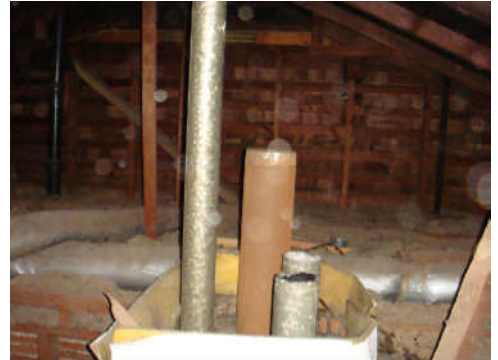
PHOTO # 27

[FE] [CR] View of 4 vents terminating into the attic, the function of two are unknown.

[SC] [CR] Two of the vents are gas vent flues for the water heater and furnace. This condition is a health and safety hazard!

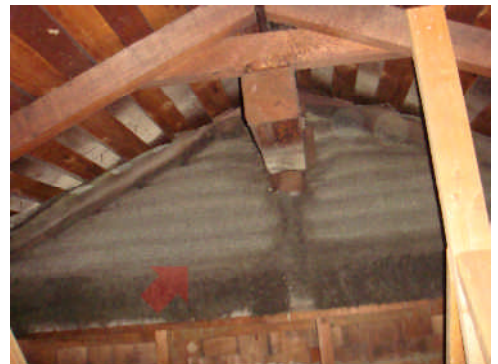
PHOTO # 28

[FE] [CR] The attic gable end vents are blocked with improper mesh.

The screen mesh should be 1/8" to 1/4" for proper ventilation.

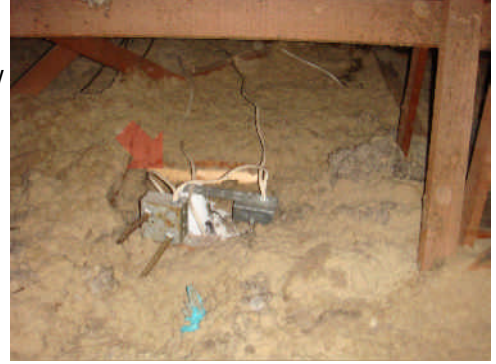
PHOTO # 29

[FE] The added recessed ceiling lights do not appear to be IC rated for insulation contact. Remove the bulbs and trim below to expose the fixture rating label.

Non IC rated fixtures are not energy efficient, recommend replacing with IC rated fixtures to place insulation around the fixtures.

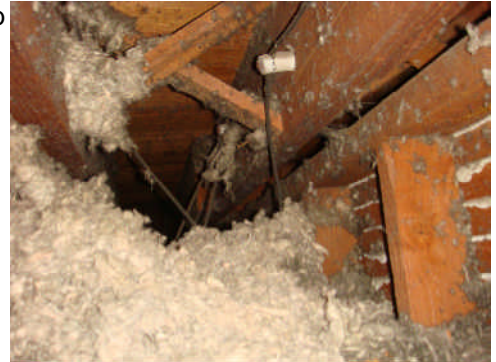
PHOTO # 30

[FE] [CR] The original cloth insulated knob & tube wiring is improperly in contact with the attic insulation and between the floor insulation at the rear first floor hallway.

The original wiring requires air space to discharge heat.

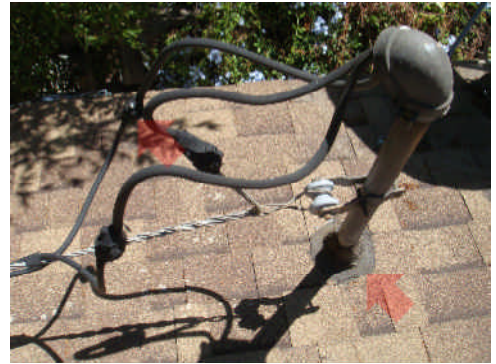
PHOTO # 31

[SC] [CR] The rear right power company electrical service drop conductors are improperly in contact with the tree and have improper clearance to the roof.

[SC] [CR] The wire connections are only taped up and wire end is exposed. Proper insulated connectors should be installed.

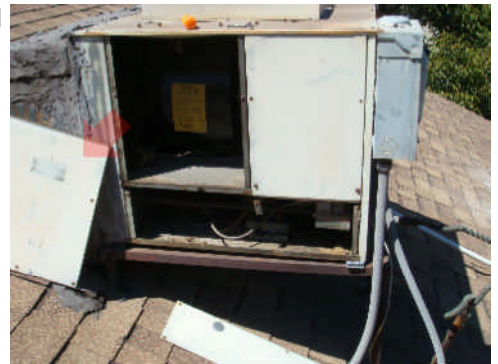
PHOTO # 43

[FE] [CR] [RU] The packaged furnace and A/C unit is at the end of its life expectancy, and did not operate.

[CR] The fan cover insulation board is soiled and loose.

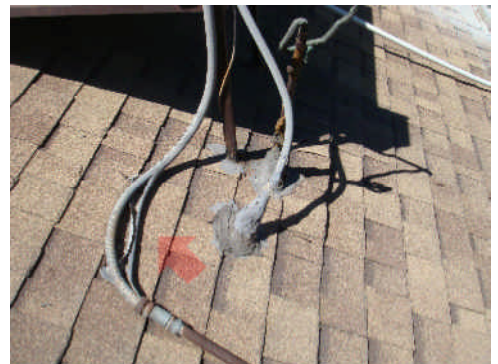
PHOTO # 44

[CR] [RU] The electrical power supply conduit is deteriorated and damaged.

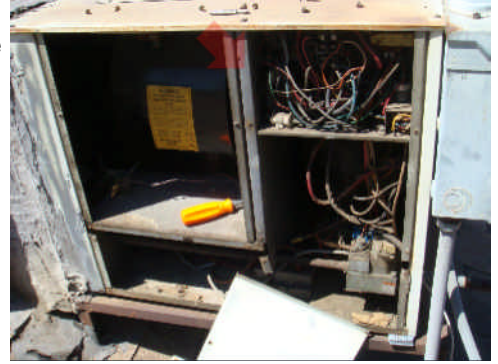
PHOTO # 45

[FE] [CR] A low voltage wire is scorched and damaged at the unit cabinet wall. The wire is lacking a bushing for protection.

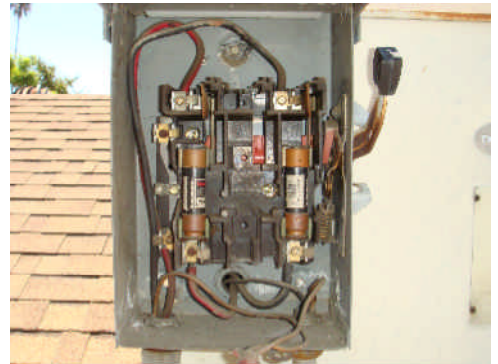
PHOTO # 46

[FE] [CR] The A/C disconnect box is not grounded /bonded.

[FE] The unit manufactures label is worn off, it is unknown what size fuses should be installed.

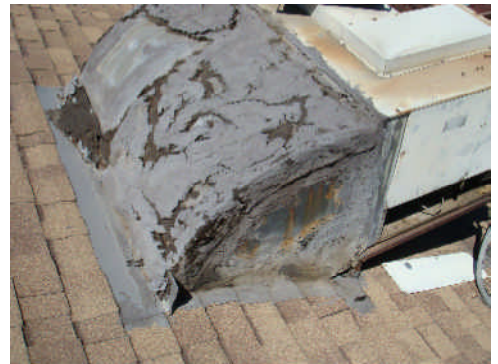
PHOTO # 47

[RU] The return air and supply air plenums are rusting.

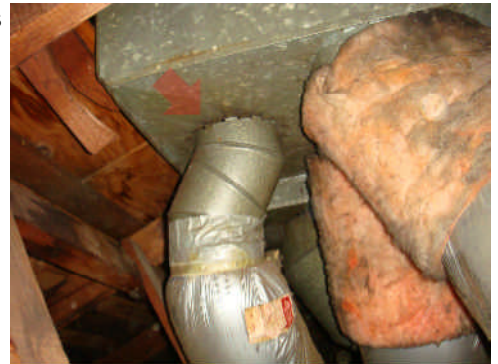
PHOTO # 50

[CR] [RU] Second picture of #49, air leaks evident, the duct connections are not sealed with mastic sealant.

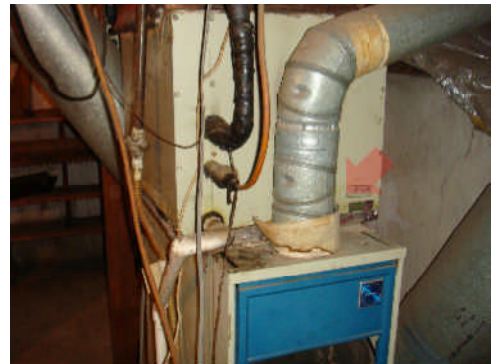
PHOTO # 51

[FE] [CR] The basement furnace vent connector is improper and has suspect asbestos tape.

[FE] [RU] This furnace is at the end of its life expectancy, and the burner is soiled with suspected soot flakes.

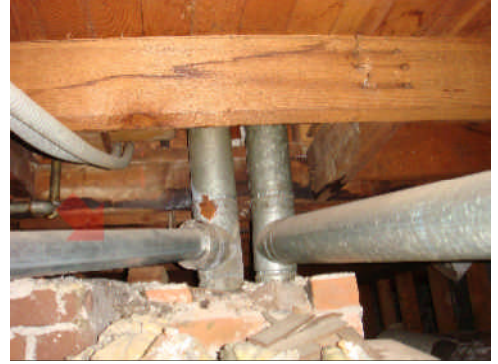
PHOTO # 57

[CR] The water heater vent connector is a single wall connector and should be a double wall B-Vent connector. Corrosion is evident at the flue.

[FE] The flues are on top of the abandoned /removed masonry chimney. The brick masonry chimney would have extended up through the house walls and terminate above the roof.

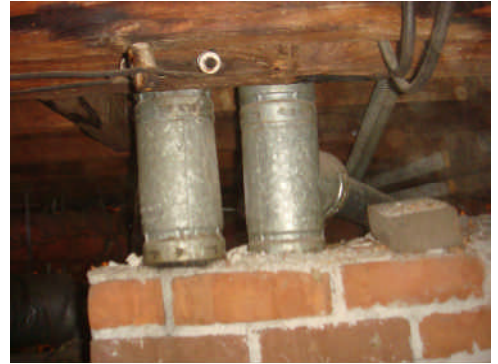
PHOTO # 58

[SC] [FE] Second picture of #57, the flues support and installation should be evaluated for fire life and safety.

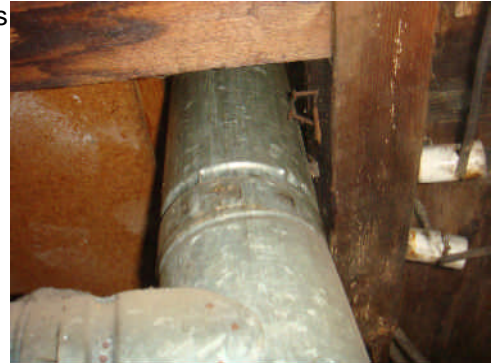
PHOTO # 59

[SC] [CR] Third picture of #57, the flue has improper clearance from wood framing.

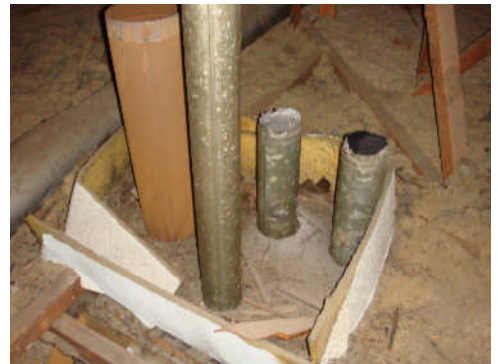
PHOTO # 60

[SC] [CR] Fourth picture of #57, termination point of the two gas flues in the attic. This condition is a health and safety hazard.

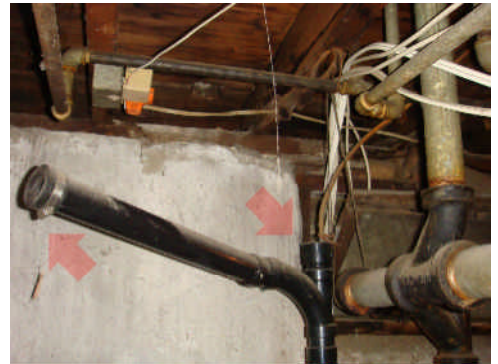
PHOTO # 62

[SC] [CR] The basement A/C cooling coil condensate pump drain hose is improperly terminating into an open plumbing drain pipe.

[SC] [CR] A plumbing drain pipe is improperly open.

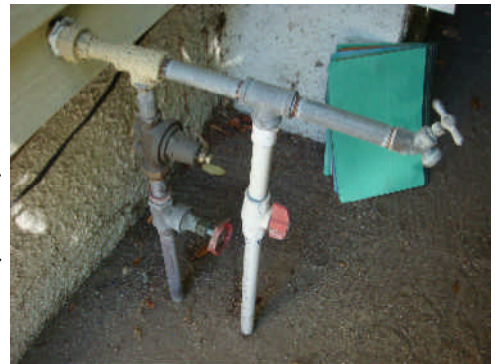
PHOTO # 63

The main water supply pipe appears to have been replaced with 1" copper pipe visible at this location.

[CR] [RU] The main shutoff valve is stuck in place. Recommend replacing with a 1/4 turn ball valve.

[RU] Install a pressure relief valve at one faucet and anti-siphon valves at all faucets /hose bibs.

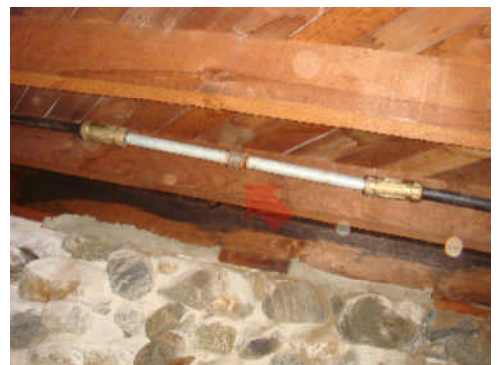
PHOTO # 64

[FE] [CR] The main water supply pipe in the craw space is connected with compression fittings, and the coupling appears to have a slight leak.

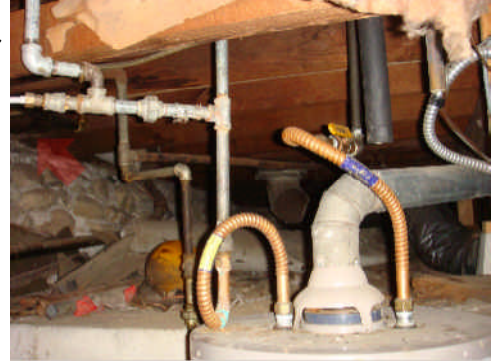
PHOTO # 65

[CR] The kitchen dishwasher water is supplied with plastic tubing from the water heater hot supply line. A shutoff valve is not provided.

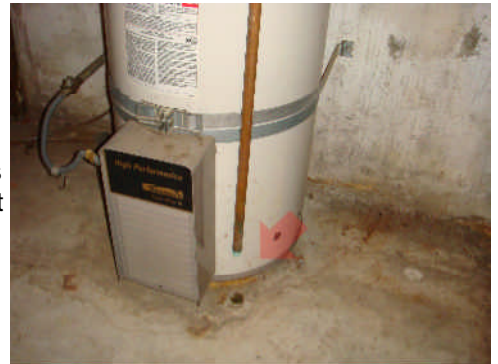
PHOTO # 66

[RU] In place of the leaking water heater TPR valve and discharge pipe as shown in the picture, install a watts valve that connects to the tank gas control.

A pressure relief valve is required to be installed outside on a hose bib with a watts valve.

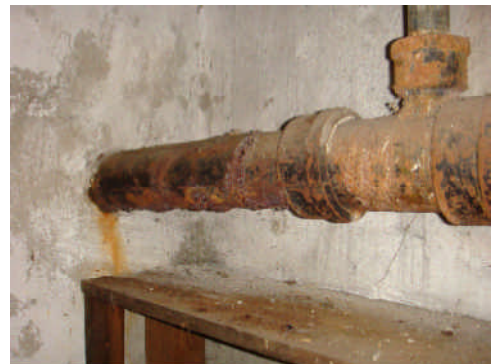
PHOTO # 67

[RU] [CR] The main cast iron drain pipe and other pipes are rusted and at the end of life.

[FE] Recommend a specialist camera / scope the main drain line to the city sewer.

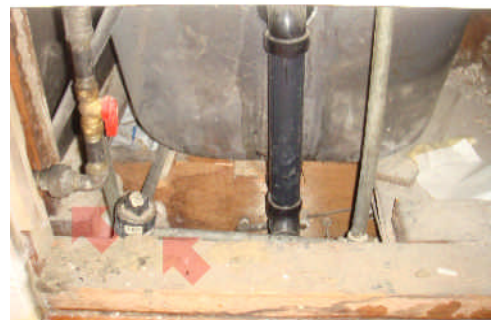
PHOTO # 68

[SC] [CR] A gas union connector is improperly installed adjacent to the bathtub, and in the craw space. Unions can separate during seismic movement.

[FE] The tub drain has a capped pipe, the venting should be evaluated.

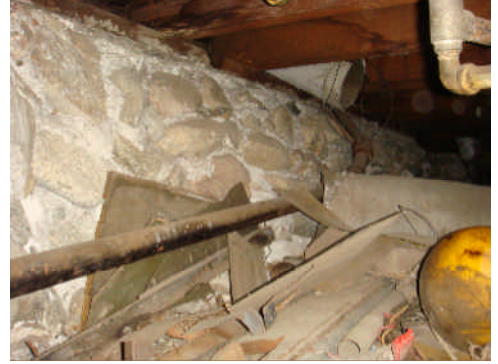
PHOTO # 69

The debris in the craw space should be removed for proper access and evaluation.

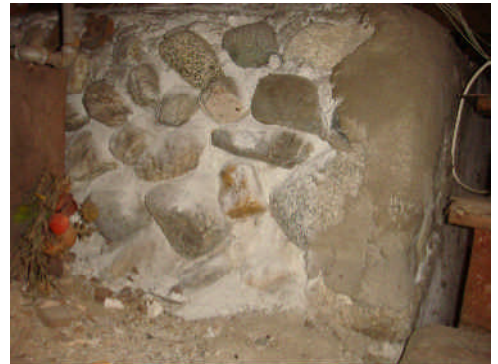
PHOTO # 70

[FE] [CR] The stone un-reinforced masonry foundation mortar is deteriorating.

[RU] This house is lacking today's hardware and bolting for seismic movement.

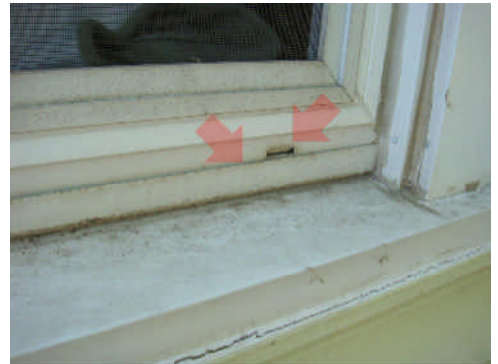
PHOTO # 86

[FE] [CR] The window drain holes are above the siding trim improperly.

[CR] The double hung window sash springs are defected and not holding the windows up.

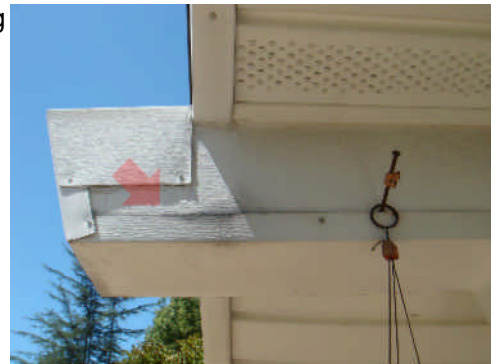
PHOTO # 87

[FE] [CR] Irregular installation of the siding trim, improper reversed overlapping.
