Pre-purchase Manufactured Home Inspection Report

Sample of a 10 year old 2754 square foot Manufactured home with detached garage/office & shed.

Steve Garcia Inspections

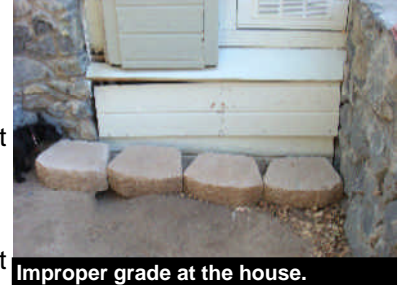
[CR] The grading at areas around the house, storage building, garage and office is not adequately sloped away from the perimeter foundation. It is important that surface grade be sloped away from the perimeter foundation to prevent moisture accumulation next to the buildings, which may infiltrate below the building effecting the structural integrity of the buildings support systems.

[CR] The grading at areas of the house, office building and storage building has inadequate slope away from or negative slope towards the buildings. The grade slope should fall away from the buildings to prevent moisture accumulation at the foundation / underside.

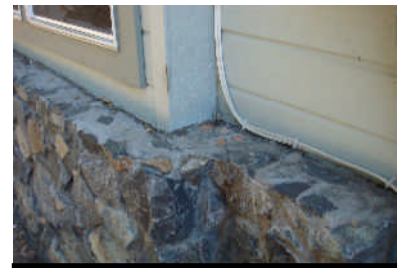
[CR] The stone veneer has been installed improperly up onto the siding, and is improperly secured. This condition is contusive to the siding becoming moisture damage.

Stone covering the siding improperly.

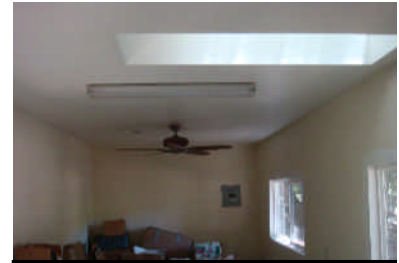
[CR] The office floor is uneven due to improper floor and wall support system.

View in the office.

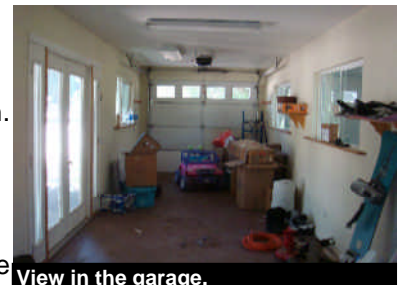
[SC] The auto-reverse safety system failed to function. The door did not reverse when it hit an object in its path while closing. Adjustment should be made to the auto-reverse sensitivity force-setting for safety.

[SC] The secondary safety system (electric eyes) were mounted higher than the manufacturers recommendation of 4" to 6" above the slab.

View in the garage.

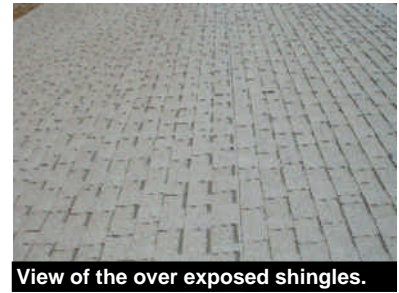
View of the over exposed shingles.

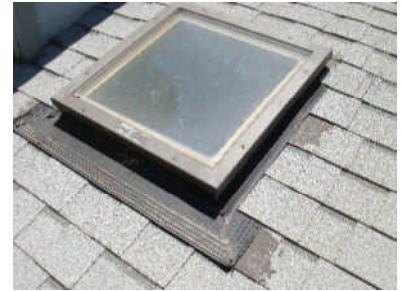
524 COMMENTS Step flashings are lacking at the skylights.

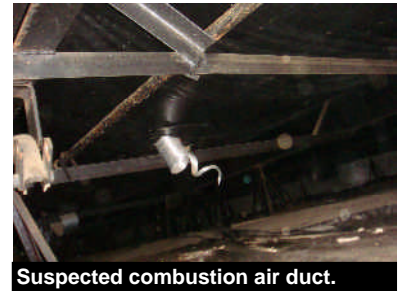
710 COMMENTS A duct is present below the building. The duct may be a combustion air duct for the fireplace.

Suspected combustion air duct.

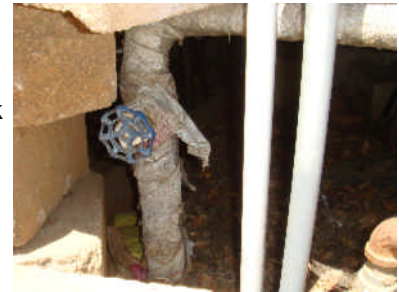
[FE] Older /original main water shutoff valves is stuck in place.

I recommend updating the gate valve with a 1/4 turn ball valve.

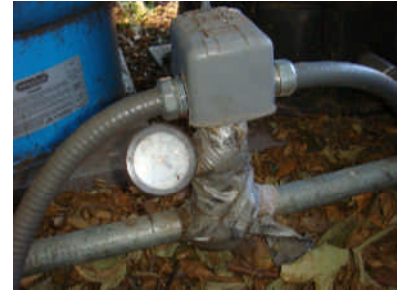
[FE] The control appears to be insulated /tapped up.

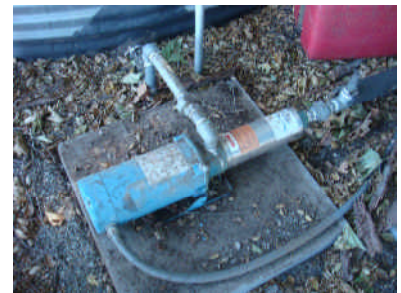
[FE] I recommend the water supply pumps and installation be evaluated.

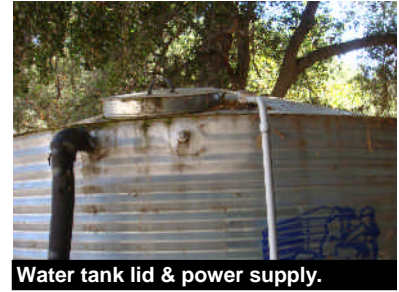
[FE] The large water tank installation and power supply should be evaluated.

Water tank lid & power supply.

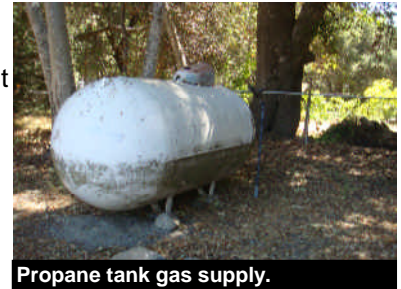
[FE] Propane tank is located away from the building. The tank appears to be an older tank, and should be evaluated. The shutoff valve on top of the tank was not tested.

[SC] The tank is leaning, lacking proper support footings, and is not bolted down for seismic safety.

Propane tank gas supply.

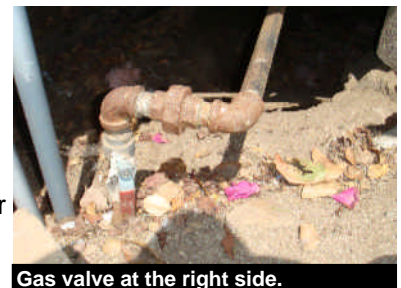
[CR] The valve has improper clearance from the soil.

Gas valve at the right side.

The gas pipe connector /union should be evaluated for leaks after seismic activity.

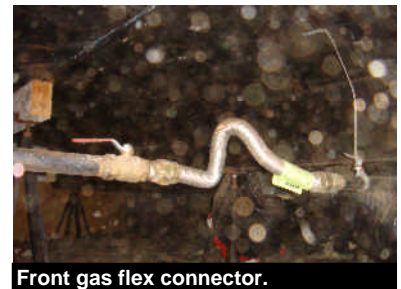
Front gas flex connector.

I recommend the gas flex connectors be evaluated every year for leaks.

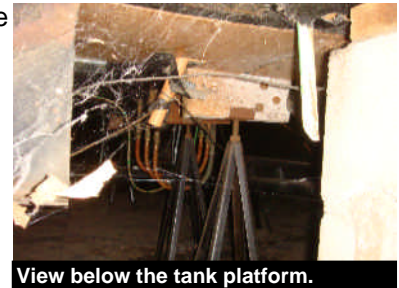
The tank is approaching /at the end of its life expectancy.

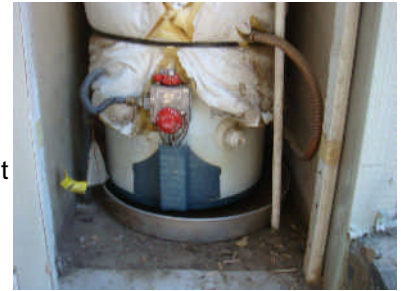
[CR] The temperature & pressure relief valve discharge line is routed in a plastic material that is not rated for this application, and terminates below the building.

I recommend installing an approved discharge line that extends to the exterior and terminates close to the ground facing downward.

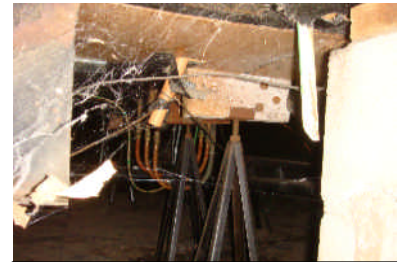
[CR] The drip pan drain line under the water heater platform terminates improperly below the building.

Drain pan & TPRV discharge line.

The drain line should be extended to the exterior.

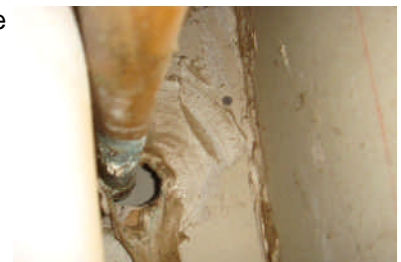
[CR] The wall at the back side is not sealed around the pipe as required.

Seal open interior wall.

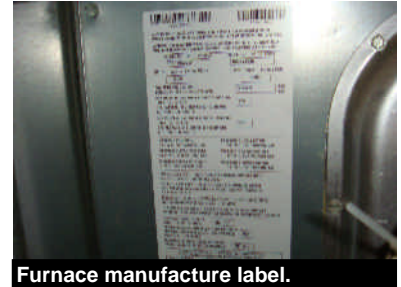
[FE] The furnace label is labeled natural gas.

Furnace manufacture label.

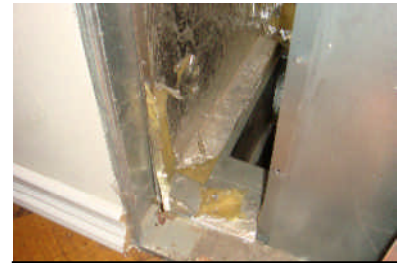
There is no filter installed on the front of the furnace cover. A filter should be installed.

Damaged & soiled return & insulation.

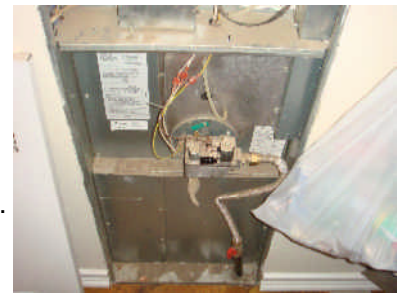
[SC] The supply air plenum is soiled with rodent debris, and the insulation is damaged.

This condition is a health concern. The air supply plenum should be cleaned and the insulation replaced.

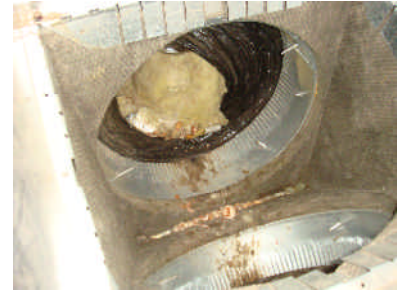
[SC] The supply air plenum is soiled with rodent debris. This condition is a health concern.

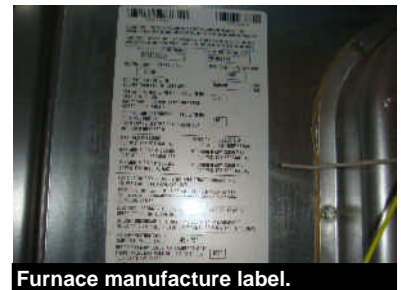
[FE] The furnace label is labeled natural gas.

Furnace manufacture label.

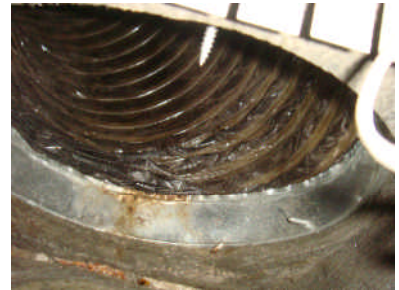
[SC] The supply air plenum is soiled with rodent debris. This condition is a health concern.

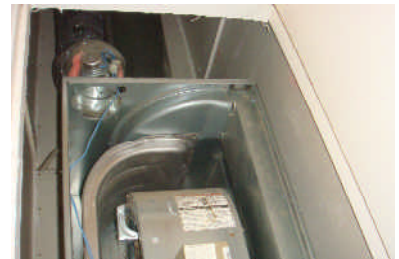
[CR] The pantry return air duct is missing a filter.

Fresh air ducts at the top of the furnac

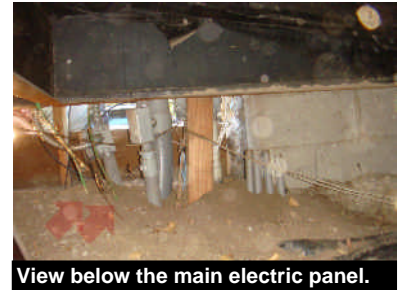
[FE] The rod is not visible.

View below the main electric panel.

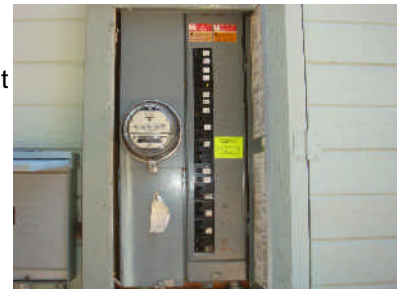
[CR] A number of the circuit breakers are not labeled or labeled properly. The circuit breakers should be accurately labeled to allow individual circuits to be shut off for maintenance or emergency needs.

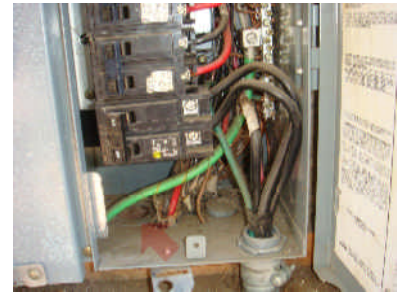
[CR] A knock-out is open at the bottom of the box.

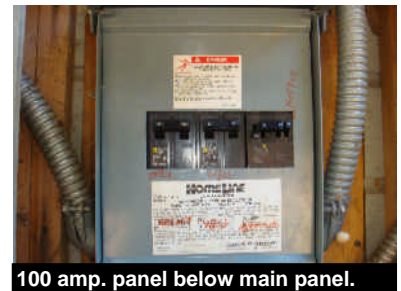
1212 LOCATION 100 amp. panel below the main panel.

50 amp. panel to the left of the main panel.

100 amp. panel below main panel.

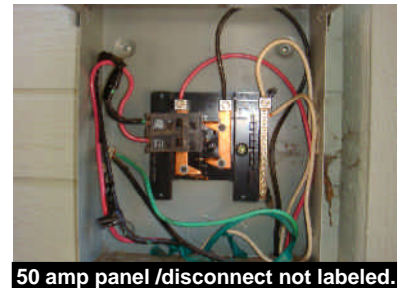
The 50 amp. panel has 1, 220 volt disconnect only.

The 100 amp panel is the feeder to the 50 amp panel.

50 amp panel /disconnect not labeled.

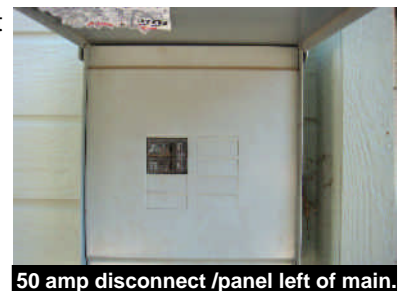
[CR] A number of breakers are not properly labeled at the panels. The circuit breakers should be accurately labeled to allow individual circuits to be shut off for maintenance or emergency needs.

50 amp disconnect /panel left of main.

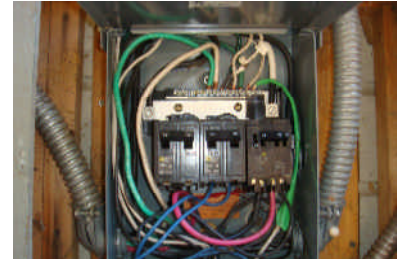
[CR] The 100 amp panel feeders wires are off a 40 amp. disconnect, that are feeding the 50 amp panel disconnect, and the wire color coding is improper.

[SC] The neutral wires and the grounding wires are connected to the same terminal bar in the 100 amp panel. This is an improper wiring arrangement in a sub panel.

100 amp panel feeding 50 amp discon

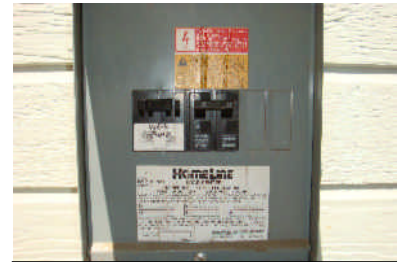
1212 LOCATION Right exterior of the building.
Storage shed.

Panel at the right side of the building.

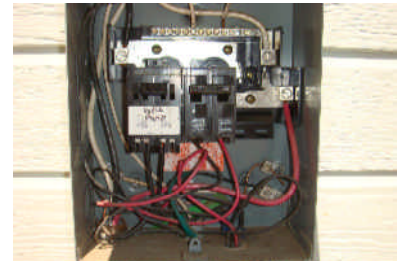
[FE] The 50 amp. panel has 2, 220 volt circuit breakers, only one labeled well.

[FE] The 20 amp. panel has 2, 110 volt circuit breakers.

Panel at the right side of the building.

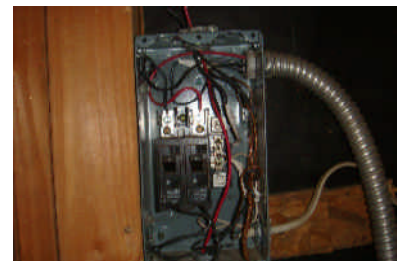
[SC] The wiring within the 20 amp. panel is improper and a safety concern.

[CR] The circuit breakers are not labeled. The breakers should be accurately labeled to allow individual circuits to be shut off for maintenance or emergency needs.

Shed sub panel improper wiring.

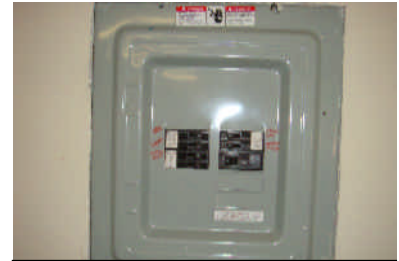
1212 LOCATION One panel is located in the office, and one panel is at the exterior of the garage.

The office panel cover lacking screws

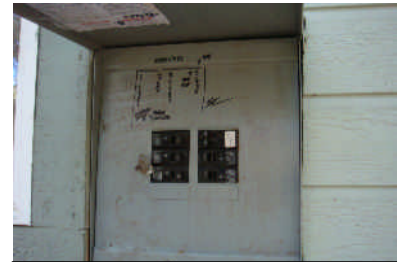
The main panel and sup panels are not labeled properly.

The garage panel cover missing screw

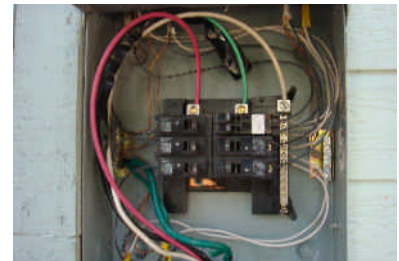
[CR] The circuit breakers are not labeled properly. The breakers should be accurately labeled to allow individual circuits to be shut off for maintenance or emergency needs.

View of the garage sub panel.

[CR] There are more than six breakers in the panels with no main breaker /disconnect. A main disconnect breaker is required. This condition requires more than one throw of the hand to disconnect the power.

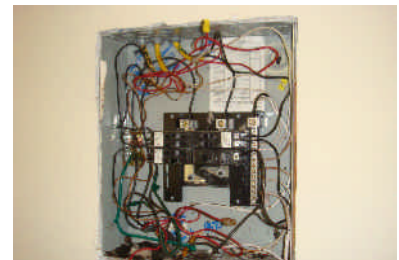
[SC] The office panel has abandoned live wires not connected to circuit breakers.

[FE] The office panel has what appears to be rodent debris at the bottom of the box.

View of the office panel live wire ends

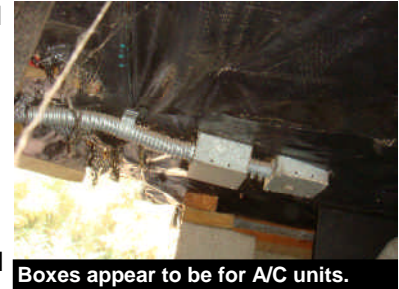
[CR] The shed wiring is exposed and has been improperly installed.

[CR] Cover plates are missing in the office.

[FE] The water supply pump wiring and fittings should be evaluated.

Boxes appear to be for A/C units.

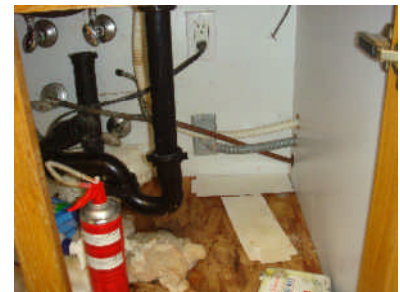
[CR] There is moisture damage in the cabinet below the sink.

[FE] A musty moldy smell is evident below the sink and adjacent to the dishwasher.

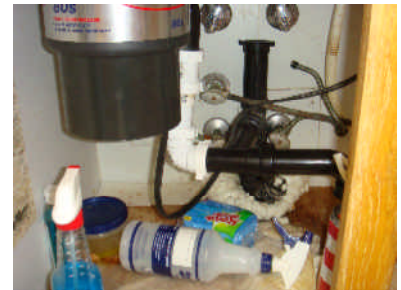
[CR] The kitchen sink drain is leaking, has improper drain pipe installation, and the air admittance valve is missing.

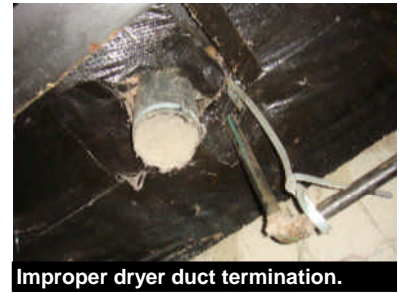
1320 DRYER VENT SYSTEM

[CR] The vent duct terminates in the craw space improperly. The duct should be extended to the exterior to prevent moisture from entering the craw space, and this condition is a potential fire safety hazard.

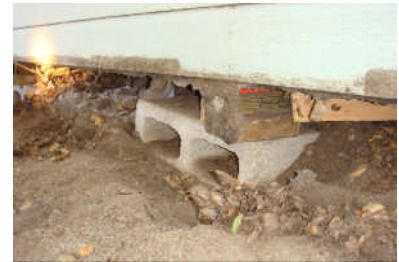
PHOTO # 1 [CR] The office is lacking a perimeter foundation and floor support system.

Improper office building support.

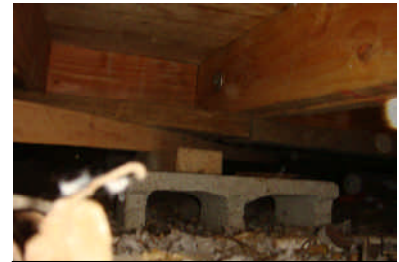
PHOTO # 2 [CR] Footings and concrete piers are lacking.

Underside office floor improper support.

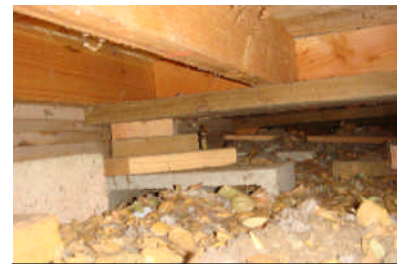
PHOTO # 3 [CR] Center support girder is lacking.

Improper office floor support.

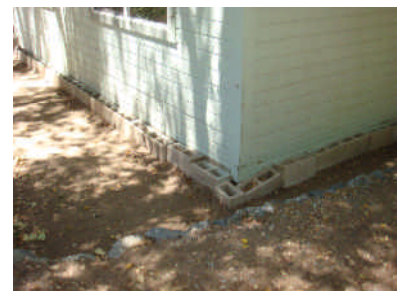
PHOTO # 4 The office perimeter has blocks and siding to prevent rodents from entering.

Evidence of rodents were visible.

[CR] The building gable end vent is lacking a screen to prevent rodent access.
