# *Pre-purchase Home Inspection Report*

Exclusively for: Good client

33 year old 1,530 square foot attached house

***Steve Garcia Inspections***

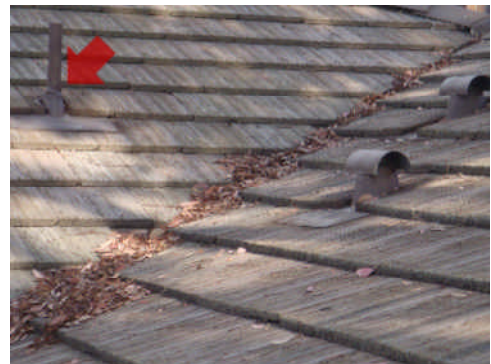
**520 PENETRATIONS**

The visible roof penetrations appeared functional. Maintain the mastic /tar around the pipes and jack flashings.

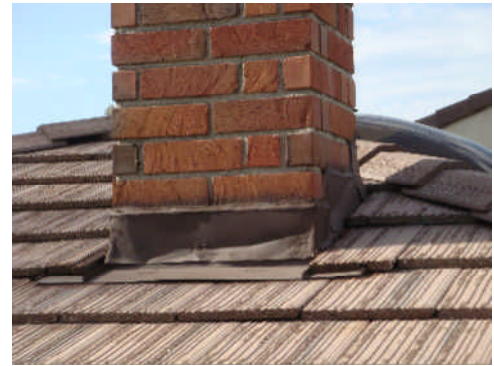
**521 GAS FLUE PIPE(S)**

The visible gas exhaust flue pipes and weather caps appeared functional, with exceptions.

[CR] The gas flue pipes are lacking storm collars.

**522 COMMENTS** Maintain the caulking /sealant at the chimney flashing.

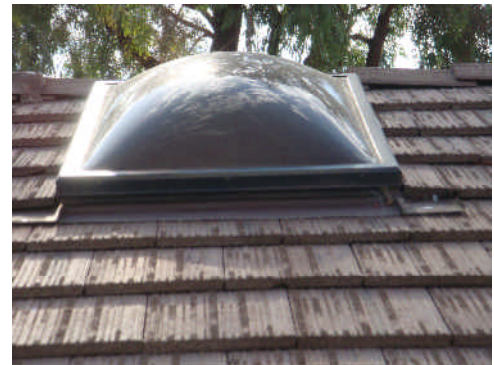
**SKYLIGHT(S)**

The visible skylight appeared functional. No evidence of leakage.

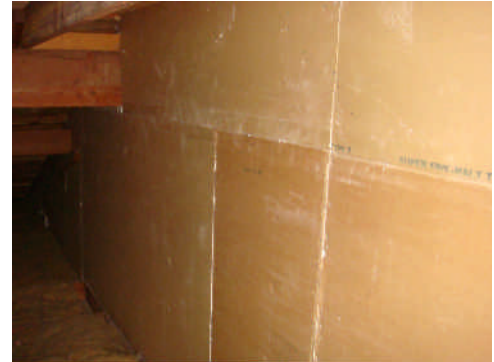
[SC] The neighbors joining wall board is not taped for fire separation, and has gaps and voids.

The board is stamped SUPER FIRE-HALT TYPE X.

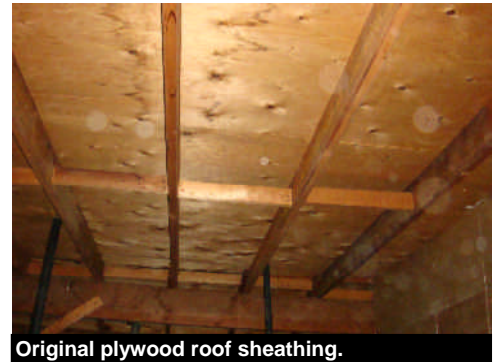
Original plywood roof sheathing.

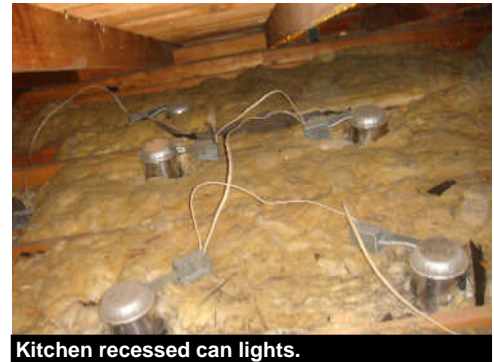
**619 COMMENTS** The kitchen recessed can lights appear to be IC rated for insulation contact.

Kitchen recessed can lights.

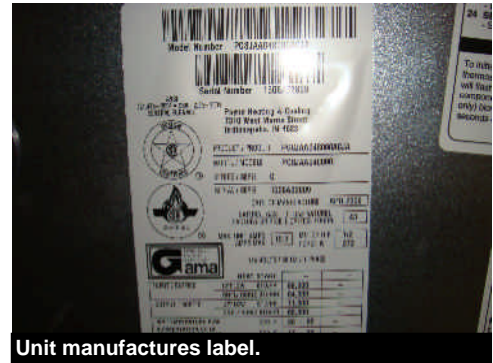
4 year old 88,000 btu. forced air natural gas fired furnace.

Unit manufactures label.

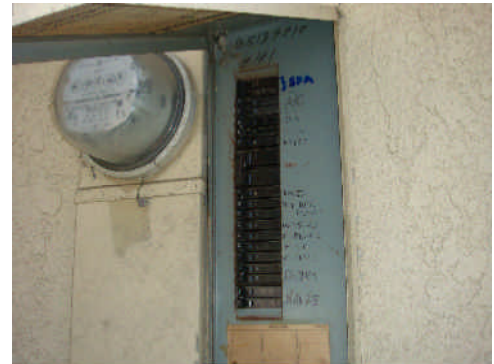
**1210 MAIN PANEL**

The circuit breakers in the panel are labeled. The accuracy of the labeling is not verified.

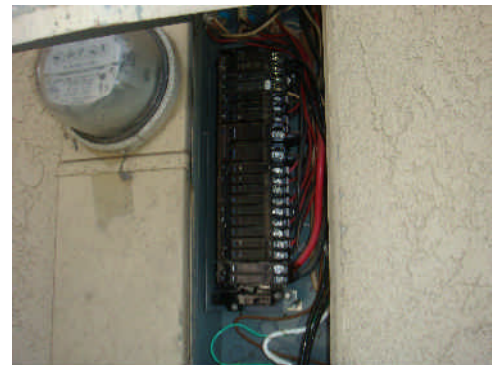
**1211 WORKMANSHIP**

The wiring within the panel appeared functional.
