Pre-purchase Condo *Inspection Report*

Sample of a 33 year old 1900 square foot Condo.

Steve Garcia Inspections

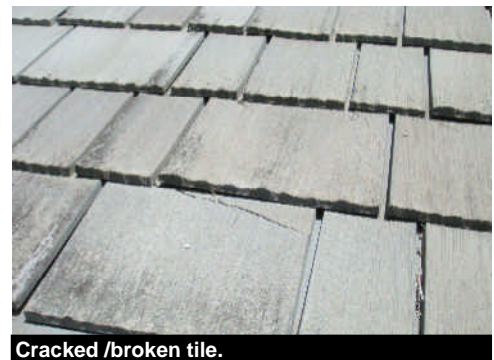
[FE] The composite tile roof was not walked on, but was inspected on a ladder from the accessible eaves. This precaution was taken to prevent damage the roof tiles.

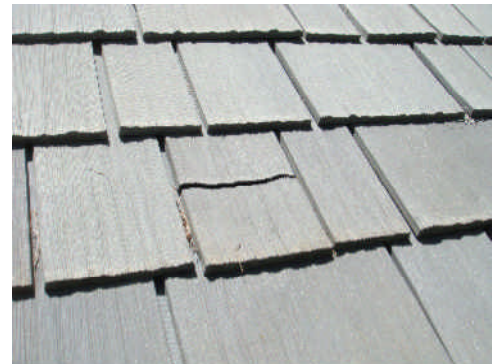
[CR] There are a number of cracked and broken tiles on the roof. These conditions are conducive to roof leaks.

Moisture stains are evident on the living room ceiling.

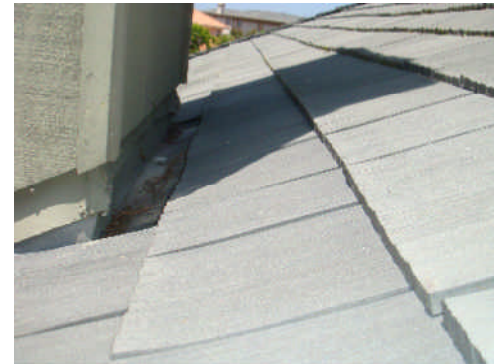
Back side chimney flashing not evaluated.

519 INSPECTOR RECOMMENDS Remove debris from flashing at the chimney.

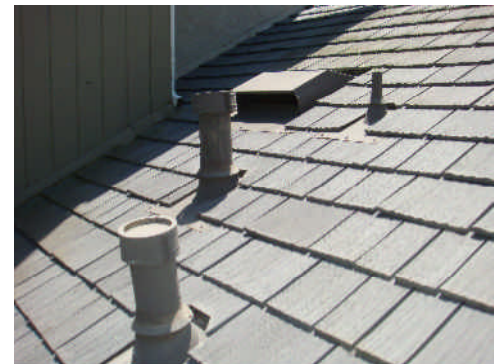
520 PENETRATIONS The visible roof penetrations appeared functional. Maintain the mastic /tar around the pipes and jack flashings.

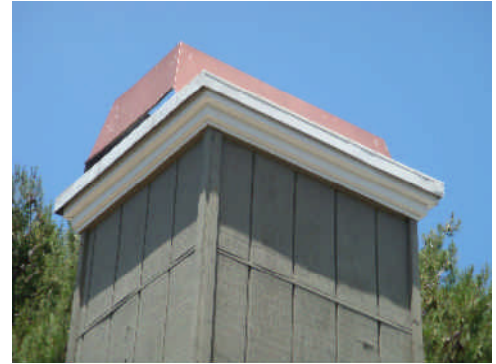
[FE] Not visible. The chimney top /termination point was not inspected or visible. The roof was not accessed for inspection.

713 COMMENTS [FE] I recommend an inspection by a qualified fireplace specialist. My inspection of the chimney flue is limited to the readily visible portion from the firebox only. The inner reaches of a flue are inaccessible. A qualified fireplace specialist will remove the flue and chase cap, use a specialized video camera as needed to evaluate the flue.

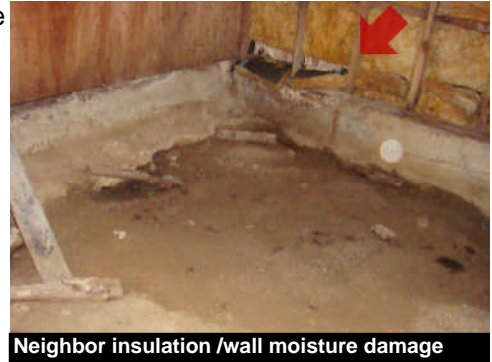
821 COMMENTS [CR] Neighbors insulation and wall is moisture damaged.

I could not ignore the moisture conditions that are very visible.

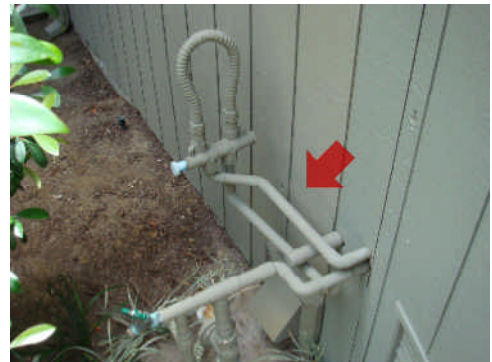
[FE] The main water supply line has been reduced to 3/4" for a water softener. The softener has been removed.

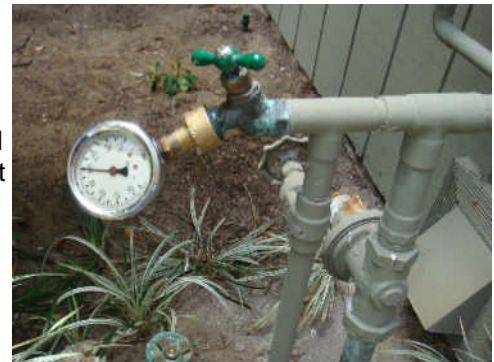
[RU] There are no anti-siphon backflow preventers on the exterior hose faucets /bibs. I recommend installing these devices to prevent water in the hose from entering the building water supply.

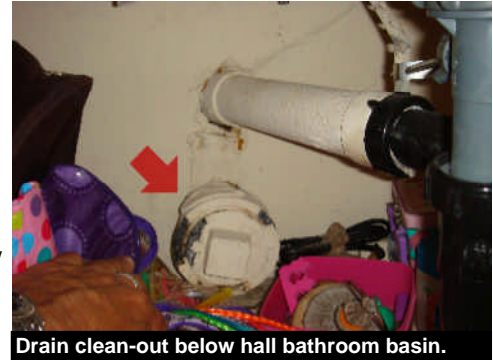
[FE] The fixture drain pipes /waste pipes operated and drained when tested, no blockage or slow drains were evident. Drain and sewer lines have been known to block at any time whether new construction or older properties. I recommend having a video camera inspection be performed on the drain / waste and sewer piping system prior to close of this transaction.

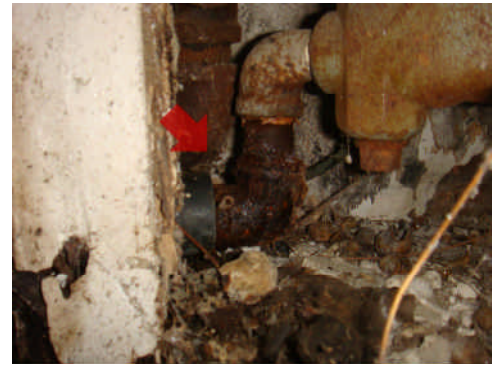
[CR] The main gas supply pipe is corroded / rusted in the gas meter cabinet due to poor landscaping /drainage.

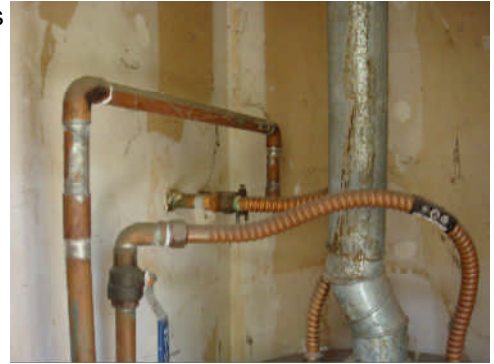
The shutoff valve and water supply connectors were functional. Valves are not operated. I recommend insulating the exposed water piping to minimize heat loss.

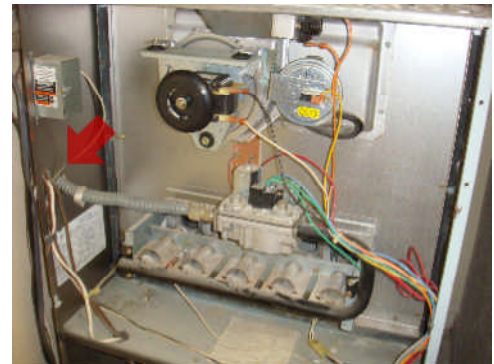
[CR] The furnace gas flex connector is not hard piped through the furnace housing.

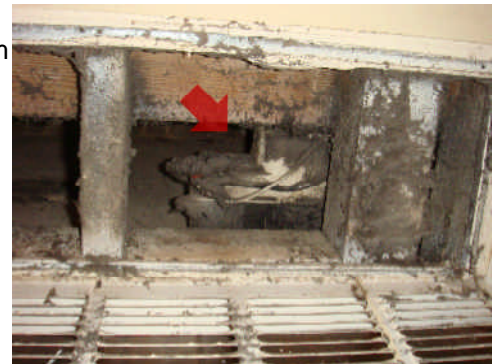
[FE] The pump is soiled and should be cleaned and tested. It is unknown if the pump could be removed for cleaning.

[FE] The termination point of the condensate drain line was not located.

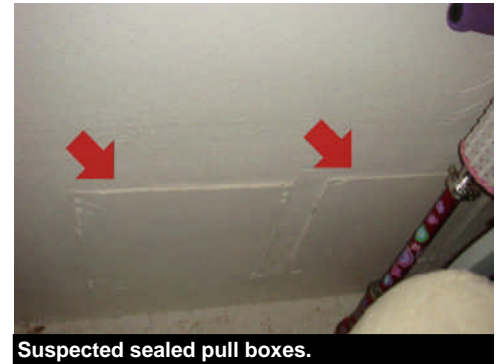
1207 COMMENTS [FE] Feeder pull boxes appear to be in the garage right side wall. The box covers were not removed /inspected.

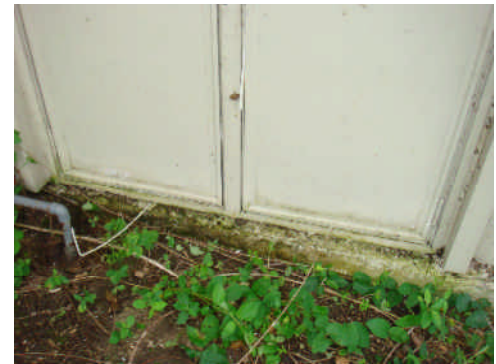
[CR] The cabinet doors do not latch, and the weather stripping is damaged.

[FE] The landscape sprinklers should be evaluated for excessive watering /spray pattern.

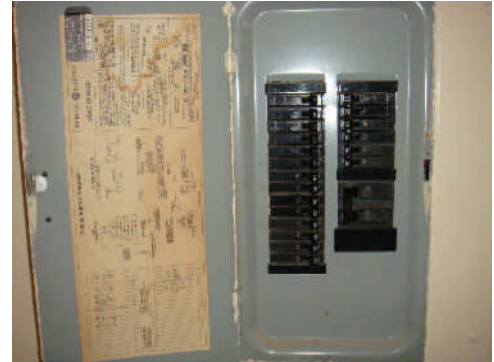
[FE] The circuit breakers in the panel are labeled, with the exception of the A/C breaker. The accuracy of the labeling is not verified.

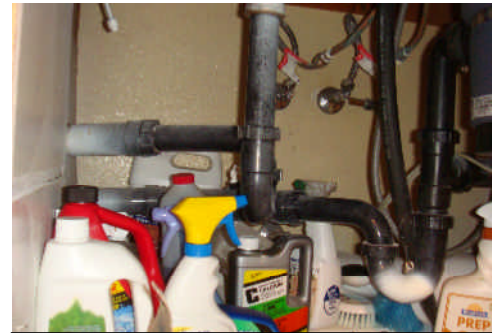
View below the sink.

[CR] The faucet hand sprayer is defective / missing part.
