Pre-purchase Home Inspection Report

Exclusively for: Good Client

Sample of a 45 year old 1,600 square foot house

Steve Garcia Inspections

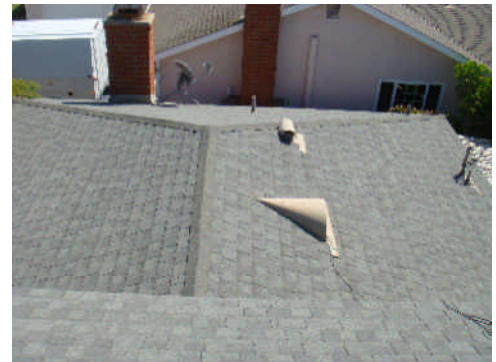
504 INSPECTOR NOTES

[CR] The ridge course shingles are over-exposed with exposed fasteners. This is an improper installation at the upper ridge.

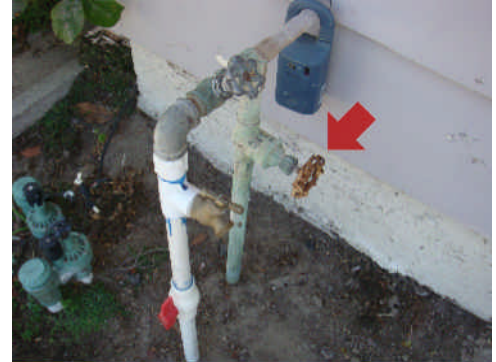
[CR] The older valve is not operational, could not turn.

[RU] I recommend replacing the main water supply valve with a 1/4 turn ball valve.

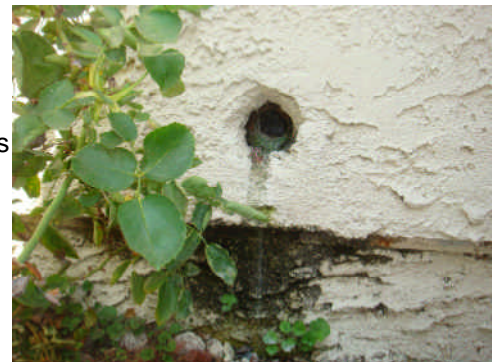
[SC] Leaking drain water and open clean-out is a health and safety concern.

[FE] The fixture drain pipes /waste pipes operated and drained when tested, no blockage or slow drains were evident. Drain and sewer lines have been known to block at any time whether new construction or older properties. I recommend having a video camera inspection be performed on the drain / waste and sewer piping system prior to close of this transaction.
