Pre-purchase Home Inspection Report

Sample report of 9 year old 4,000 square house

Steve Garcia Inspections

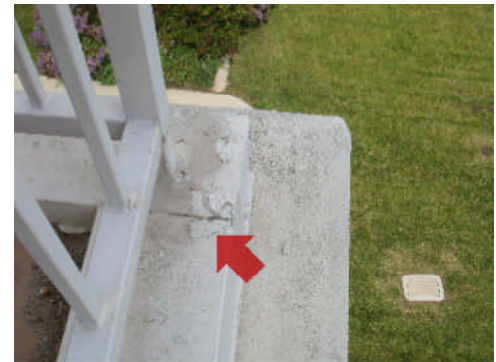
308 COMMENTS [CR] The balcony metal cap flashing paint is chipping off and the seams are not sealed.

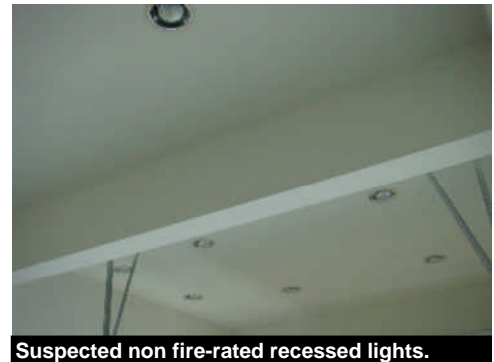
The right side bay in the garage has an added wall, recessed lighting and receptacles. The water heaters have an added enclosure.

Suspected non fire-rated recessed lights.

[SC] The added recessed lights in the ceiling may be a breach in the fire-resistive ceiling. The lights should be evaluated for approved fixture rating, location and installation.

[FE] Building permits should be obtained for the additions to the garage.

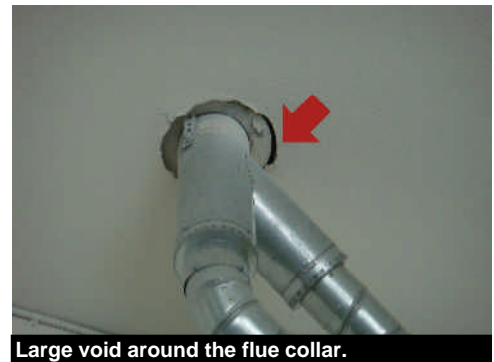
Large void around the flue collar.

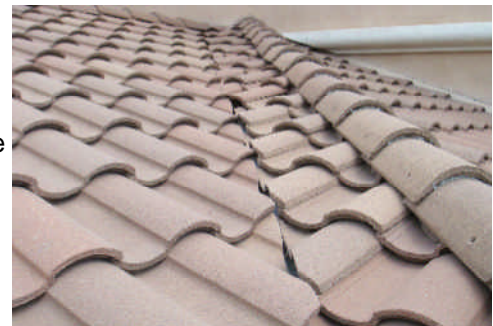
[FE] The valley flashing should be evaluated for tiles blocking water runoff, and all debris be removed.

Closed valley may restrict water runoff.

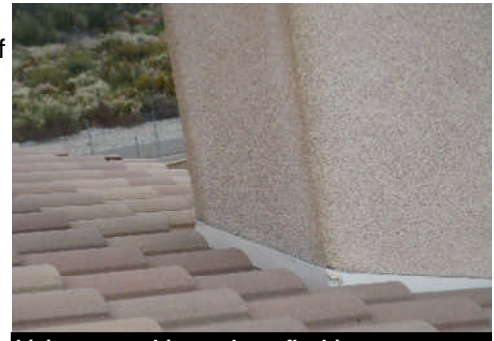
[FE] The chimneys do not appear to have crickets to divert water around the back side of the base flashings. 30 wide chimneys should have crickets.

Living room chimney base flashing.

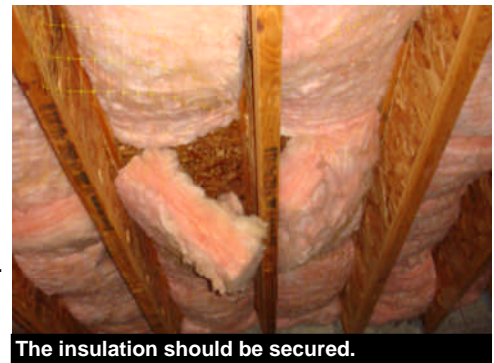
[CR] Insulation is not securely attached to the underside of the floor and has fallen out of a number of joist bays.

The insulation should be secured and in contact to the subfloor without voids and gaps.

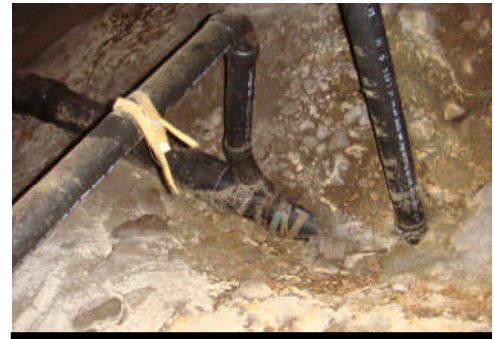
View of the main drain line at rear left.

[FE] The fixture drain pipes /waste pipes operated and drained when tested, no blockage or slow drains were evident. Drain and sewer lines have been known to block at any time whether new construction or older properties. I recommend having a video camera inspection be performed on the drain / waste and sewer piping system prior to close of this transaction.

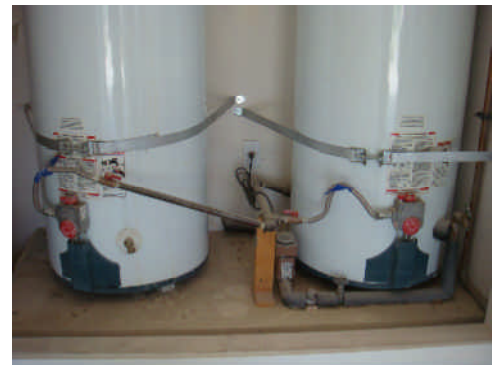
The two original 50 gallon 9 year old natural gas water heater tanks are located in the garage.

[CR] The sheetrock enclosure has been added without proper vent openings.

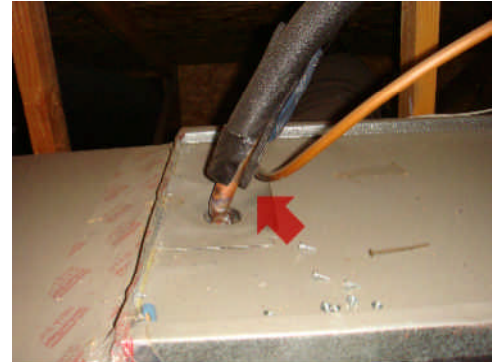
[CR] The lines are lacking bushings and insulation at the cooling coils.

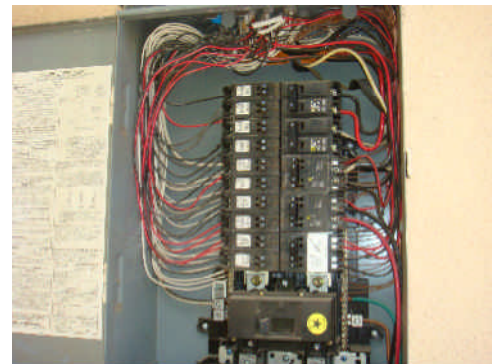
The main panel has 26, 110 volt circuit breakers, and 5, 220 volt circuit breakers.

[CR] A number of the circuit breakers are not labeled or labeled improperly. The circuit breakers should be accurately labeled to allow individual circuits to be shut off for maintenance or emergency needs.
