Pre-purchase Home Inspection Photo Supplement

337 East Lincoln Avenue, Pomona, CA. 91767

Photo Supplement to the Itemized Building Inspection Report

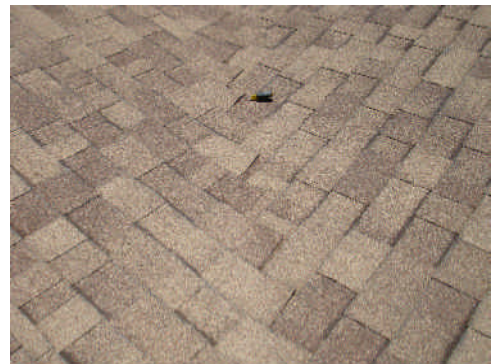
PHOTO # 12

[FE] [CR] The front valley shingle tabs are trapping some debris.

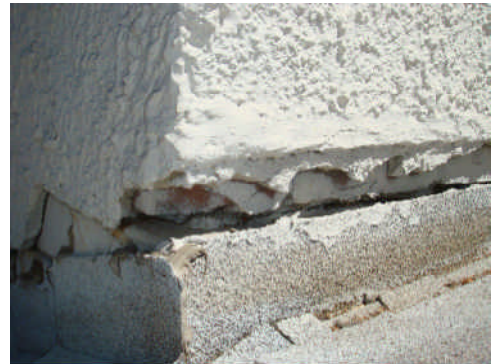
PHOTO # 18

Third picture of #16.

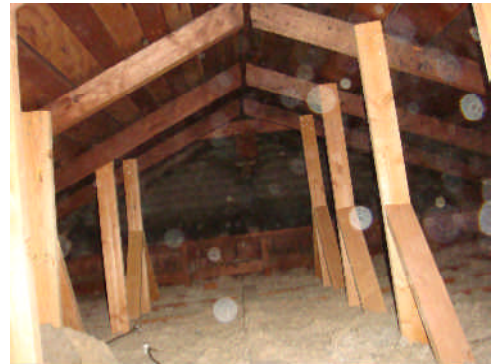
This installation is irregular, due to the added weight to the roof rafters.

[FE] The ceiling joists and wood lath / plaster ceilings are not visible due to the insulation covering.

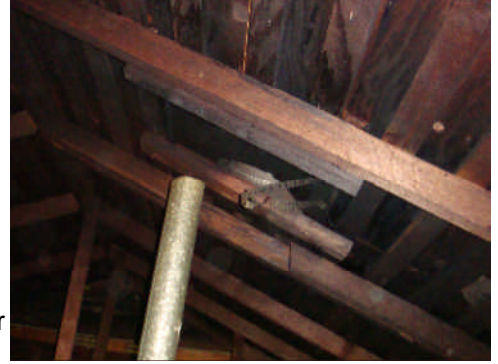
PHOTO # 25

The original basement water heater and furnace would have been vented into the masonry chimney terminating above the roof.

[FE] The framing and roof deck sheathing is black from the furnace and water heater vents venting into the attic below this area.

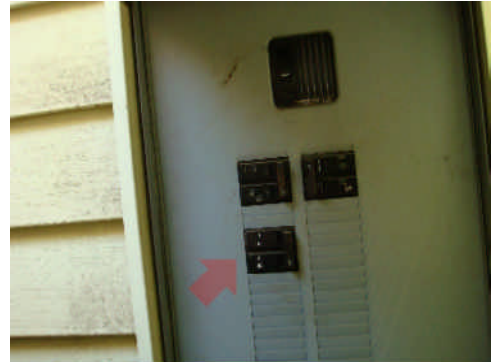
The 100 Amp. disconnect is for the basement sub panel.

The two other circuit breakers appear to be for the A/C units disconnects.

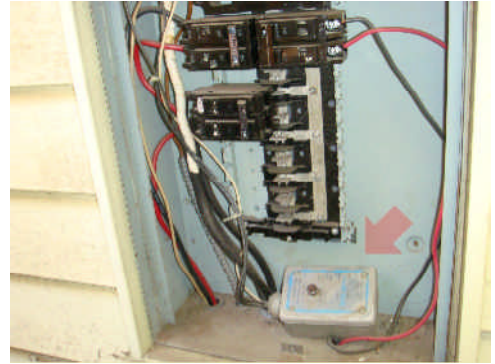
PHOTO # 33

[CR] The added device is improperly wired to the main service conductors.

[FE] [CR] The panel grounding electrode and bonding is not visible.

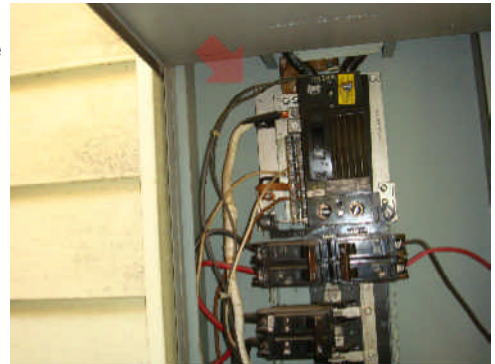
PHOTO # 34

Second picture of #33. The device added wires should be removed from the service conductor lugs.

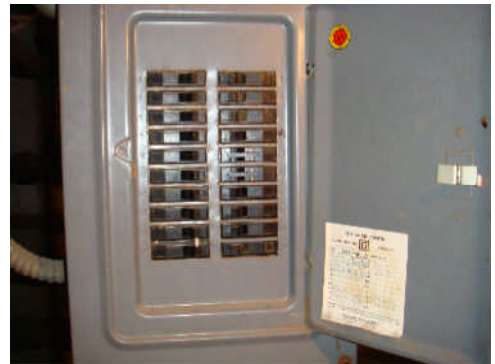
PHOTO # 35

[CR] The basement sub panel circuit breakers are not labeled as required.

[RU] This panel is at it's maximum, no other circuits can be added, and the main disconnect is only at the main panel.

[FE] The panel /box grounding and bonding is not evident.

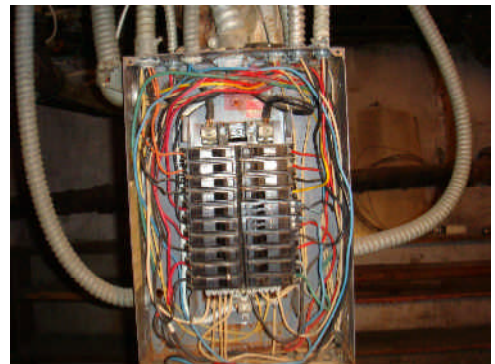
PHOTO # 36

[FE] The power supply feeder stranded wire is installed in an irregular manner.

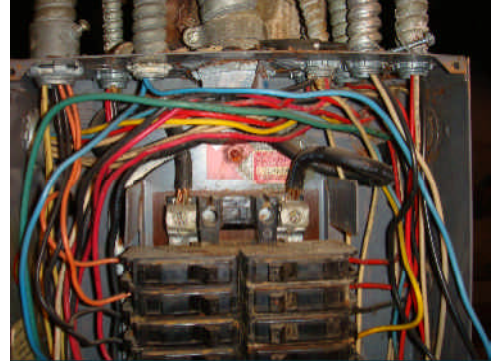
PHOTO # 37

[FE] [CR] Second picture of #36, of the stranded wire installation.

[FE] [RU] The panel box is rusting and corroding.

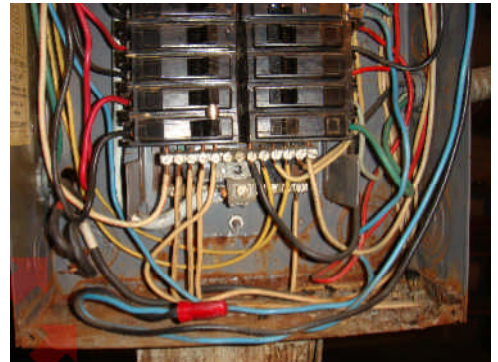
PHOTO # 38

[FE] Third picture of #36, abandoned and dead wires at the bottom of the box.

[FE] The dead wires appear to have been for the 220 volt outlet in the family room and kitchen.

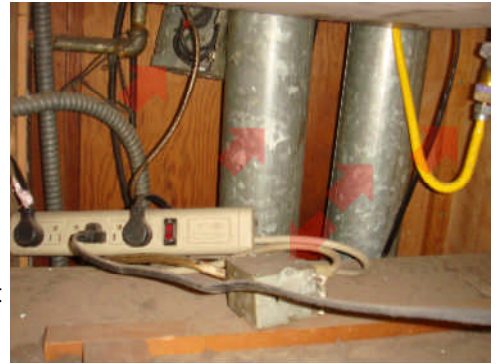
PHOTO # 39

[SC] [FE] [CR] In the kitchen behind the microwave and below the oven is unsecured wiring, open and unsecured junction box.

[SC] [CR] The gas supply to the oven is lacking a gas supply shut off valve.

[SC] [CR] The two metal galvanized pipes are the water heater and furnace gas vent flues. Improper clearance to combustible materials.

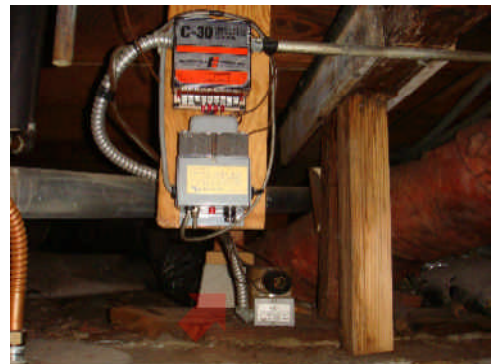
PHOTO # 40

In the basement is abandoned water supply pipes and this control for a solar system.

An abandoned water softener is located below the basement stairs.

[FE] [CR] The abandoned wiring should be disconnected and removed.

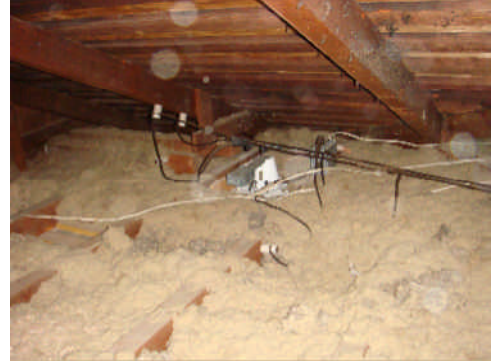
PHOTO # 41

[SC] [FE] [CR] [RU] The original knob & tube wiring has been spliced into improperly with updated wiring, in the attic, basement and garage.

The electrical system and circuit breakers should be evaluated for fire life and safety.

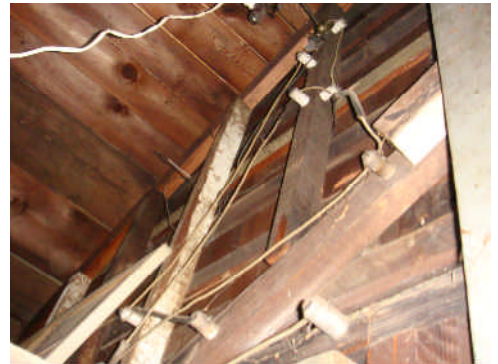
PHOTO # 42

[SC] [RU] Knob and tube wiring in the garage has been altered improperly.

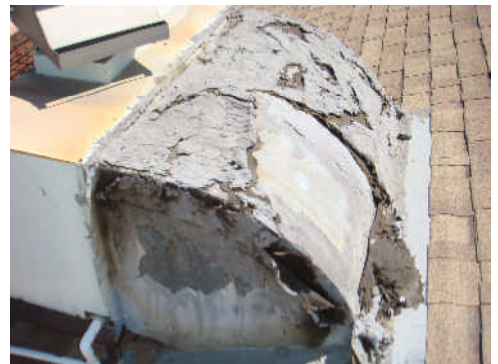
PHOTO # 48

Second picture of #47.

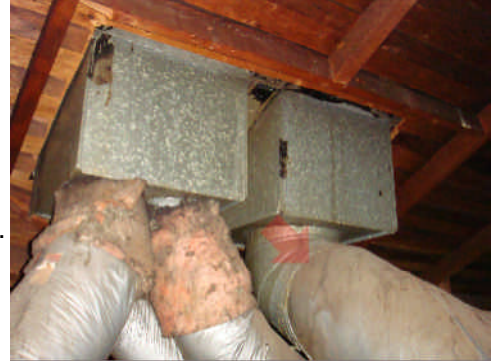
PHOTO # 49

[FE] [CR] Water stains are evident on the plenums and the metal duct connectors are not insulated properly.

[FE] The return air duct to the right is connected at the hall ceiling return air grill. The filter is soiled and should be evaluated, cleaned /replaced.

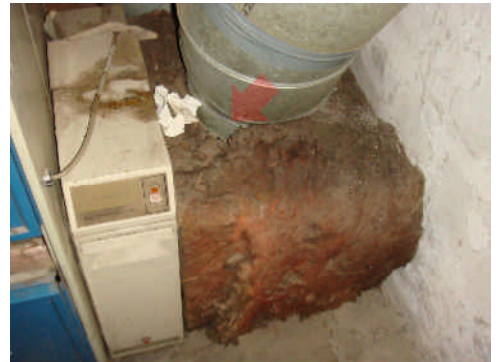
[CR] The furnace return air plenum is leaking air, mastic sealant is lacking.

A second return air duct from the addition is connected to the plenum at the rear of the box.

[FE] The return air grill in the family room addition was not located due to the furniture.

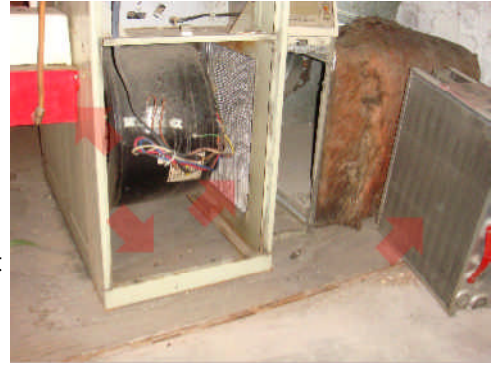
PHOTO # 53

[CR] The electronic pre-filter is improperly after the electronic filter. The electronic filter does not appear to be operating and is soiled.

[FE] [CR] Rodent droppings are evident at the bottom of the furnace.

The box attached to the side of the furnace is the A/C cooling coil condensate drain pump.

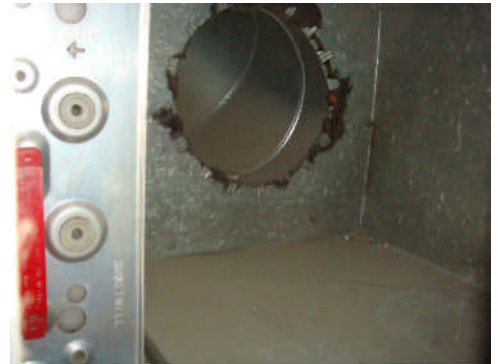
PHOTO # 54

View inside of the return air plenum of the addition air duct connection.

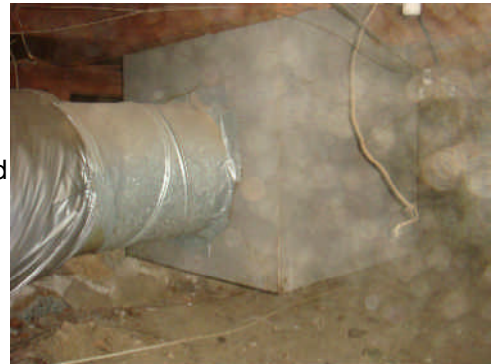
PHOTO # 55

[RU] View of the return air plenum below the living room, the metal box and duct is not insulated.

[FE] [CR] The floor above is soft at this area, the framing should be evaluated and corrected.

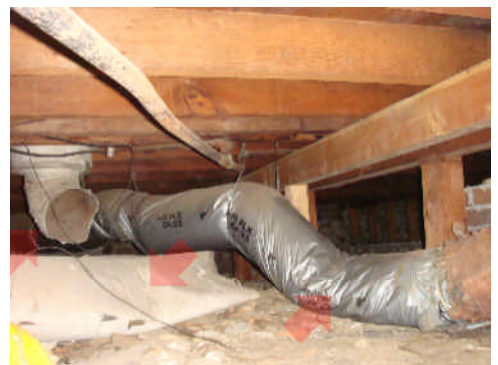
PHOTO # 56

[FE] The original heating ducts are metal with suspected asbestos wrap outside of the ducts.

[FE] [CR] The ducts and wrap are damaged and abandoned in the craw space.

[FE] [CR] The original ducts are in place feeding the second floor wall registers / grills, that are not sealed off.

[CR] The abandoned registers should be sealed off, and the ducts sealed off in the craw space to prevent air transfer.

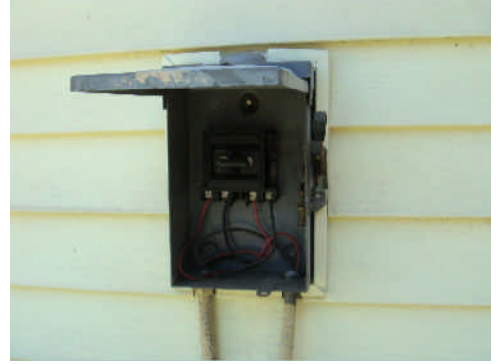
[CR] The family room addition A/C disconnect fuses are oversized and a ground wire is lacking.

[FE] The disconnect box does not appear to be sealed to the wall.

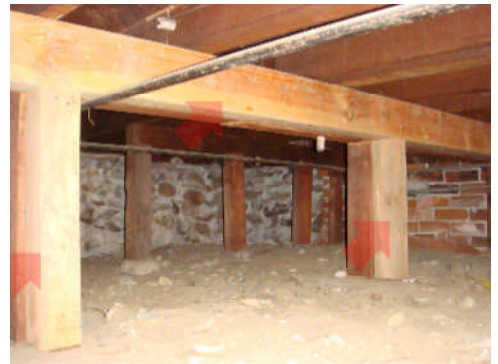
[FE] Added girder and posts evident below the living room and kitchen.

[FE] The posts appear to be on concrete pads, it is unknown if the pads have footings.

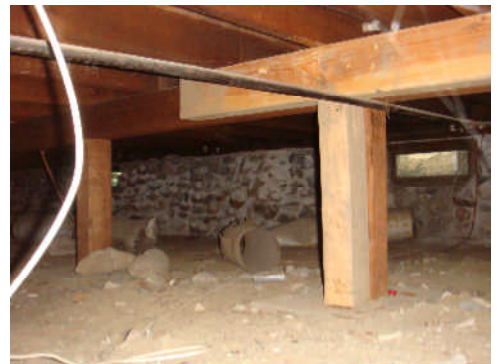
PHOTO # 72

[FE] Second picture of #71, uneven floor area from the living room to the hall / stairs.

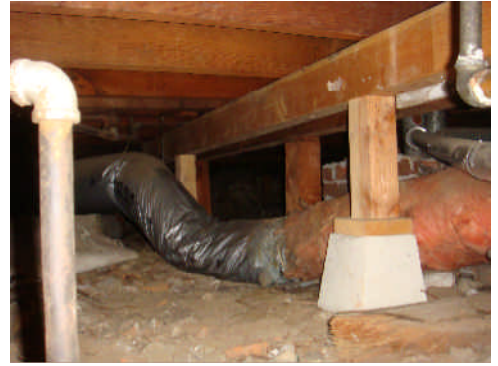
PHOTO # 73

[FE] View of the added pier, posts and girder below the kitchen.

The pier does not appear to be on a footing.

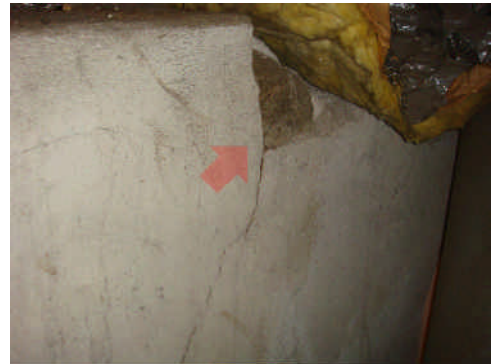
PHOTO # 74

[FE] The basement walls are unreinforced stone masonry with a parg coating.

The parg coat has broken off at this area exposing the stone.

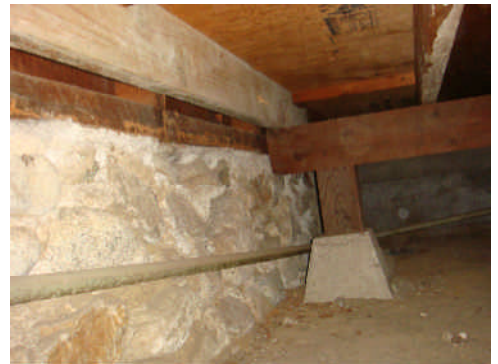
PHOTO # 75

View at the rear left below the addition and original foundation.

[FE] This area was not accessed due to the heating ducts blocking access.

[CR] The pipe is unsecured.

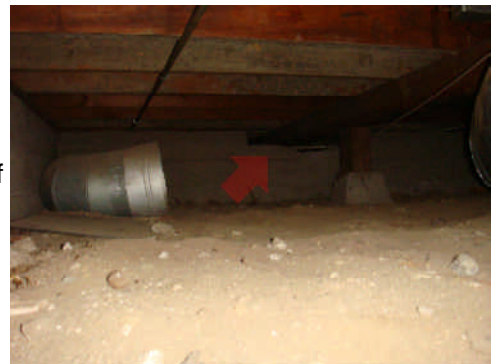
PHOTO # 76

View at the rear right of the addition crawlspace, inaccessible due to the heating ducts.

[FE] The concrete foundation appears to have been broken off for the installation of the girder. This is irregular.

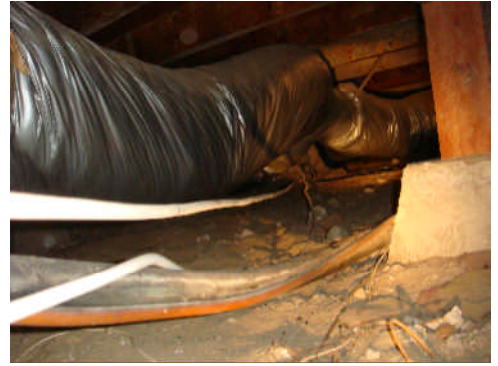
PHOTO # 77

[FE] View at the left area of the addition crawl space. Not accessed due to the ducts and systems.

[CR] The addition A/C freon lines are not secured properly.

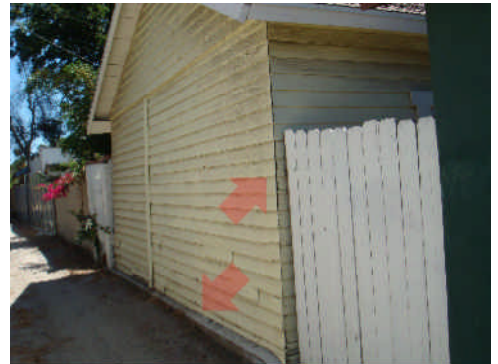
PHOTO # 78

[FE] The corner of the garage wall is separated up to 3/8"

[CR] The curbs have been placed as a correction for improper grading or drainage.

[FE] The garage does not appear to have been built on a foundation.

Roof gutters are recommend to direct water away from the garage.

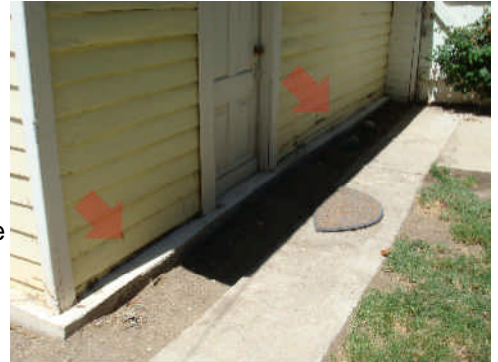
PHOTO # 79

[FE] Second picture of #78, I recommend digging to determine if a foundation is present.

[RU] A concrete sidewalk is recommend to be placed below the wall siding and wall framing, to divert water away from the garage.

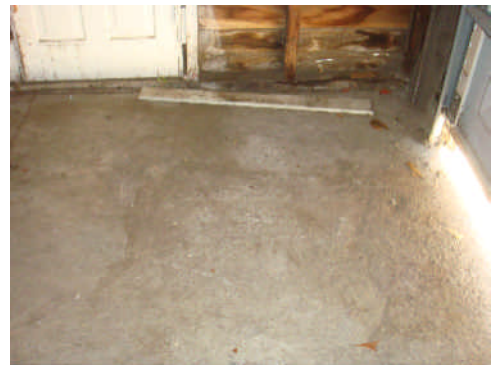
PHOTO # 80

[FE] Evidence of moisture intrusion into the garage, the wall framing and siding is moisture stained.

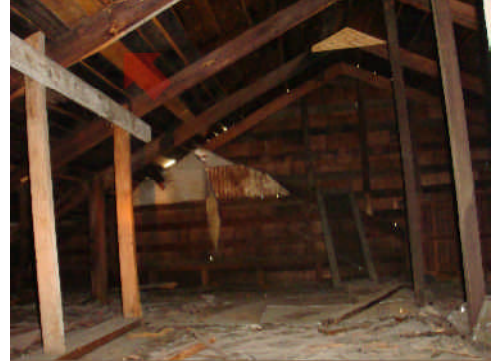
PHOTO # 81

[CR] The garage roof rafters are cracked and damaged.

Improper repairs are evident.

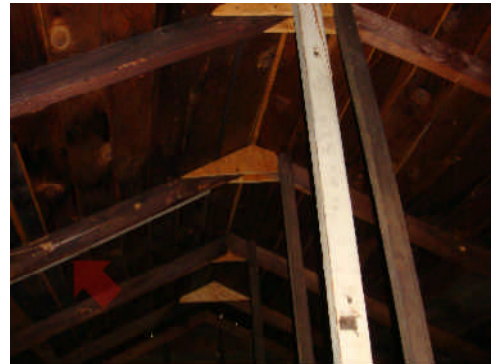
PHOTO # 82

[RU] Second picture of #81. The roof rafter spacing is double the spacing of a 1940 ties rafter spacing.

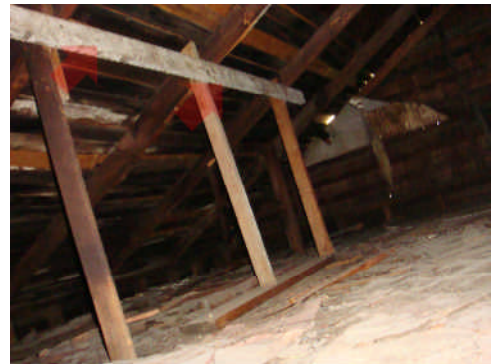
PHOTO # 83

[CR] The added perlin rafter support is supported below the ceiling from irregular metal studs.

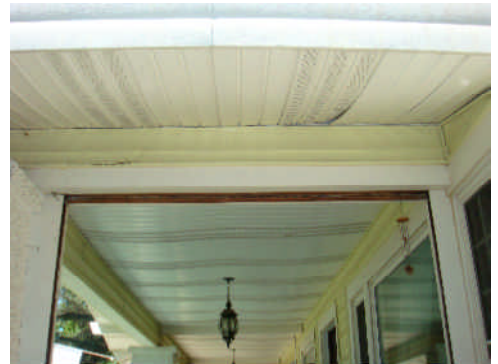
PHOTO # 84

[FE] The added vinyl siding at the eaves and porch is sagging.

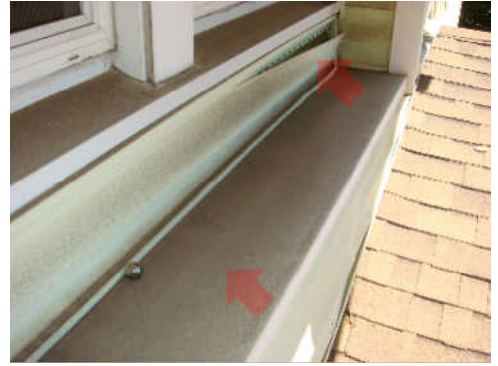
PHOTO # 85

[CR] The front pot shelf slopes towards the wall improperly, and the siding is separated.

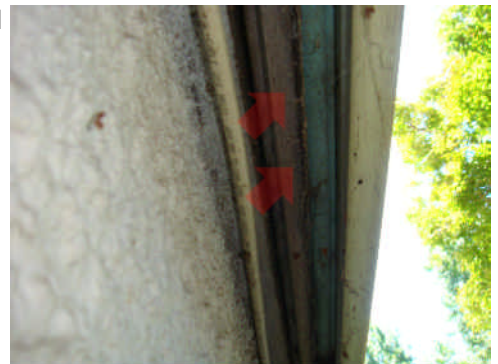
View of the bottom termination of the vinyl siding.

[FE] Lacking visible drainage system for possible water intrusion into the back side of the vinyl siding.

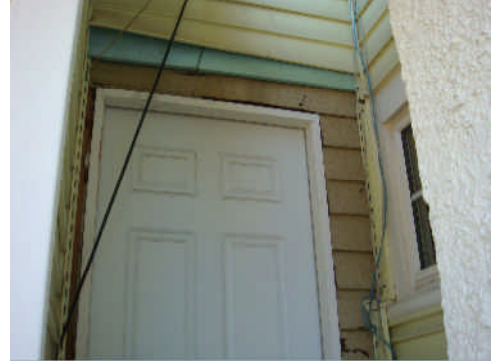
PHOTO # 89

[SC] [CR] The added exit door at the left side of the house does not comply with building standards and is a safety hazard.

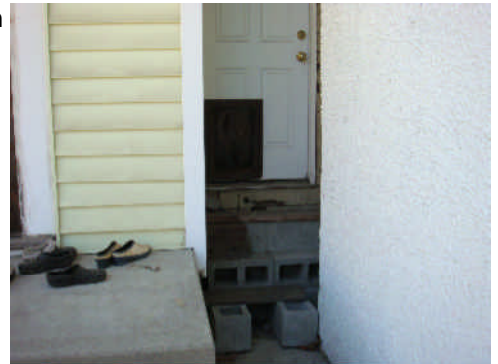
PHOTO # 90

Second picture of #89, the space between the chimney and house is only 24"

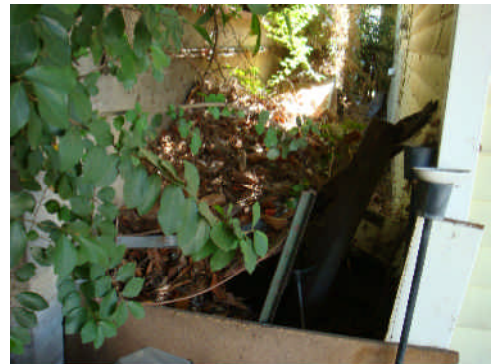
PHOTO # 91

[CR] The debris at the right side of the house should be removed for emergency personal and access to the electrical panel.

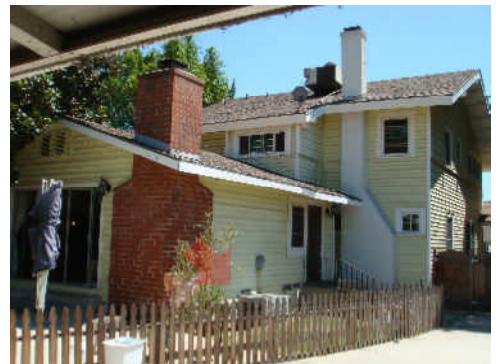
PHOTO # 92

[CR] The soil at the left side of the addition should be back filled and compacted.
